Reference: G0186 AA_RE01

Broken Hill Operations (BHOP) – Rasp Mine

RE: GEOTECHNICAL ASSESSMENT OF THE MLD DRIVE BELOW THE KINTORE PIT

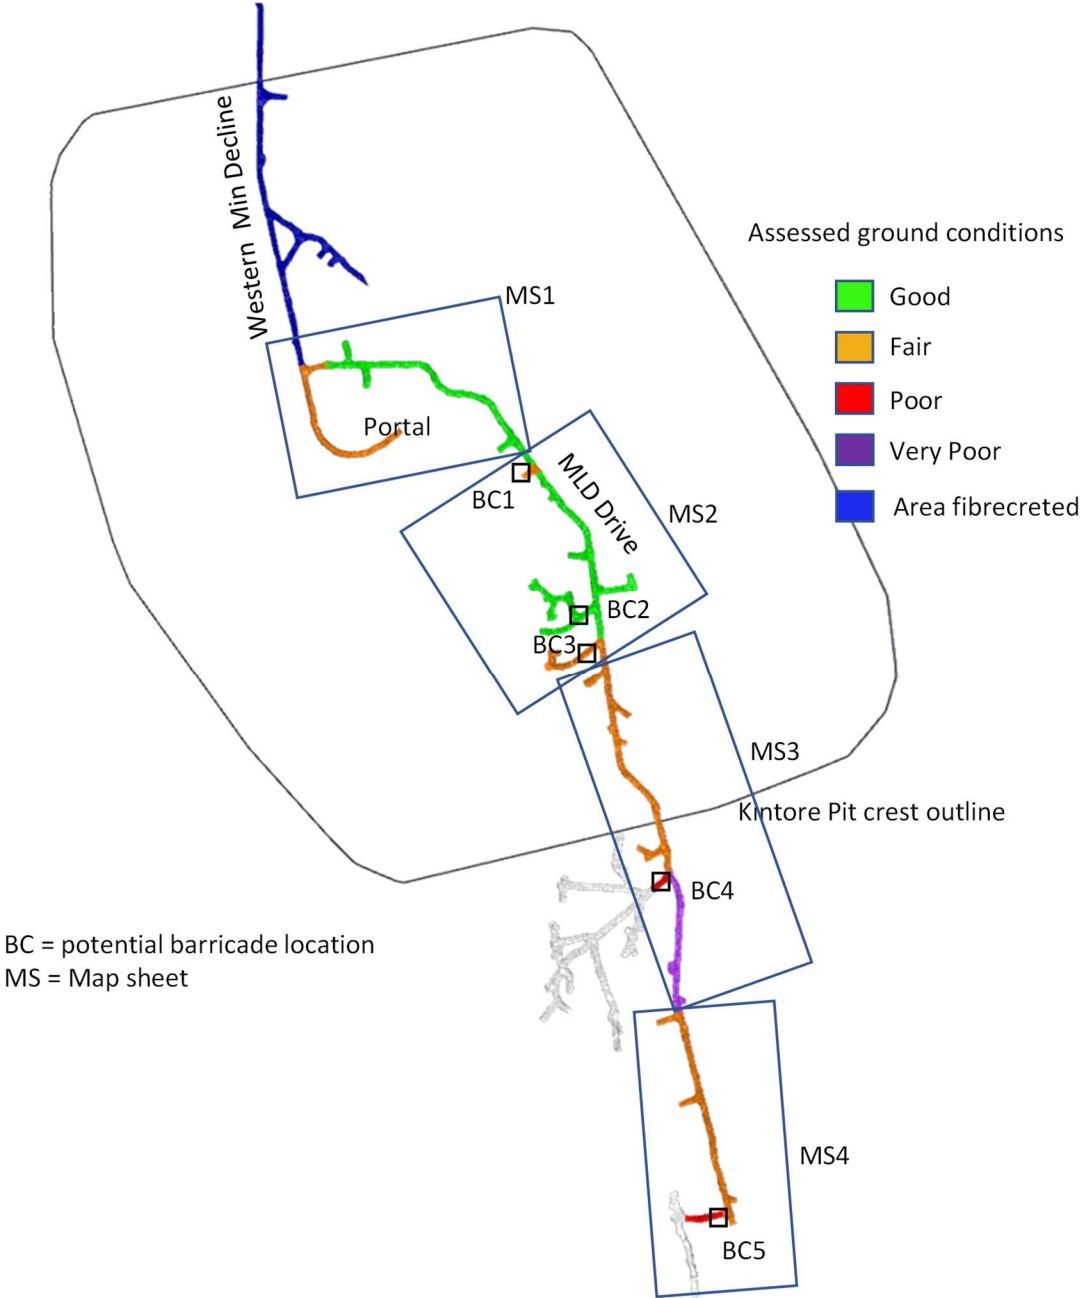
Figure 3 Geotechnical conditions for the Western Min decline (Portal to MLD intersection) and MLD Drive

The geotechnical conditions for each zone are summarised in Table 6 and shown in Figure 3. In general, the ground conditions were sound with only minor, local areas of lower strength rock (associated with shear zones).

Zone	Estimated Rock Strength	Q	Rock mass Description	Major Structures	Water Ingress	Ground Support (GS)
PORTAL TO MLD T/O	R4	4.00	Fair	Two small shears near t/o to MLD	None observed, however GS corroded and salt precipitation (Photo 01)	Fibrecrete: good Spilt sets corroded
MLD STOCKPILE-NORTH (9700 E)	R3	13.63	Good	None observed	None observed, however GS corroded and salt precipitation	Fibrecrete: good Spilt sets corroded
MLD STOCKPILE-SOUTH (9725 E)	R4	15.00	Good	None observed	None observed, however GS corroded and salt precipitation	Fibrecrete: good Spilt sets corroded
MLD	R4	18.17	Good	None observed	~0.2 L/min dripping from ungrouted hole in backs. Corrosion and heavy salt precipitation (Photos 02 and 03)	Fibrecrete: good Spilt sets corroded
MLD CROWNS-BARRICADE SITE 1	R3-R4	3.25	Poor	Minor shear (intact), some surface staining	None observed, however GS corroded and salt precipitation	Fibrecrete: good Spilt sets corroded

MLD CROWNS-BARRICADE SITE 2	R4	21.19	Good	None observed	None observed, however GS corroded and salt precipitation	Fibrecrete: good Spilt sets corroded
MLD CROWNS-BARRICADE SITE 3	R3-R4	7.10	Fair	Shear zone: ~1 m wide, R3 (Photo 04)	None observed, however GS corroded and salt precipitation	Fibrecrete: good Spilt sets corroded

Zone	Estimated Rock Strength	Q	Rock mass Description	Major Structures	Water Ingress	Ground Support (GS)
MLD	R3-R4	5.50	Poor	Shear zone (~1100 N): ~0.5 m wide, R2 with some clay	None observed, however GS corroded and salt precipitation	Fibrecrete: good Spilt sets corroded
MLD CROWNS - BARRICADE SITE 4	R3-R4	0.90	Very Poor	Shear zone: ~1 m wide, R3, RQD ~10-20%, salt precipitation	None observed, however GS corroded and salt precipitation	Fibrecrete: good Spilt sets corroded
MLD: STOCKPILE (850 N)	R3-R4	1.21	Poor	Shear zone: around pegmatite, crushed infill 50 mm	None observed, however GS corroded and salt precipitation	Fibrecrete: good Spilt sets corroded
MLD: STOCKPILE (770 N)	R3-R4	5.50	Fair	Minor shear: some surface weathering	Very small amount of water dripping from GS openings. GS corroded, heavy salt precipitation	Fibrecrete: good Spilt sets corroded
MLD: F PILLAR-BARRICADE SITE 5	R3-R4	2.13	Poor	Shear zone: intact, R3-R4, follows foliation	None observed, however GS corroded and salt precipitation	Fibrecrete: good Spilt sets corroded and damaged due to re-stripping drive

MLD-F PILLAR	R3-R4	5.58	Fair	None observed	None observed, however GS corroded and salt precipitation	Fibrecrete: good Spilt sets corroded

If access to the MLD Drive is required post tailing disposal, it is recommended to install engineered barricades where the MLD drive intersects the old workings to control potential inundation risks. The barricades should be installed prior to the commencement of tailing placement.

Where access to the MLD Drive is not required post tailing disposal, it is recommended that waste rock is placed in the MLD Drive to prevent access prior to the commencement of tailing placement.
