**RE: KINTORE OPEN PIT – STABILITY ANALYSIS OF PIT SLOPE COMPRISING HISTORIC TAILINGS**

### Kintore Pit Historic Tailings Slope Stability Modelling Results Summary

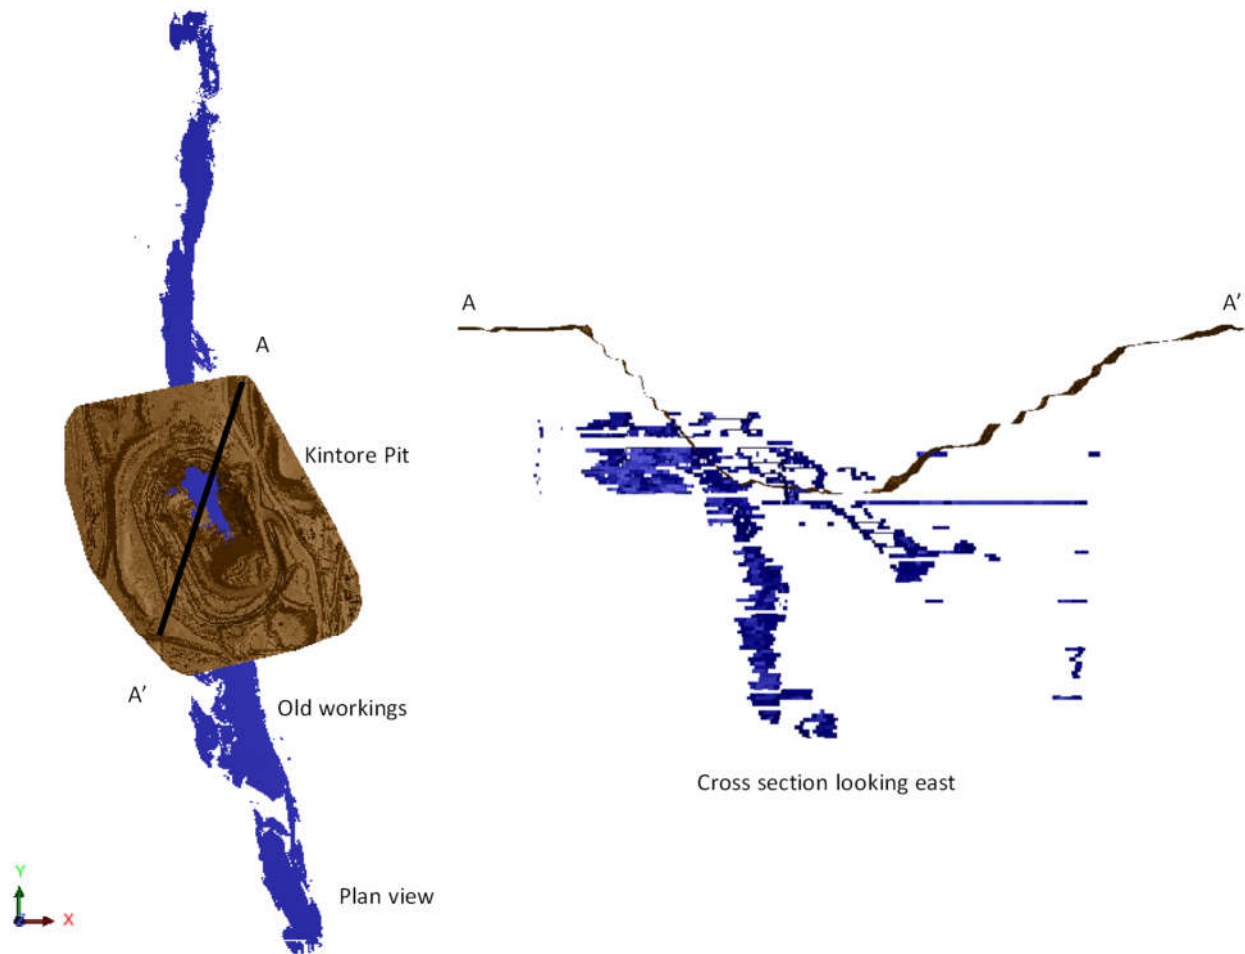
**Figure 1** Section line location with respect to existing as-built pit

The location of the section line where the cross-sections were generated for the analyses is shown in Figure 1. The location was selected by GCE to evaluate the likely 'worst case' slope configurations, approximately perpendicular to the historic tailings slope and with consideration of the most likely failure mechanism.

The 2D modeling does not incorporate or quantify the stabilizing influence of confinement related to the circular pit geometry. The stability of the remnant tailings slope will likely be positively influenced by slope confinement geometry in the pit corner, as shown in Figure 1.

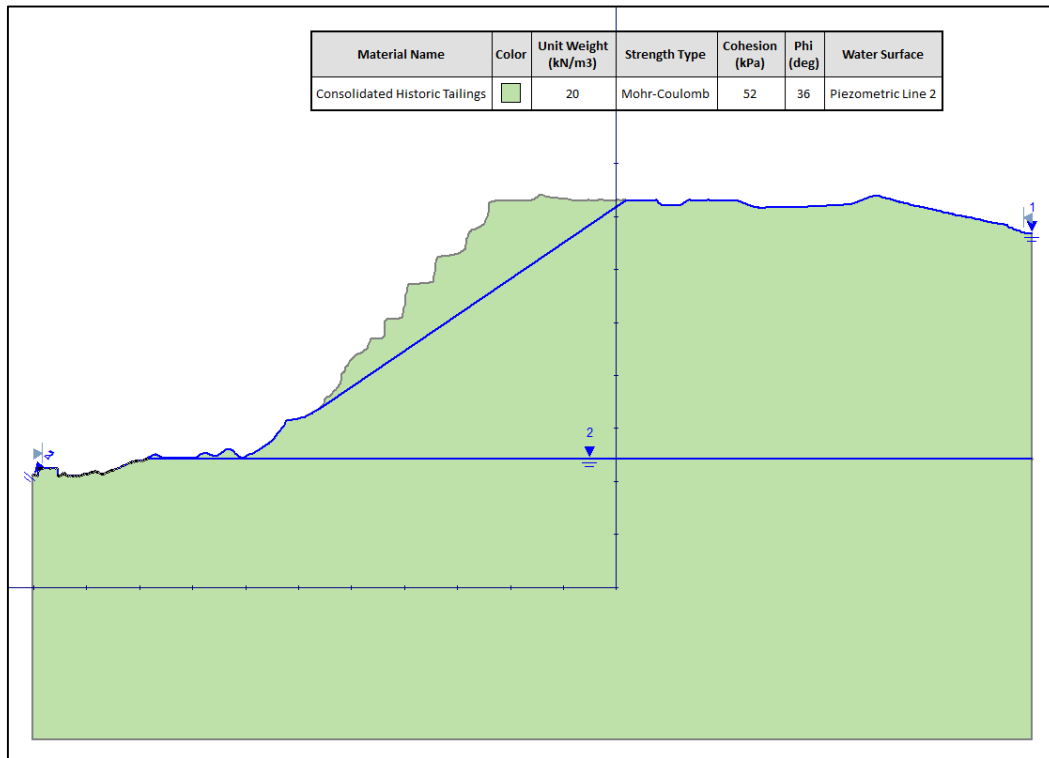
**Figure 2** Slope configuration #1 – no ‘new’ tailings

Existing historic tailings pit wall slope, prior to commencement of backfilling pit with ‘new’ tailings, as shown in Figure 2.

- Dry case and horizontal piezometric surface case
  - No failure surfaces are indicated at  $FOS < 1$ .
  - Minimum  $FOS = 1.142$ , corresponding to a multi-batter slope scale circular failure surface with moderate depth of failure. This indicates that, with the estimated material properties applied, the existing dry slope is relatively close to the threshold of stability.
  - At  $FOS < 1.3$ , numerous potential multi-batter slope scale failure surfaces are indicated.
- Sloped piezometric surface case
  - Significant reduction in slope stability from the dry condition. However, as described in Section 3.4, the historic tailings slope is understood by GCE to be highly permeable, effectively free draining, and hence this worst case groundwater scenario is considered to be unlikely.

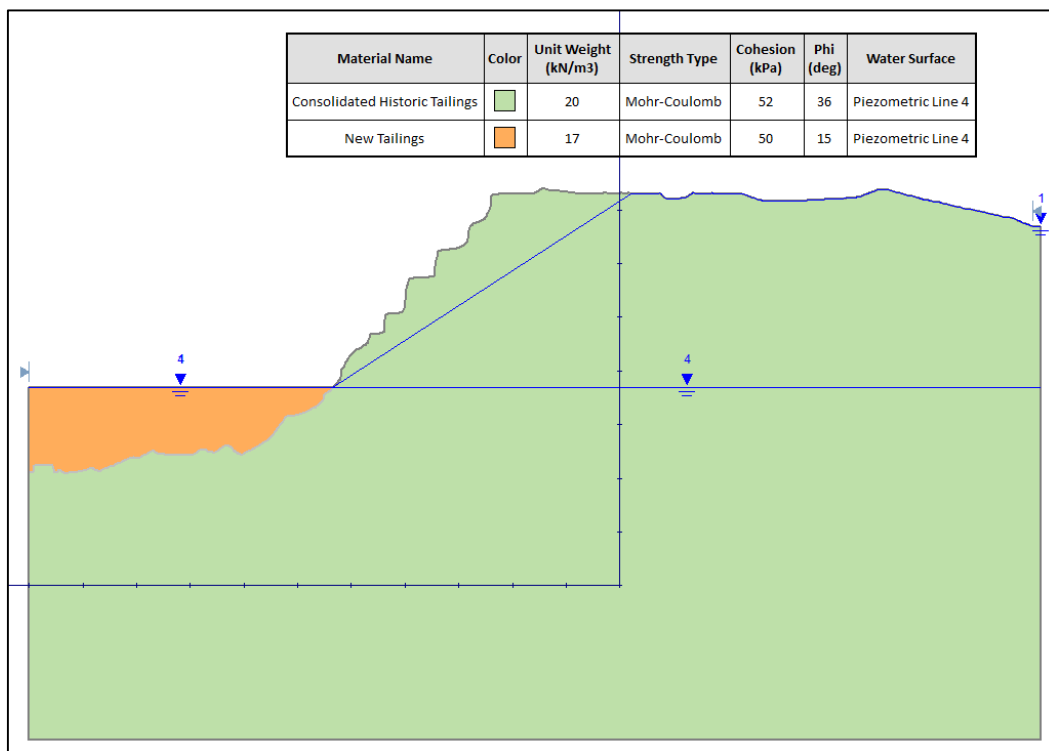
**Figure 3** Slope configuration #2 - 25m of ‘new’ tailings

Placement of 25m of ‘new’ tailings in the pit, adjacent to the existing historic tailings pit wall slope, as shown in Figure 3.

- Dry case and horizontal piezometric surface case
  - No failure surfaces are indicated at  $FOS < 1$ .
  - Minimum  $FOS = 1.164$ , corresponding to a multi-batter slope scale failure surface from the top of the 'new' tailings to the pit crest. This indicates that, with the estimated material properties applied, the slope is relatively close to the threshold of instability.
  - At  $FOS < 1.3$ , numerous potential multi-batter slope scale failure surfaces are indicated. However, slope stability is somewhat increased from slope configuration #1 - no 'new' tailings case.
- Sloped piezometric surface case
  - Significant slope scale instability at  $FOS = 1.116$ . In this case, potential for circular failure resulting in significant floor heave through the tailings is indicated at  $FOS < 1.3$ .

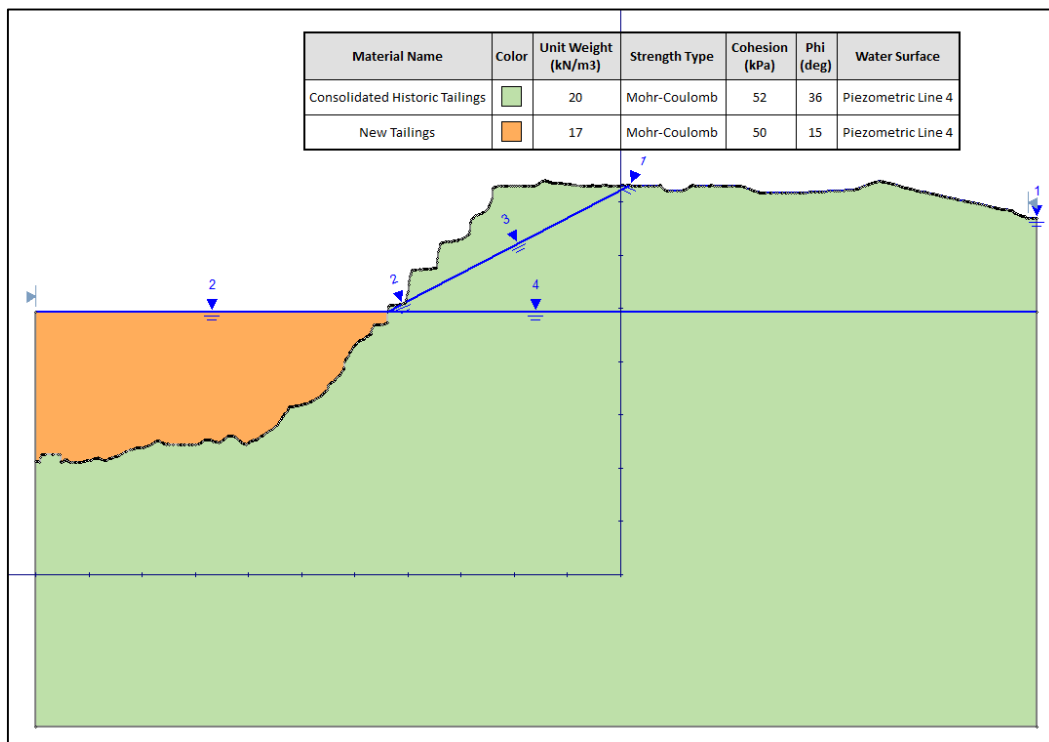
**Figure 4** Slope configuration #3 - 50m of 'new' tailings

Placement of 50m of 'new' tailings in the pit, adjacent to the existing historic tailings pit wall slope, as shown in Figure 3.

- Dry case and horizontal piezometric surface case
  - No failure surfaces are indicated at  $FOS < 1$ .
  - Minimum  $FOS = 1.421$ , corresponding to a multi-batter slope scale failure surface from the top of the 'new' tailings to the pit crest.
  - At  $FOS < 1.3$ , no failure surface is indicated. Slope stability is significantly increased from slope configurations #1 and #2.
- Sloped piezometric surface case
  - No material change or reduction in slope stability from the dry condition.

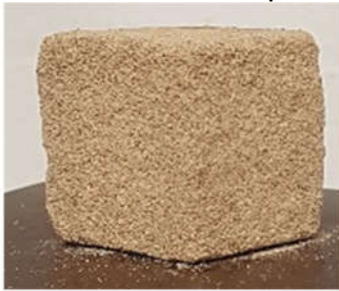
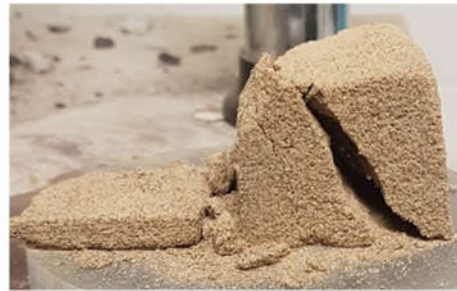
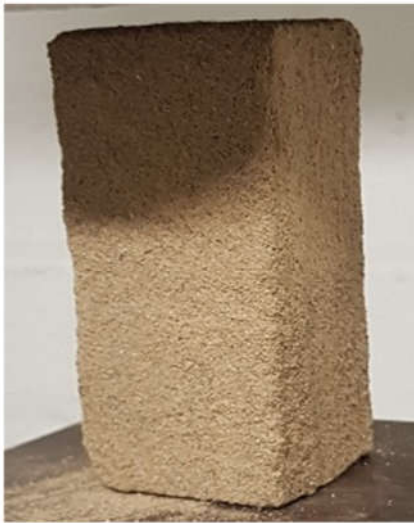
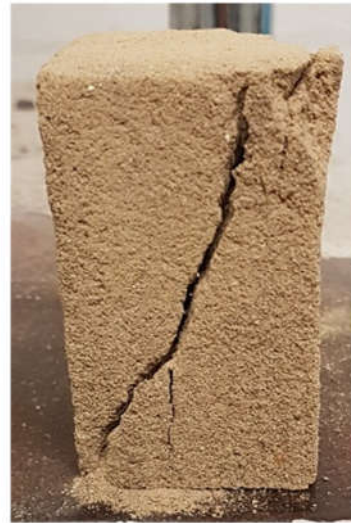
**Figure 5 Unsaturated UCS test samples**

The insitu material was successfully tested under dry conditions, however, total disintegration and strength loss was observed under saturated conditions.

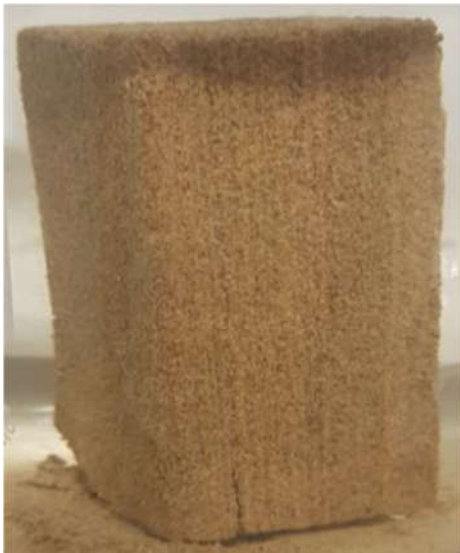
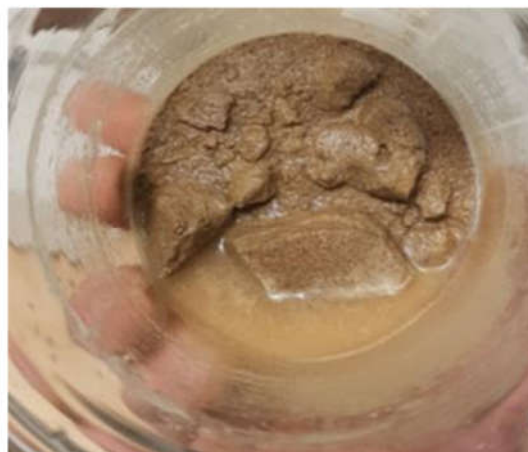
**Figure 6 Saturated UCS test results**

Material testing conducted has highlighted the potential for disintegration of the historic tailings material when saturated with water. BHOP should consider the potential for slope washout at the toe of the historic tailings slope following significant rainfall events. Water must not be allowed to accumulate and 'pond' at the toe of the historic tailings slope while placing 'new' tailings in the pit.

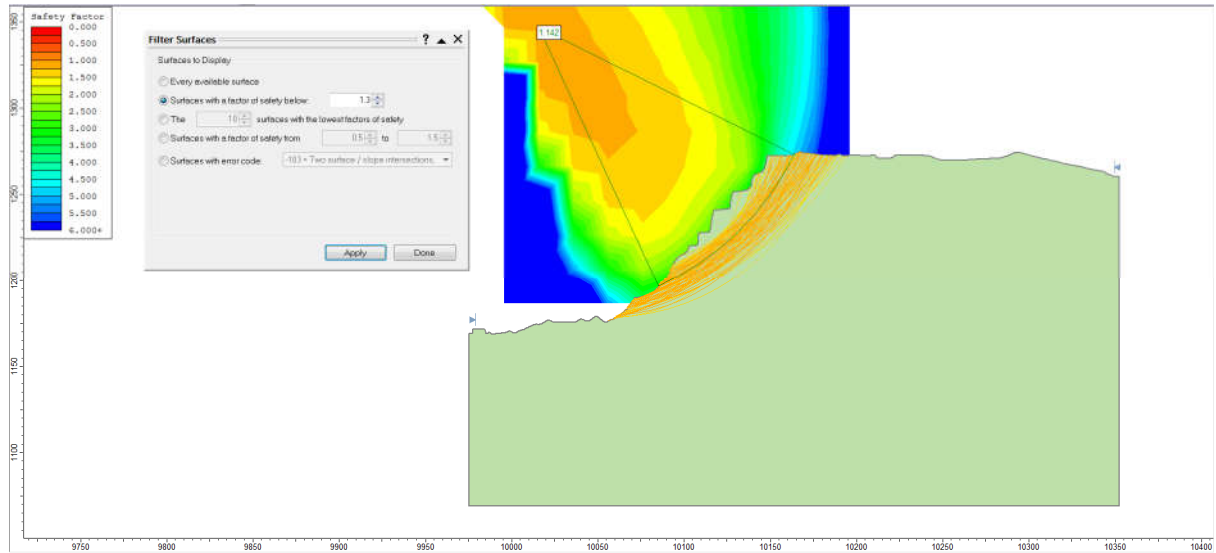
**A. No tailings, no water**

- FOS min = 1.142, multi-batter slope scale failure.
- FOS < 1.3, numerous failure surfaces indicating significant slope scale failure potential.

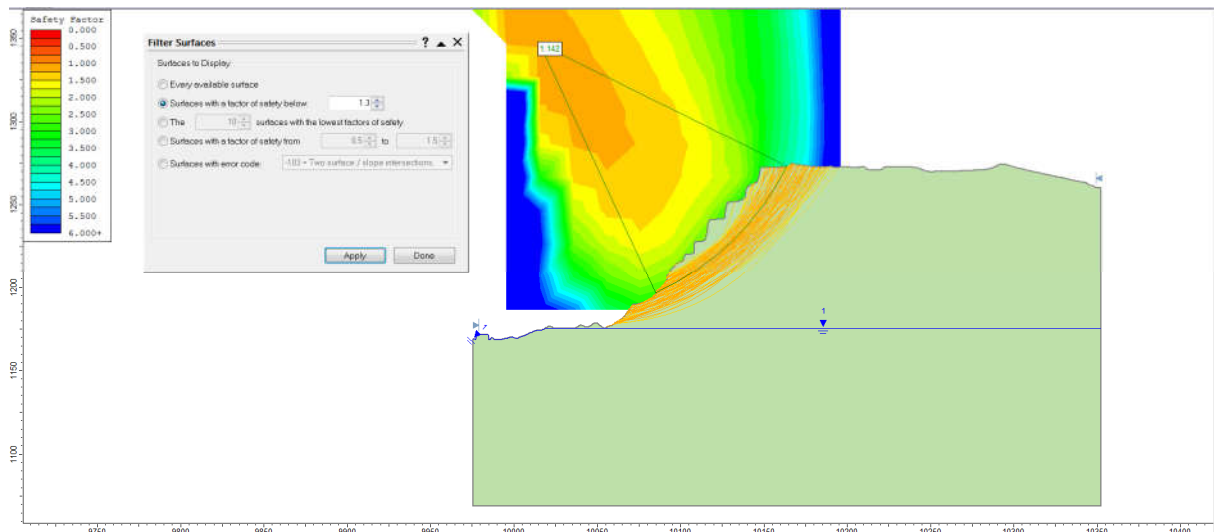
**B. No tailings, horizontal water table at base of pit**

- FOS min = 1.142, multi-batter slope scale failure.
- FOS < 1.3, numerous failure surfaces indicating significant slope scale failure potential.
- No material change from dry condition.

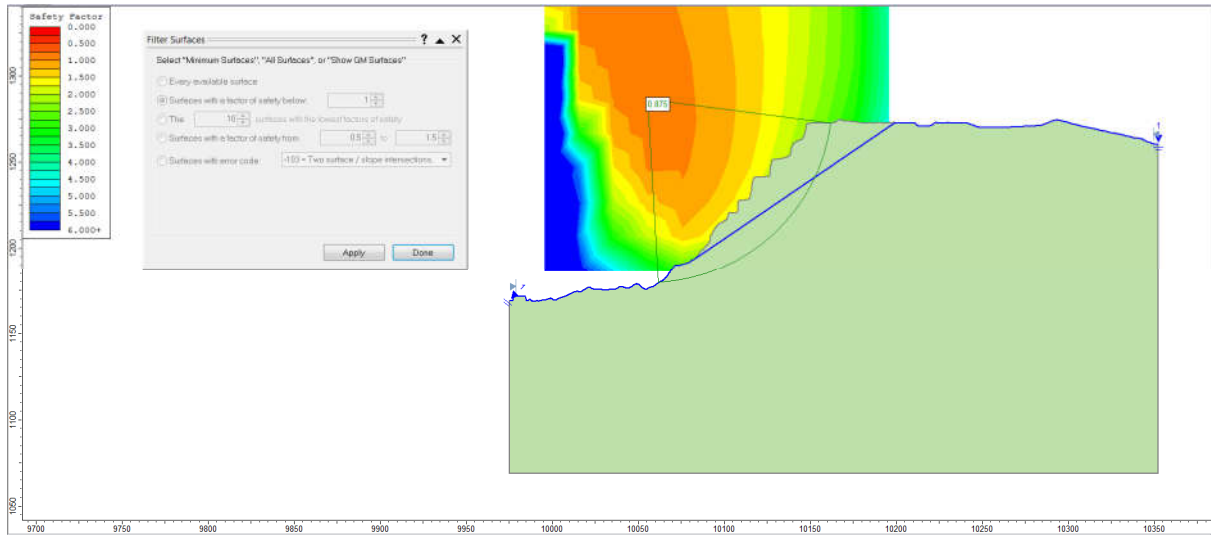
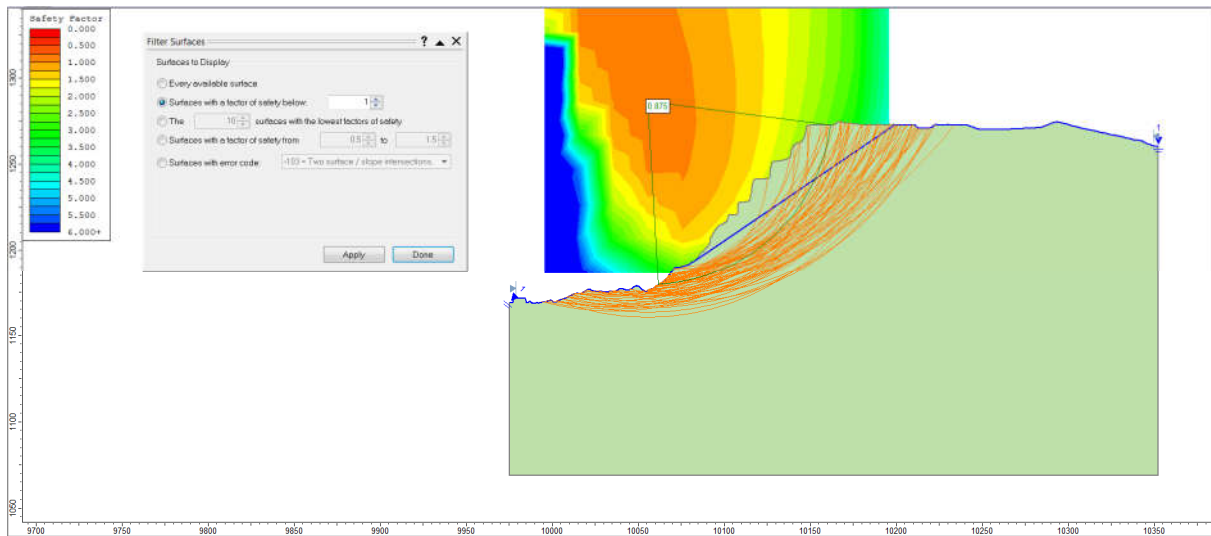
### C. No tailings, water sloped from base of pit to 50m setback from pit crest (“worst case”)

- FOS min = 0.875, significant multi-batter slope scale failure indicated.
- FOS < 1.0, significant slope scale failure, including floor heave indicated.
- Significant reduction in stability from dry condition. Low likelihood, transient groundwater condition.

- Given the reduction in slope stability indicated by the modelling for the sloped groundwater scenarios, GCE recommends that Rasp determine an appropriate stand-off period and procedure following rainfall events or if pooled water is observed at the base of the tailings slope, whereby the tailings slope (crest and toe) will be isolated and access to the pit will be restricted until any accumulated groundwater has drained from the pit walls. These restrictions are required while filtered tailings are being placed in the Kintore Pit and personnel access is required.

- The installation of groundwater monitoring bores in the tailings slope is recommended to ensure that the level of piezometric surface remains below the “worst case” modelling configuration.

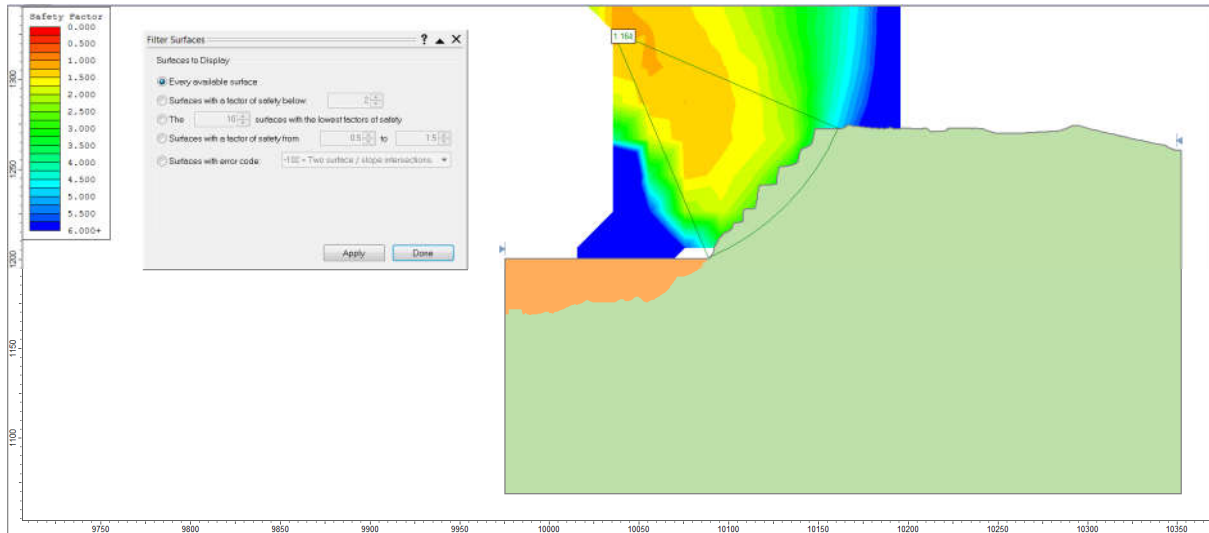
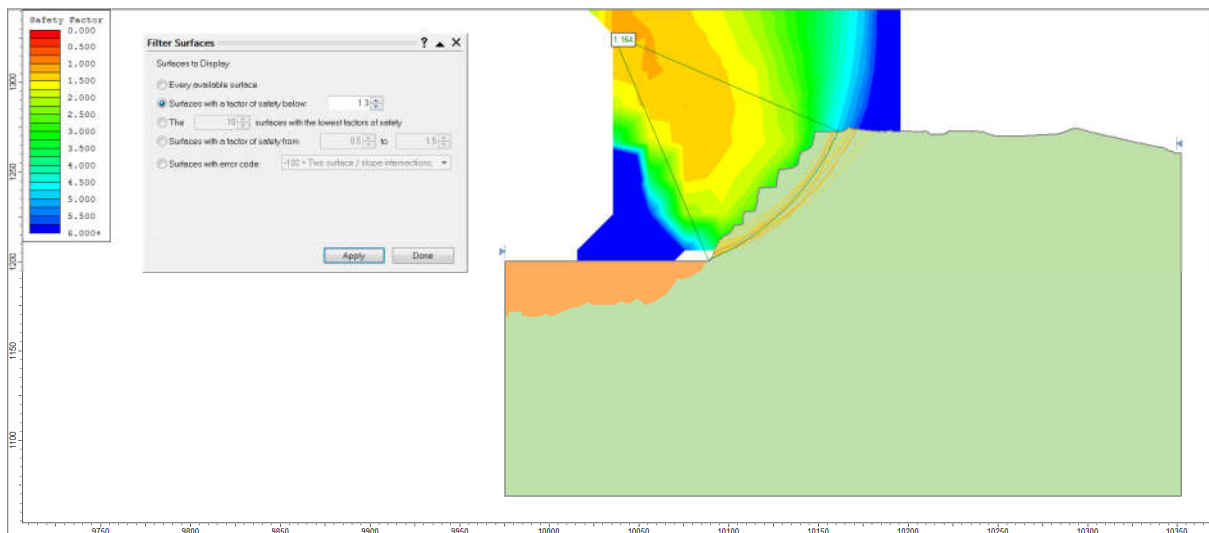
### A. 25m tailings, no water

- FOS min = 1.164, slope scale failure
- FOS < 1.3, significant slope scale failure indicated. However, stability slightly increased from 'no tailings' case. i.e. current slope configuration.

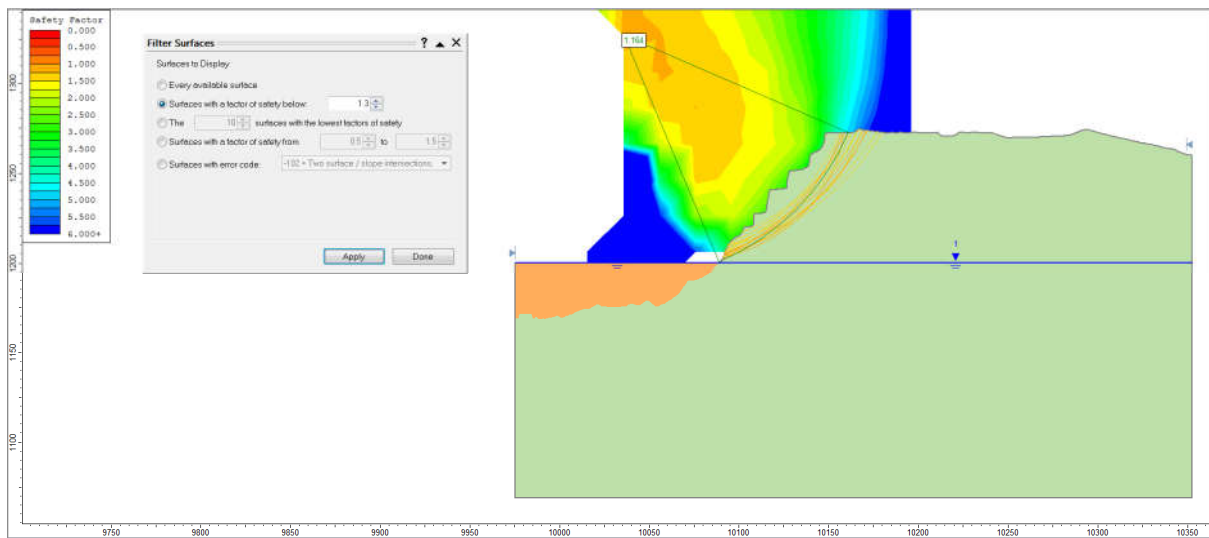
## B. 25m tailings, horizontal water table at top of tailings

- FOS min = 1.164, slope scale failure.
- FOS < 1.3, significant slope scale failure indicated.
- No material change from dry condition.

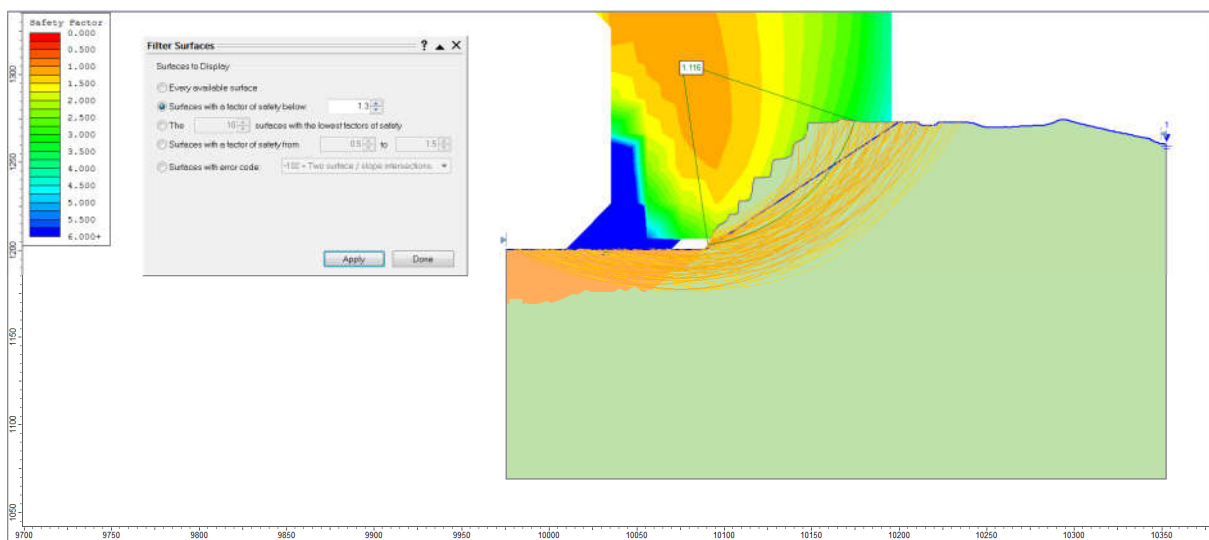
## C. 25m tailings, water sloped from top of tailings to 50m setback from pit crest ("worst case")

- FOS min = 1.116, slope scale failure.
- FOS < 1.3, significant slope scale failure, including floor heave indicated.
- Significant reduction in stability from dry condition. Low likelihood, transient groundwater condition.

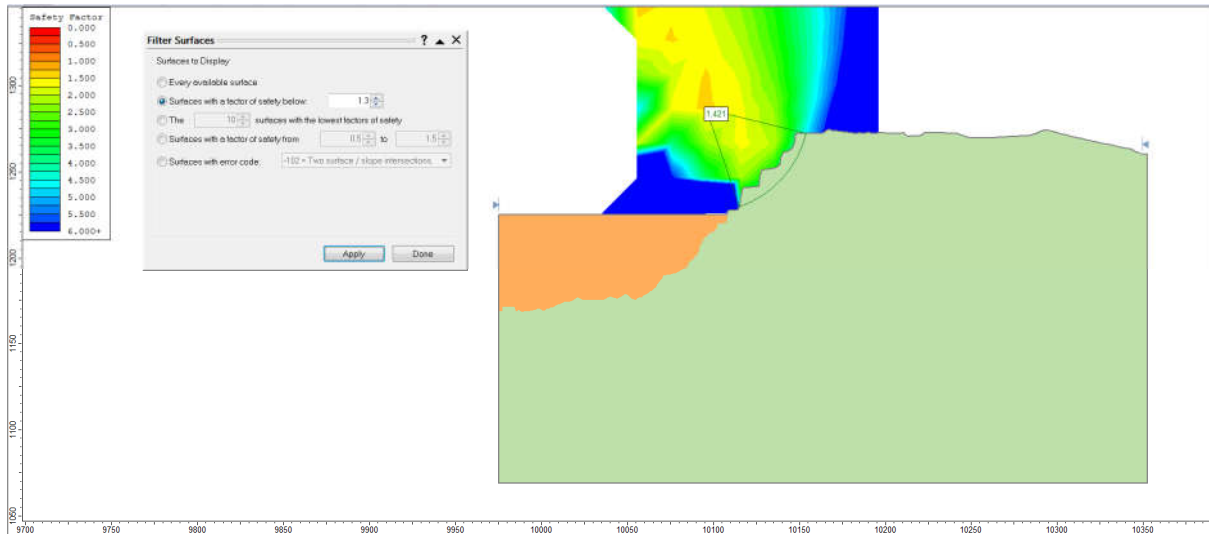
### A. 50m tailings, no water

- FOS min = 1.421, slope scale failure to top of tailings.
- FOS < 1.3, no failure surfaces indicated. Stability significantly increased from 'no tailings' case. i.e. current slope configuration.

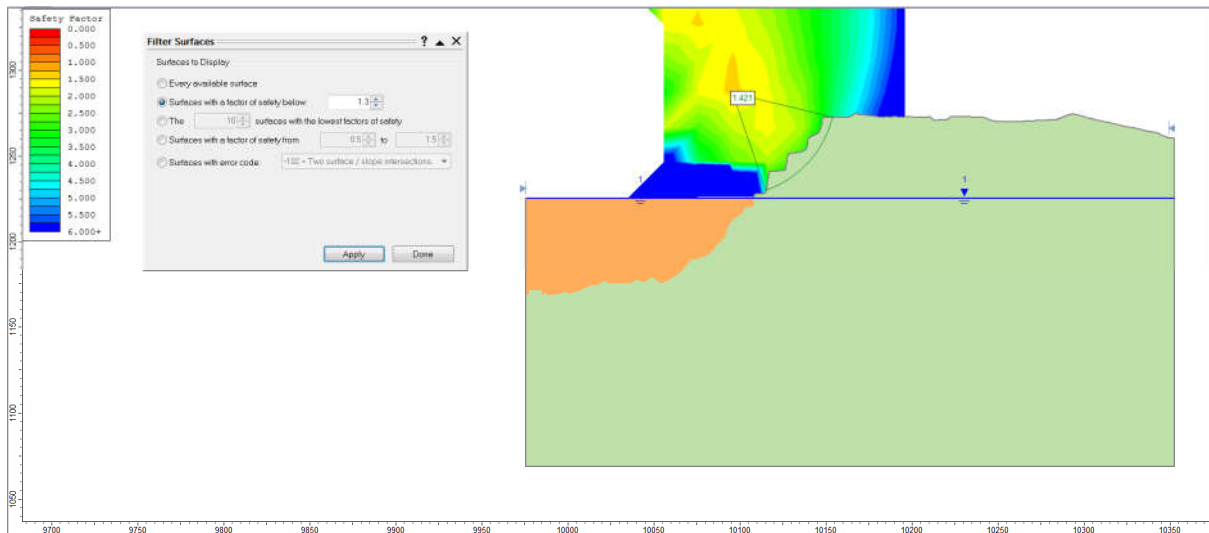
### B. 50m tailings, horizontal water table at top of tailings

- FOS min = 1.421, slope scale failure to top of tailings.
- FOS < 1.3, no failure surfaces indicated.
- No change from dry condition.

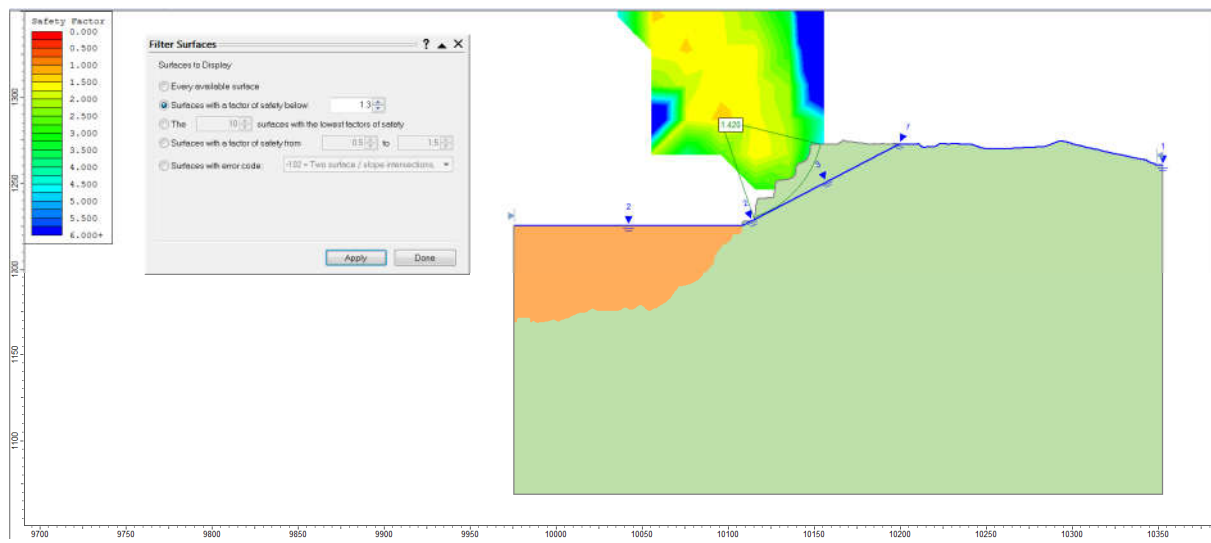
**C. 50m tailings, water sloped from top of tailings to 50m setback from pit crest (“worst case”)**

- FOS min = 1.420, slope scale failure to top of tailings.
- FOS < 1.3, no failure surfaces indicated.
- No material change from dry condition.
