Broken Hill Operations Pty Ltd

Rasp Mine  
*Heritage Impact Assessment*

November 2007

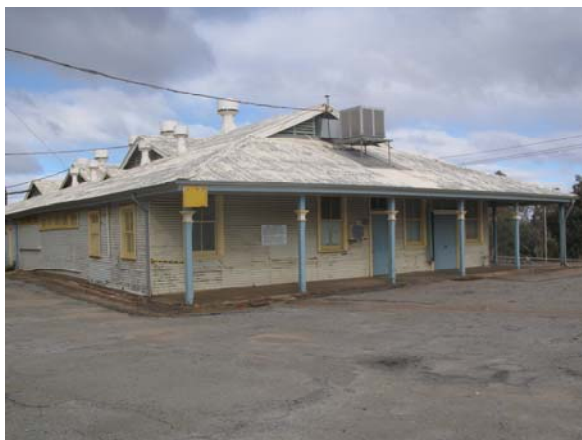
The windows of the building are predominantly four pane sliding sash windows, with the exception of those windows along some aspects of the northern elevation, coincident with where the verandah has been enclosed.

The western portion of the building appears to be a later extension.

***Photograph 4.1 Eastern Elevation of the Underground Office Building***

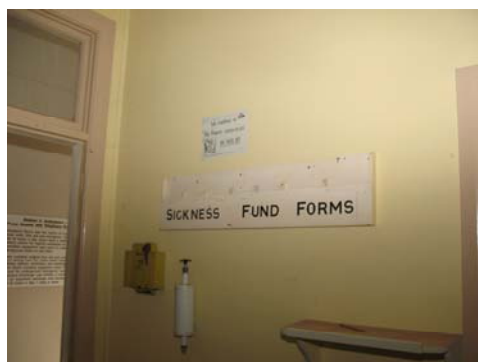
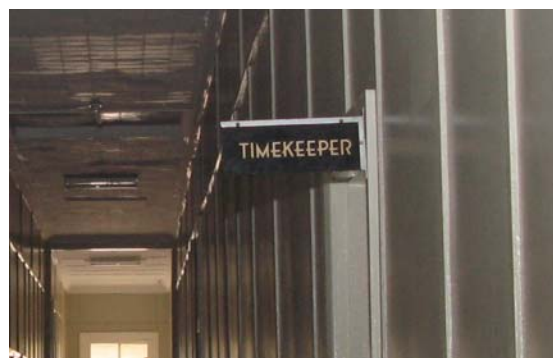
***Photographs 4.2 & 4.3 Examples of wall mounted objects located within the Underground Offices***

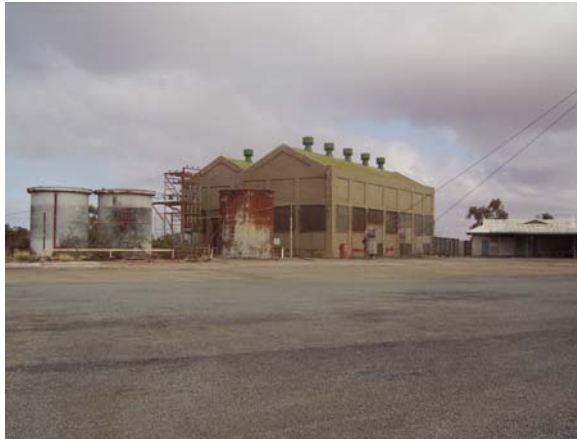
The winding house is a two storey brick building with a galvanised metal roof (see *Photograph 4.4*). It contains the engine that powers the winding gear connected to the hoisting pulley system mounted on top of the No. 7 Headframe (described in *Section 4.1.3*).

*Photograph 4.4 No 7 Winding House*

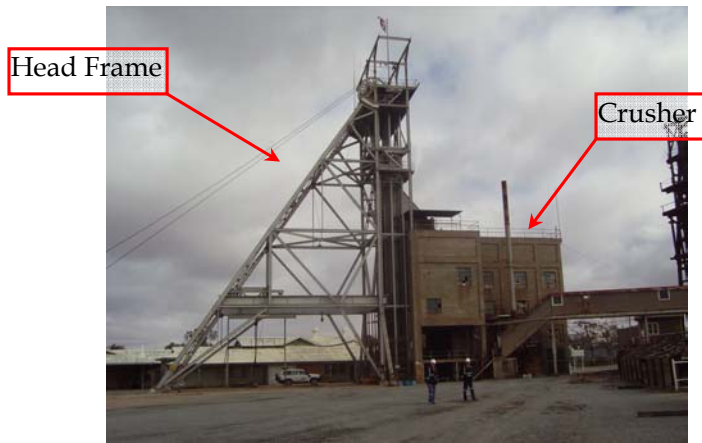
A headframe is the frame at the top of a shaft, to which the hoisting pulley is mounted. The No. 7 Headframe (see *Photograph 4.5*) is constructed of steel with a timber shaft. This headframe was in operation until 1975, when underground operations ceased. Whilst it is not currently operating as a headframe, it does have a pump for dewatering the shaft.

The building located to the immediate east of the headframe is the crusher building (see *Photograph 4.5*) which was last used for crushing ore approximately six years ago. The crusher building has not been identified as a heritage item and was not inspected as part of this assessment.

**Photograph 4.5 No 7 Headframe**

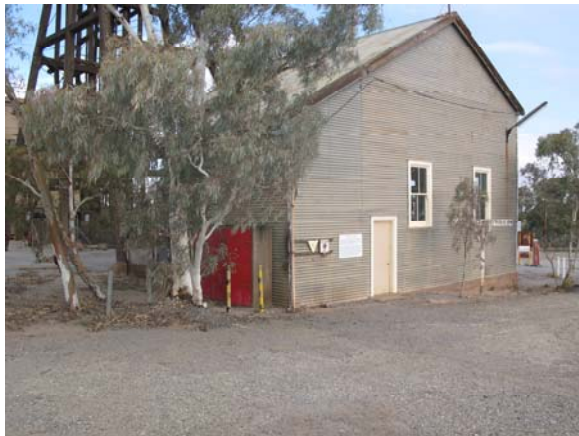
*The No 4 winder engine is said to be the 1<sup>st</sup> electric winder on the Broken Hill Field. The No 4 winder was powered by a 150 horsepower, 3 phase, 550 volts, 40 cycle, 300 rpm, contractor controlled induction motor. The winder located in this section is the original one used when it was operational. They have been kept as found and lightly conserved. The No 4 winder house today looks like when it was built."*

This building is not currently used. The interior of this building will not be affected by the Project and so was not inspected during the course of the site investigation.

**Photograph 4.6 No 4 Winder House**

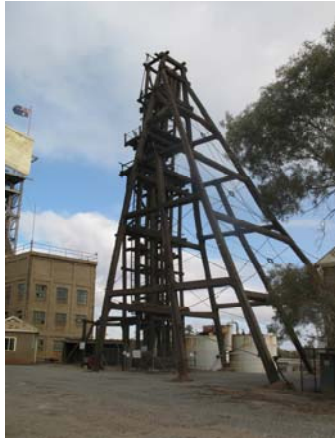
Item No. 180 (see *Photograph 4.7*) is similar in general appearance to Item No. 178. The major differences between the two structures are that Item No. 180 is the earlier example of the two and is constructed of timber.

This item has been subject to structural repair.

*Photograph 4.7 No 4 Head Shaft*

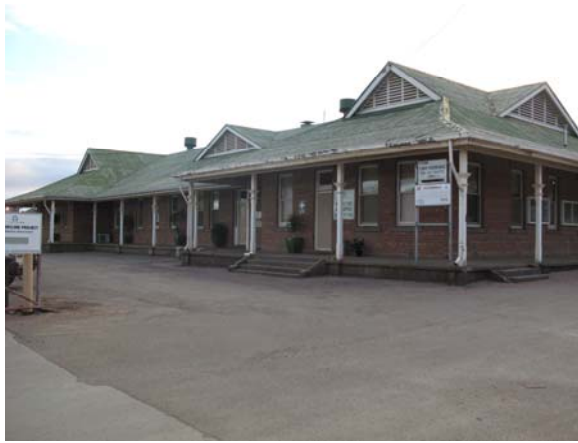
The verandah is set under the main broken back roof and is supported by timber columns which have the same decorative details as those seen on the Underground Office building.

The interior of the building is divided into a series of small offices with a central corridor. The interior of the building contains evidence of various phases of use, including a c.1960s wages office and two solid metal vaults.

*Photograph 4.8 Eyre Street General Offices*

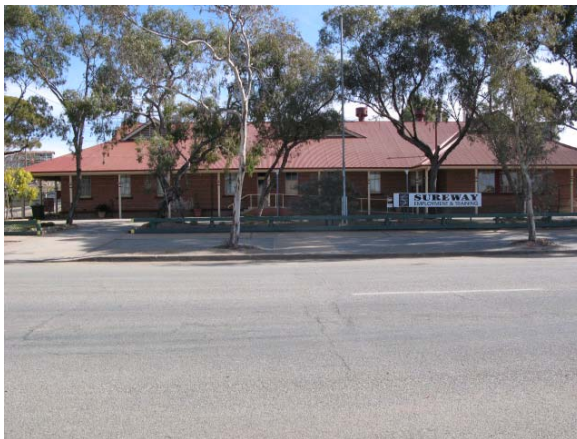
*Photograph 4.9 Radford House as viewed from Eyre Street*

Radford House (see *Photograph 4.9*) is located on Eyre Street to the immediate north of Item No. 273 General Offices. This building has until recently been used by the Sureway recruitment company as a training and employment centre, and it is proposed to be used for administrative purposes for the Project.

This building is a single storey brick building in set under a galvanised metal roof that has recently been painted red. It has two pane sliding sash windows. The building has undergone alteration and extension to the rear as well as the temporary enclosure of the rear verandah (see *Photograph 4.10*).

The interior of the building is similar to that of the General Offices and is divided into a series of small offices with a central corridor.

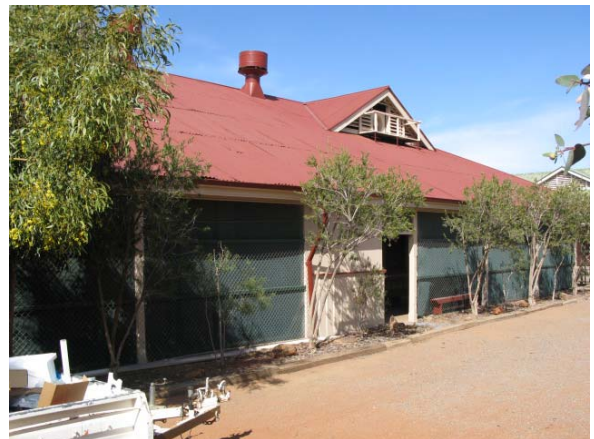
*Photograph 4.10 Enclosure of the rear verandah*

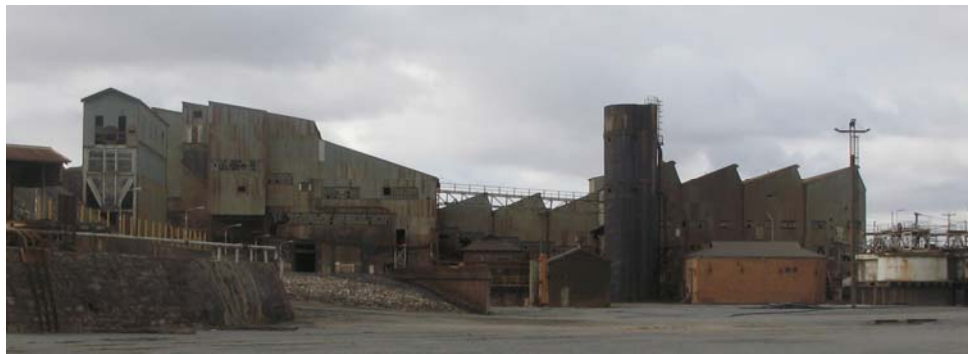
*Photograph 4.11 Broken Hill South Mill*

The old Broken Hill South Mill building (see *Photograph 4.11*) is a multi level steel framed building which is clad on all elevations, including roof, in galvanised iron. The galvanised iron metal has rusted and has been replaced in sections.

The interior of the building contains a near intact collection of mill processing equipment and associated infrastructure.

This building is currently disused.

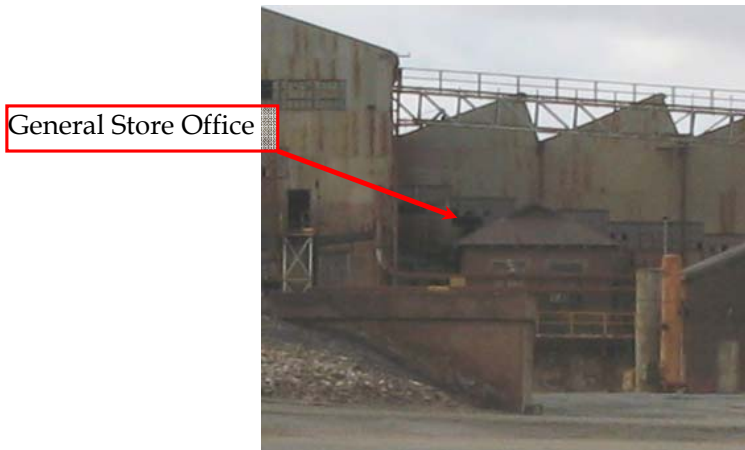
*Photograph 4.12 General Store Office*

The General Store Office is a small red brick building located on the southern side of the Broken Hill South Mill building (see *Photograph 4.12*).

This building is currently disused. The interior of this building will not be affected by the Project and so was not inspected for this assessment.

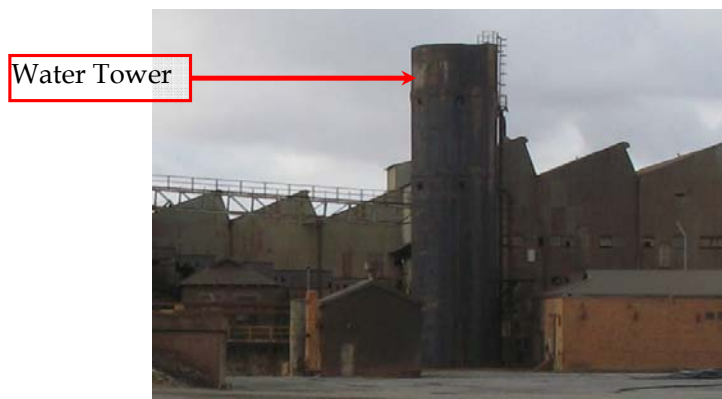
*Photograph 4.13 Water Tower*

The Water Tower, pictured in *Photograph 4.13*, is a large water storage structure that would have been used to supply water to the mill for the extraction process.

This item is currently disused. The interior of this building will not be re-used as part of the Project and so was not inspected during the site inspection.

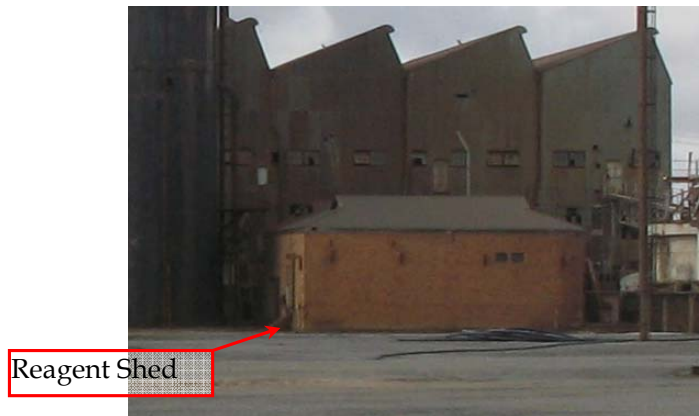
*Photograph 4.14 Reagent Shed*

The Reagent Shed, pictured in *Photograph 4.14*, is a red brick building, originally used for storage of reagents (the chemicals used for starting a reaction when introduced to another substance). In this instance the reagent would have been added to the unrefined ore to encourage chemical leaching.

This building is not currently used. The interior of this building will not be re-used as part of the Project and so was not inspected for this assessment.

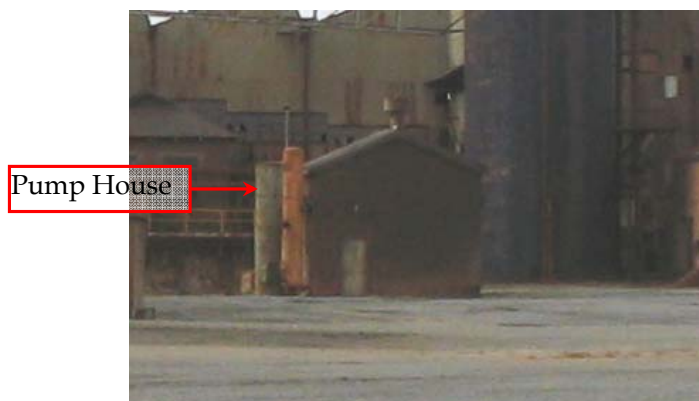
The Pump House (see *Photograph 4.15*) is a small single storey red brick building that would have originally housed pumps to pump water from the water tower to the Reagent Shed and mill. The interior of this building will not be re-used as part of the Project and so was not inspected for this assessment. However, it is possible that the original pumps are still located within the interior of this building.

*Photograph 4.15 Pump House*

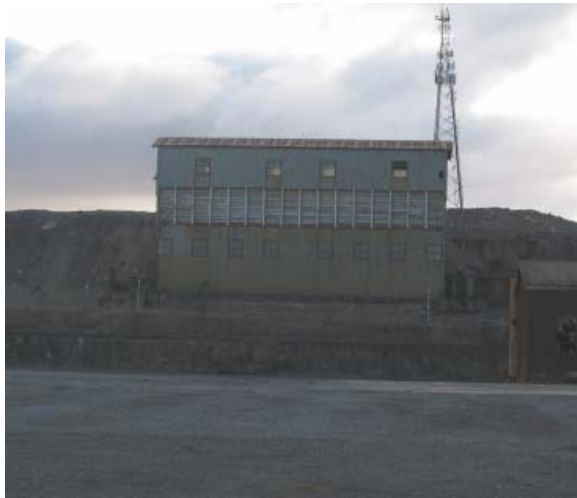
*Photograph 4.16*   *Mullock Bin*

The term mullock refers to rubbish or waste rock. The Mullock Bin building (see *Photograph 4.16*) is set into the slope of the land. Its western side is one storey in height and its eastern side is three storeys in height.

The Mullock Bin is currently disused. The interior of this building will not be re-used as part of the Project and so was not inspected for this assessment.

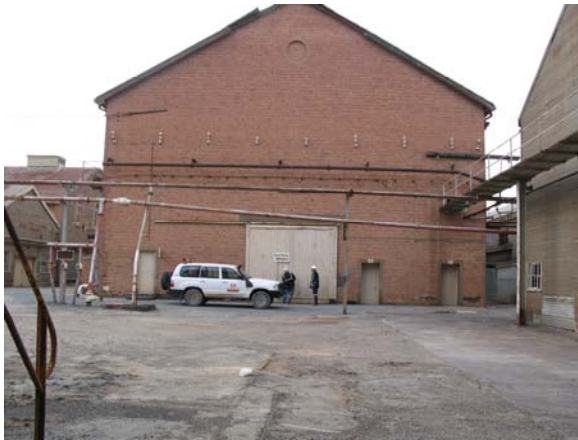
*Photograph 4.17 Electrical Workshop*

The Electrical Workshop is proposed to be used as maintenance offices, fixed plant workshop and potentially an electrical centre for the Project. It is a large red brick building with a gabled roof featuring a decorative circular blind vent detail located high within the gable wall (see *Photograph 4.17*). The roof is constructed of galvanised metal, though part of the barge board is missing.

The most recent use for this building was as an interpretation centre by LOLA.

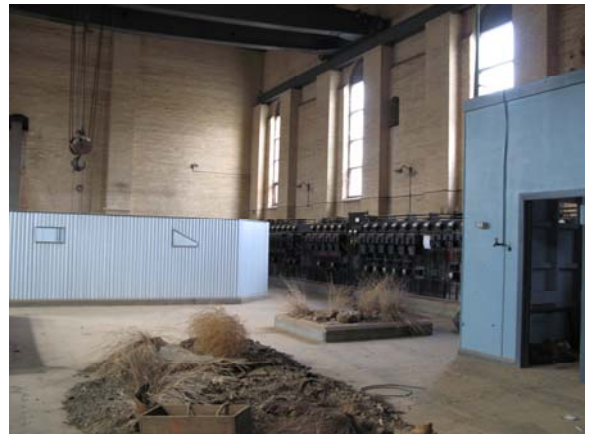
The physical character of northern and southern sections of the building's interior are distinctly different. The southern section contains the entire electrical infrastructure. This includes rows of electrical infrastructure (some of which may still be in use) and a large basement area which may have previously housed the generator. The northern section (see *Photograph 4.18*) contains LOLA material. It contains two demountable office areas and other material associated with the LOLA use of the site. The eastern demountable has been decorated with the cartoon of one of the former miners. A large board was added to this demountable by LOLA, on which visitors have signed their names. Other displays are located around this building.

*Photograph 4.18 Interior of building showing LOLA installations.*

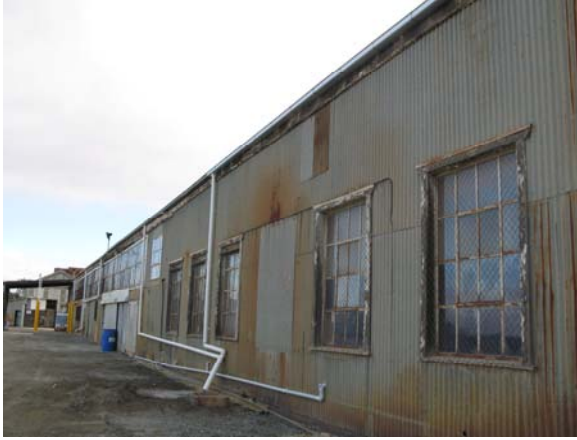
*Photograph 4.19 Mechanical Workshop*

The Mechanical Workshop building is a large galvanised iron saw toothed roof building (see *Photograph 4.19*), which is planned to be used as a mobile plant and maintenance store for the Project. It has recently been adaptively re-used as a mechanical workshop, specifically for the repair of the large underground machinery. Some large mechanical infrastructure pertaining to the former use of this building as a workshop for past mining activities is concreted into the floor within this building. Where this infrastructure was prohibitive to the reuse it has been removed and relocated to the forecourt of the Broken Earth Café where it can be viewed by the general public. However if its location within the building has not conflicted with the re-use it has been left in situ to illustrate the building's former role.

To accommodate the adaptive re-use there has been some minor repairs of the galvanised iron work and also some more substantial maintenance work such as the replacement of the box gutters and the roof plumbing system.

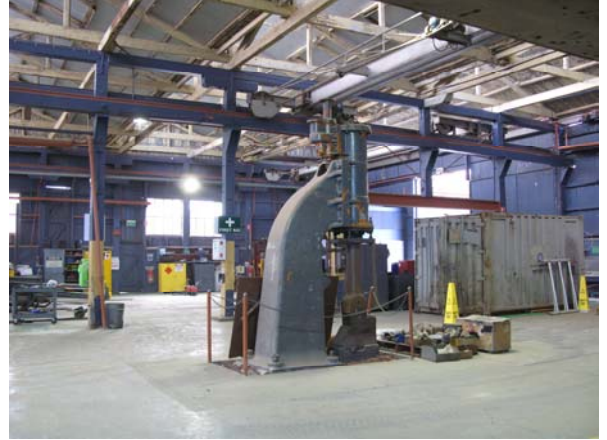
The interior of this building is a large open space divided into three bays by its timber frame and is open to the underside of the sawtooth roof (see *Photograph 4.20*). A roof mounted crane system housed in this building is currently being repaired and considered for re-use.

*Photograph 4.20 Interior of Mechanical Workshop*

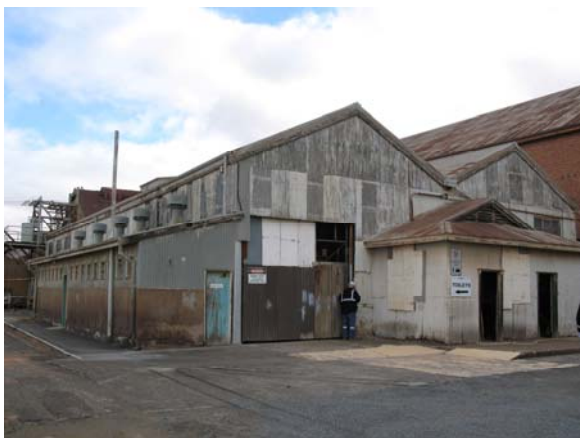
*Photograph 4.21 Change House*

The Change House building is proposed to be used as a crib room, training room, first aid centre and underground offices for the Project. It is a steel framed building with a boxed gutter running along its centre (see *Photograph 4.21*). Its interior is pictured in *Photograph 4.22*.

Of all the buildings within the Project Area, the Change house is considered to have undergone the most change. The alterations have included the addition of a concrete floor, false ceiling and banks of showers to the eastern section of the interior of the building and several extensions and ad-hoc repairs to the exterior.

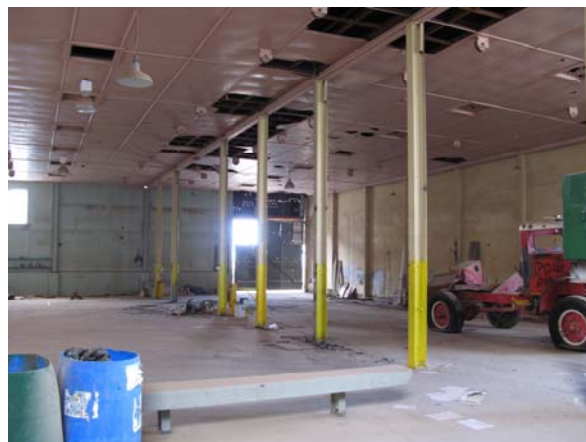
*Photograph 4.22 Interior of Change House*

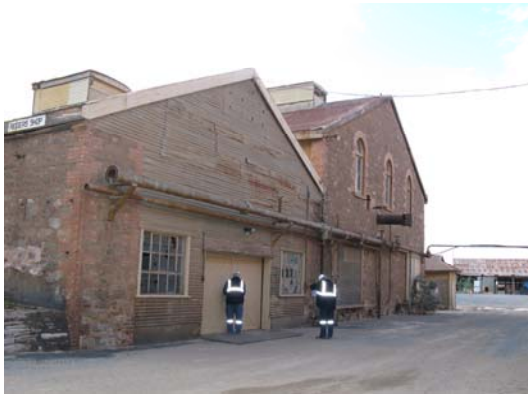
*Photograph 4.23 Rigger Shop and Compressor House*

The Riggers Shop is proposed to be used as an emergency services store for the Project while the Compressor Room will not be re-used. The Riggers Shop and the Compressor Room share a common wall (see *Photograph 4.23*). The Compressor Room was formerly used as the Old Power House. This would have been used for generating electricity from coal, when electricity was first introduced to the site in the 1920s.

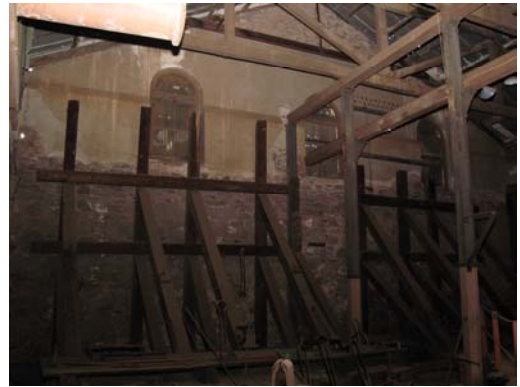
*Photograph 4.24 Structural supports to interior of Compressor House*

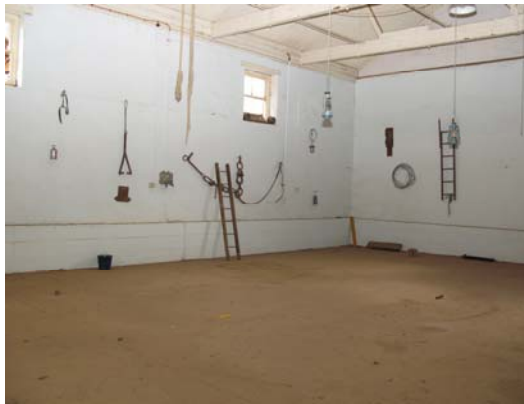
*Photograph 4.25 Interior of Riggers Shop*

The interior of the Riggers Shop has white washed walls and high small windows, as evident in *Photograph 4.25*. Old equipment hung by LOLA is located on the walls.

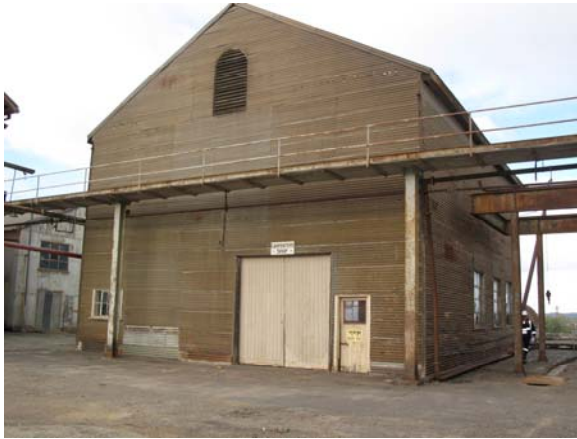
*Photograph 4.26 Carpenter's Paint Shop*

The carpenters shop is a gabled building constructed of galvanised iron (see *Photograph 4.26*). Its interior (see *Photograph 4.27*) is approximately two storeys in height but open to the roof trusses.

Neither building is currently in use.

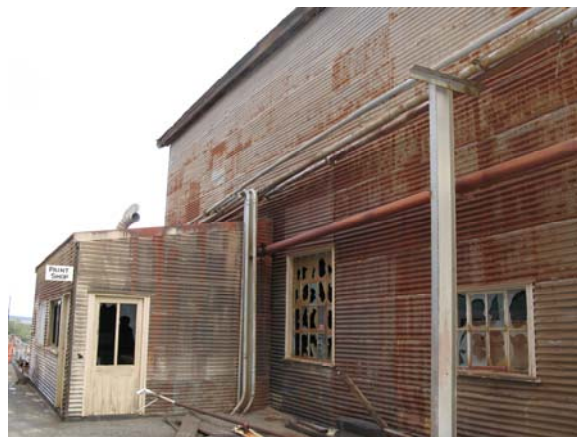
*Photograph 4.28 Paint Shop located to the northern elevation of the Carpenters Shop*

The paint shop is a small lean-to addition to the northern side of the carpenters shop, also constructed of galvanised iron (see *Photograph 4.28*).

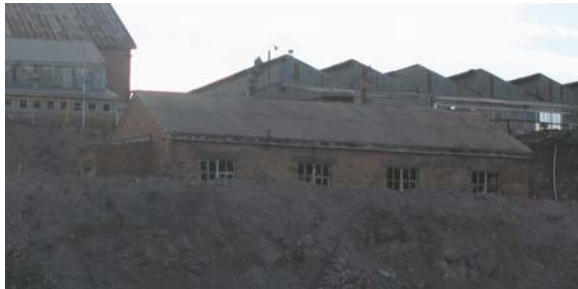
***Photograph 4.29 Pump house and Cooling Water Reservoir***

The Pump House and Cooling Water Reservoir building is a red brick one storey building (see *Photograph 4.29*), located to the west of the Changehouse. It is in a degraded state. There is no aboveground evidence of the reservoir.

This building is not currently in use. Its interior will not be re-used as part of the Project and as such was not subject to inspection as part of this assessment.

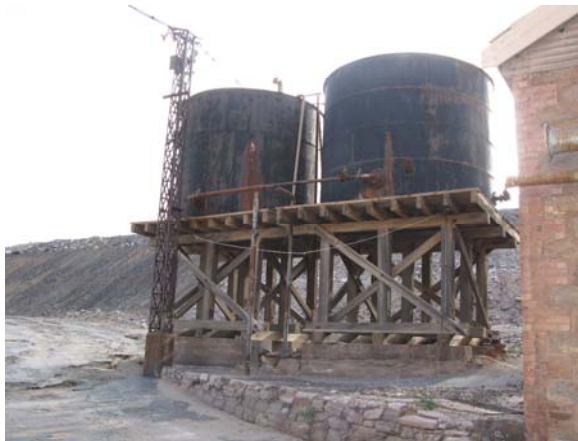
This item comprises of two galvanised metal water tanks, located on an elevated timber platform (see *Photograph 4.30*) to the immediate south of the Riggers Shop. These tanks are not currently in use.

***Photograph 4.30 Two Water Tanks***

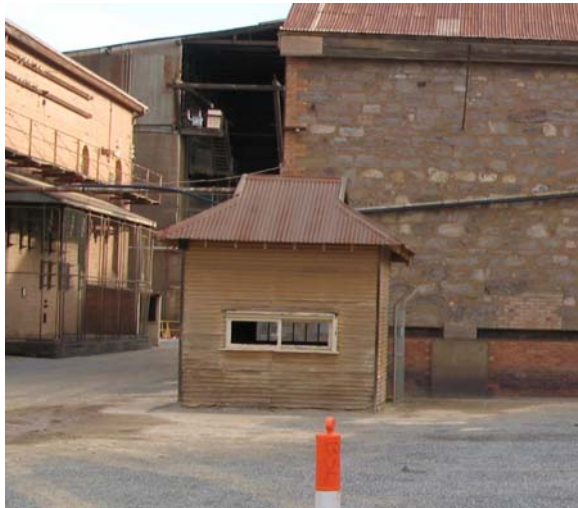
*Photograph 4.31 Yardman's Office*

The Yardman's Office (see *Photograph 4.31*) is a small one room building constructed entirely of galvanised metal sheeting and located immediately north of the Compressor House.

This building is not currently used. Its interior will not re-used as part of the Project and so was not inspected as part of the site investigation.

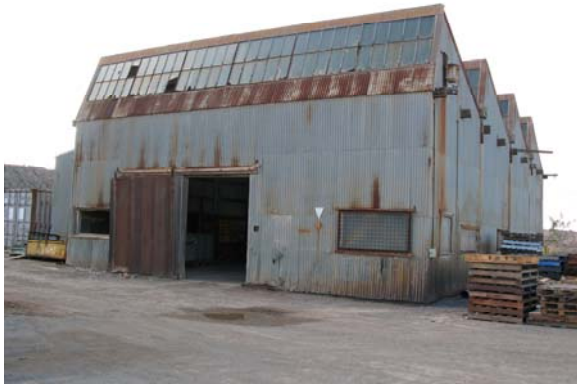
*Photograph 4.32 Pattern Store*

The Pattern Store is planned to be used for storage for the Project. This building is a timber framed galvanised iron saw toothed building (see *Photograph 4.32*). There is a lean to addition to the east, which is also constructed of galvanised iron set over a timber frame. The interior of both sections of the building contain remnant equipment.

This building is currently used for storage.

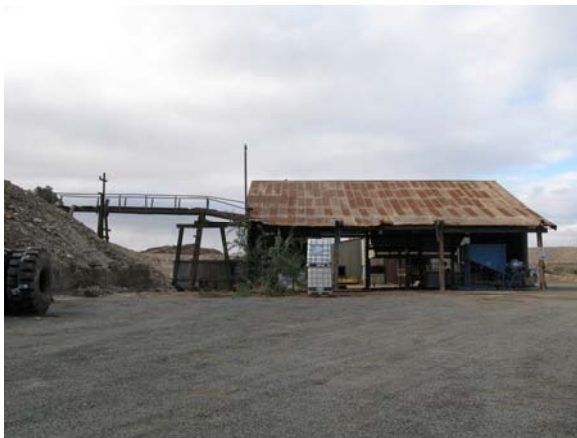
*Photograph 4.33 Saw Mill and Extension*

The Saw Mill is an open sided barn with a solid timber frame and a galvanised metal roof (see *Photograph 4.33*). Some of the original saw mill infrastructure remains to the east of the building.

This building is currently used for storage and this use is planned to continue for the Project.

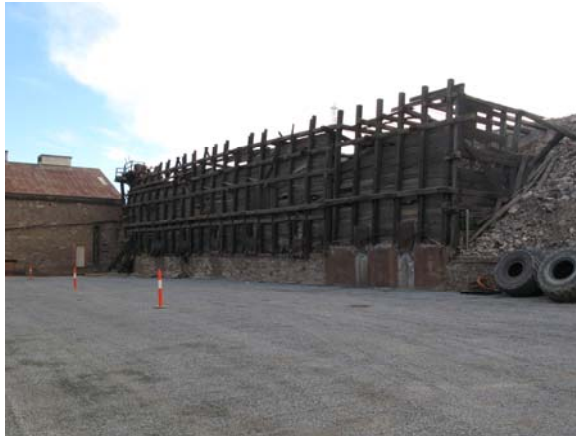
This item is not currently in use and may be structurally unstable.

*Photograph 4.34 Coal Bins*

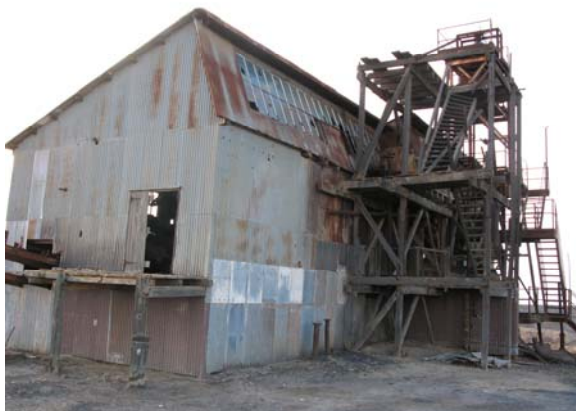
The Sand Plant is a galvanised iron building with a skillion style roof with windows set within the eastern elevation (see *Photograph 4.35*). This building contains much of its original equipment and infrastructure to the exterior and interior.

*Photograph 4.35 Sand Plant*

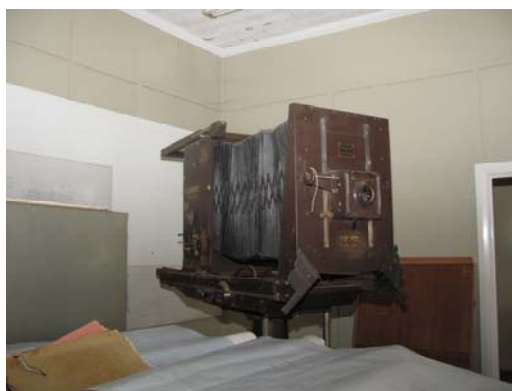
**Photograph 4.36** *Antique Photostat Machine is part of the CML 7 Moveable*

*Photographs 4.36 and 4.37 show examples of moveable heritage at the site. A Moveable Heritage Policy exists for the site. In the recent past, LOLA has relocated moveable heritage from its original location within CML 7 to the Broken Earth Café forecourt, which is also within CML 7, where it can be viewed by the public. For this Project, items of moveable heritage under BHOP ownership and located such that they would not be disturbed or damaged for construction or operations, will be retained and conserved in-situ. Items that are required to be moved to avoid adverse impacts will be fully recorded and handed over to LOLA or a similar local historical organisation.*

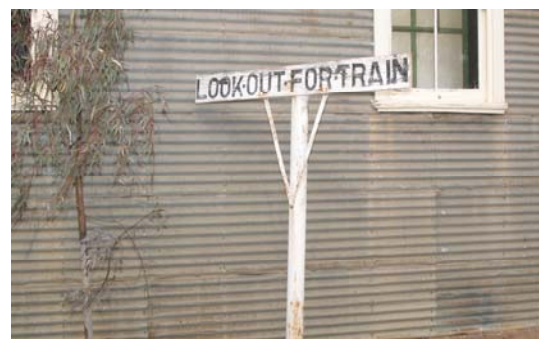
**Photograph 4.37** *Sign relating to former rail interface at CML 7 heritage collection*
