26 July 2021

Giorgio Dall'armi  
General Manager  
Broken Hill Operations (BHOP) – Rasp Mine

**GEOTECHNICAL ASSESSMENT OF THE RASP MINE BOX CUT**

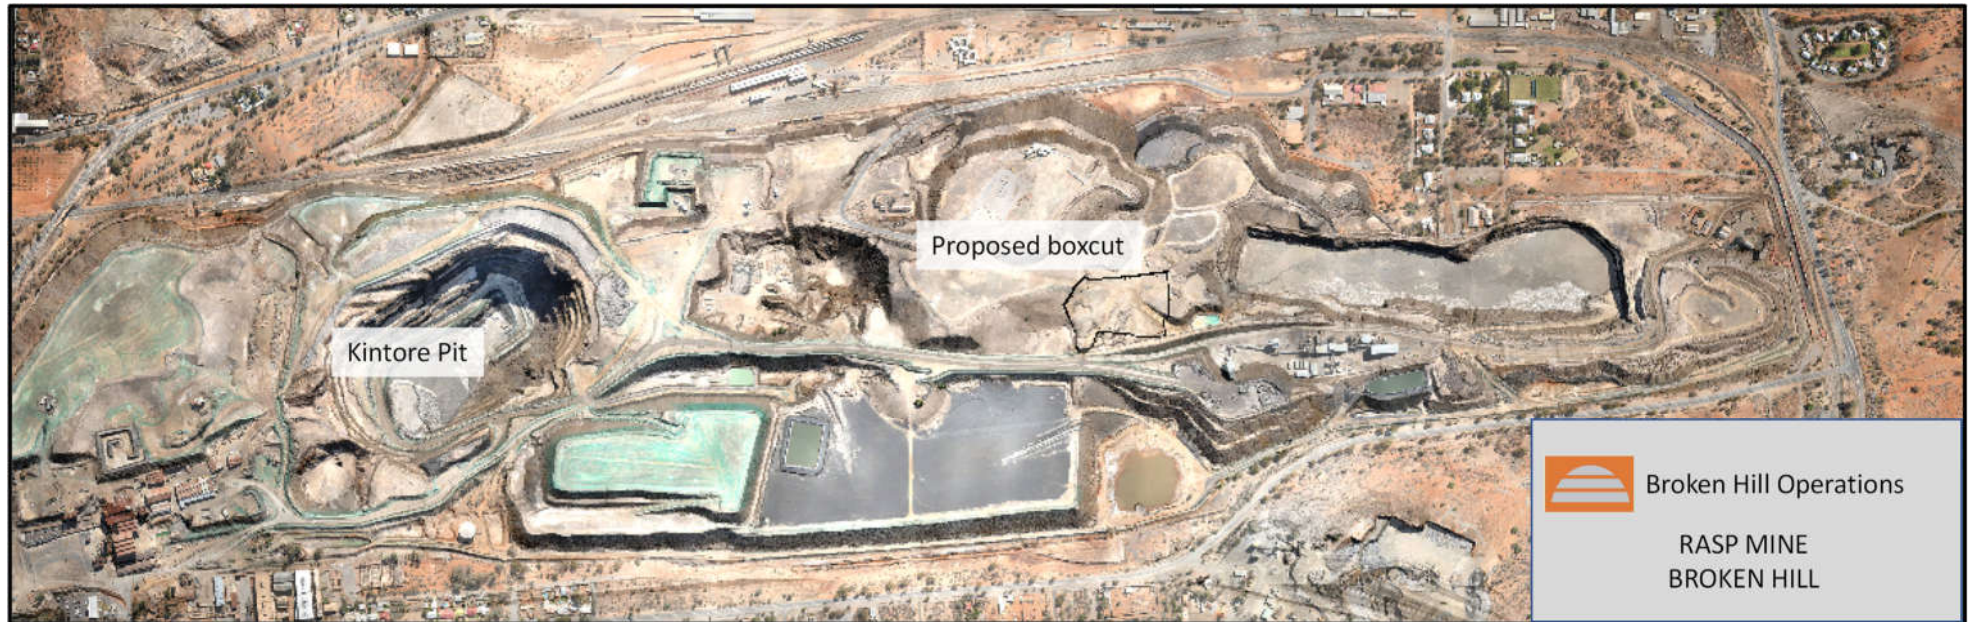
Figure 1 shows the location of the current portal location and proposed boxcut excavation

Figure 1 Kintore pit and box cut design outline within existing topography.

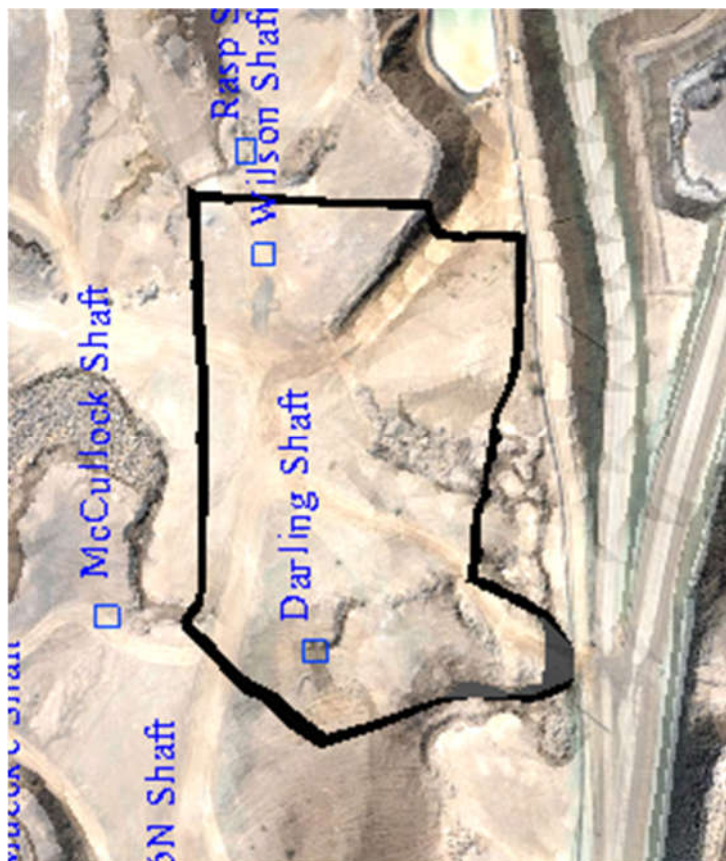
The location for the boxcut does not intersect known underground workings apart from the Wilson and Darling Shafts located on what will be the western wall of the boxcut. These shafts originally connected the underground workings to the surface; however, it is believed that these shafts were filled after abandonment. The location of the Wilson and Darling Shafts is shown in Figure 4.

**Figure 4 Wilson and Darling Shaft locations – plan view**

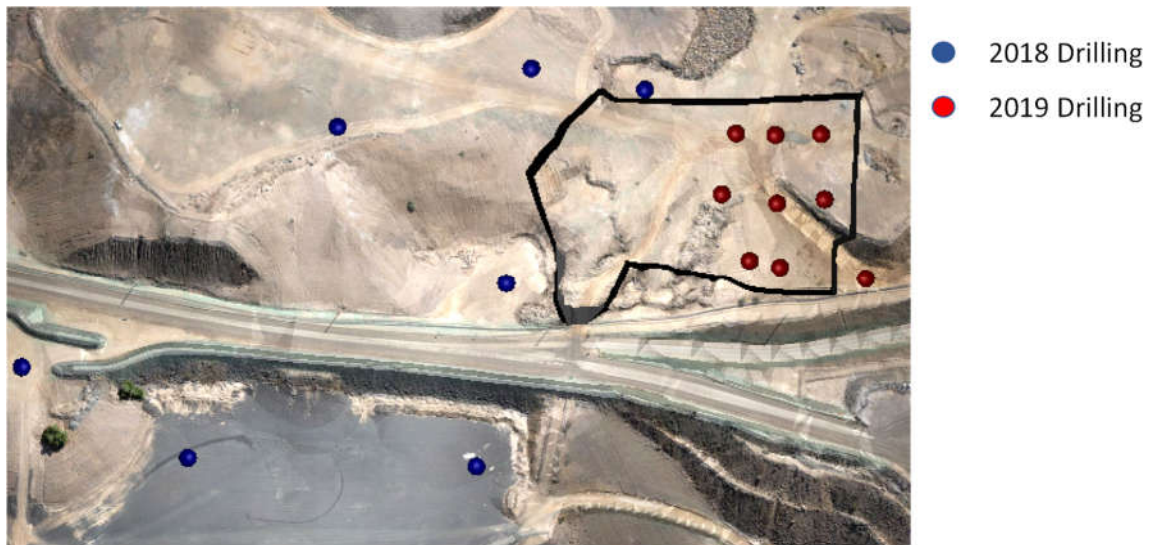
Hole ID	Depth (m)	Dip	Easting (m)	Northing (m)	RL (m)
MLDD3873	45.0	-90.0	9888.6	2351.0	10334.6
MLDD3874	36.0	-90.0	9989.4	2333.6	10325.0
MLDD3875	42.6	-90.0	9985.0	2177.8	10324.6
MLDD3876	44.4	-90.0	9935.2	2085.4	10335.5
MLDD3877	53.6	-90.0	9802.2	2259.7	10354.0
MLDD3878	42.0	-90.0	9771.0	2365.0	10352.0
MLDD3879	42.0	-90.0	9782.4	2426.0	10344.8
MLDD4132	41.0	-90.0	9842.4	2526.1	10343.3
MLDD4133	40.9	-90.0	9806.8	2524.2	10343.0
MLDD4134	40.1	-90.0	9807.2	2499.1	10343.2
MLDD4135	40.0	-90.0	9806.3	2477.5	10343.0
MLDD4136	40.1	-90.0	9806.9	2524.7	10342.9
MLDD4137	40.3	-90.0	9844.6	2500.1	10340.7
MLDD4138	41.0	-90.0	9876.1	2485.0	10342.1
MLDD4139	40.3	-90.0	9879.8	2501.7	10341.8
MLDD4140	40.9	-90.0	9886.0	2548.7	10335.8

**Figure 5 Plan view of diamond drill investigation holes**

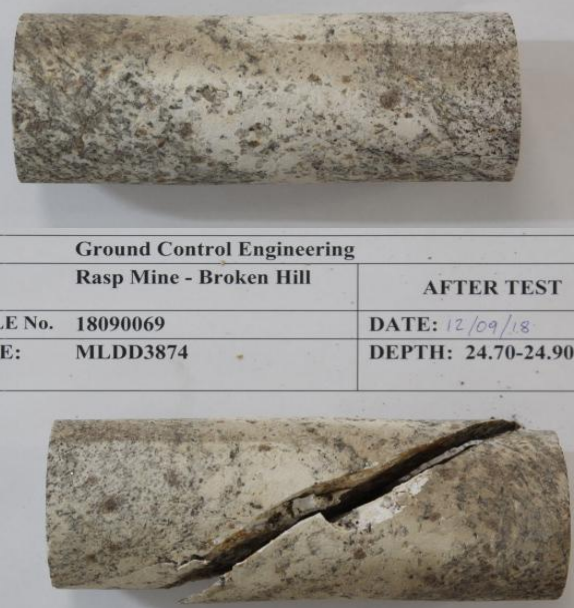
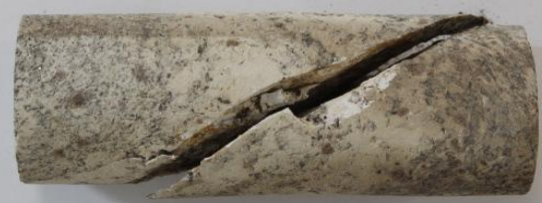
<b>PROJECT:</b> Rasp Mine - Broken Hill	<b>BEFORE TEST</b>	
<b>LAB SAMPLE No.</b> 18090069	<b>DATE:</b> 12/09/18	
<b>BOREHOLE:</b> MLDD3874	<b>DEPTH:</b> 24.70-24.90

<b>PROJECT:</b> Rasp Mine - Broken Hill	<b>AFTER TEST</b>	
<b>LAB SAMPLE No.</b> 18090069	<b>DATE:</b> 12/09/18	
<b>BOREHOLE:</b> MLDD3874	<b>DEPTH:</b> 24.70-24.90

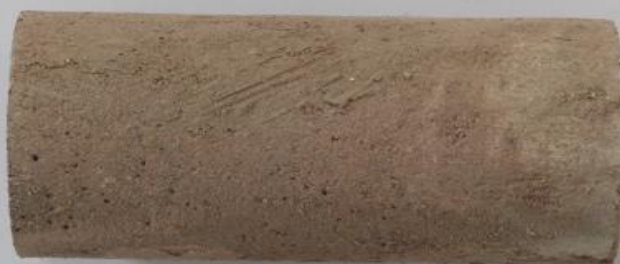
<b>CLIENT:</b>	Ground Control Engineering	
<b>PROJECT:</b>	Rasp Mine - Broken Hill	<b>BEFORE TEST</b>
<b>LAB SAMPLE No.</b>	18090073	<b>DATE:</b> 11/09/18
<b>BOREHOLE:</b>	MLDD3874	<b>DEPTH:</b> 18.70-19.00

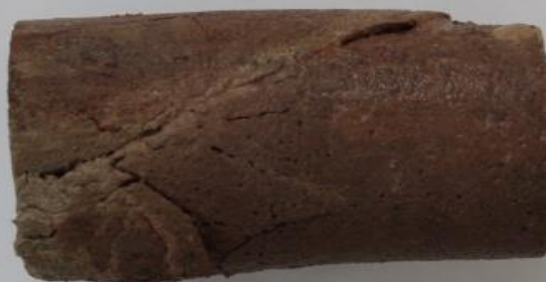
<b>CLIENT:</b>	Ground Control Engineering	
<b>PROJECT:</b>	Rasp Mine - Broken Hill	<b>AFTER TEST</b>
<b>LAB SAMPLE No.</b>	18090073	<b>DATE:</b> 05/10/18
<b>BOREHOLE:</b>	MLDD3874	<b>DEPTH:</b> 18.70-19.00

Remarks: Tested as Received  
Sample/s supplied by the client

Effective Pressure	Confining Pressure	Back Pressure	Initial Pore	Failure Pore	Principal Effective Stresses			Deviator Stress	Strain
					$\sigma'_1$	$\sigma'_3$	$\sigma'_1 / \sigma'_3$		
120 kPa	624 kPa	504 kPa	504 kPa	591 kPa	1628 kPa	33 kPa	49.774	1595 kPa	1.15 %
243 kPa	747 kPa	504 kPa	504 kPa	606 kPa	2665 kPa	141 kPa	18.917	2525 kPa	1.58 %
494 kPa	1000 kPa	506 kPa	506 kPa	584 kPa	4516 kPa	416 kPa	10.864	4100 kPa	2.21 %

Interpretation between stages :	1 to 2	2 to 3	1 to 3
Cohesion C' (kPa) :	212.1	330.7	270.9
Angle of Shear Resistance $\Phi'$ (Degrees) :	54.2	47.9	49.7
Failure Criteria:	Peak Principal Stress Ratio

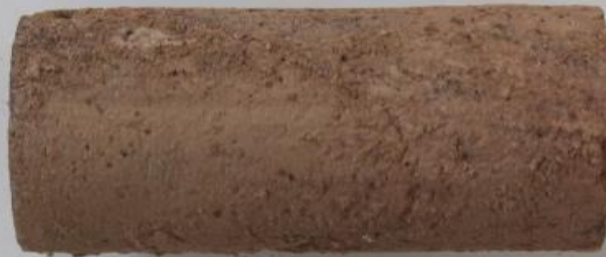
<b>CLIENT:</b>	Ground Control Engineering	
<b>PROJECT:</b>	Rasp Mine - Broken Hill	<b>BEFORE TEST</b>
<b>LAB SAMPLE No.</b>	18090074	<b>DATE:</b> 11/09/18
<b>BOREHOLE:</b>	MLDD3876	<b>DEPTH:</b> 31.40-31.60

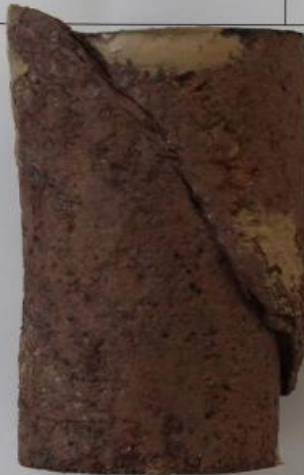
<b>CLIENT:</b>	Ground Control Engineering	
<b>PROJECT:</b>	Rasp Mine - Broken Hill	<b>AFTER TEST</b>
<b>LAB SAMPLE No.</b>	18090074	<b>DATE:</b> 03/10/18
<b>BOREHOLE:</b>	MLDD3876	<b>DEPTH:</b> 31.40-31.60

**Remarks:** Tested as Received  
Sample/s supplied by the client

Effective Pressure	Confining Pressure	Back Pressure	Initial Pore	Failure Pore	Principal Effective Stresses			Deviator Stress	Strain
					$\sigma'_1$	$\sigma'_3$	$\sigma'_1 / \sigma'_3$		
128 kPa	627 kPa	499 kPa	499 kPa	559 kPa	531 kPa	68 kPa	7.802	463 kPa	0.83 %
253 kPa	751 kPa	498 kPa	498 kPa	574 kPa	968 kPa	177 kPa	5.466	791 kPa	1.58 %
503 kPa	904 kPa	401 kPa	401 kPa	488 kPa	1688 kPa	416 kPa	4.054	1272 kPa	2.38 %

Interpretation between stages :	1 to 2	2 to 3	1 to 3
Cohesion C' (kPa) :	64.6	125.4	93.4
Angle of Shear Resistance $\Phi'$ (Degrees) :	36.9	30.1	32.2
Failure Criteria:	Peak Principal Stress Ratio

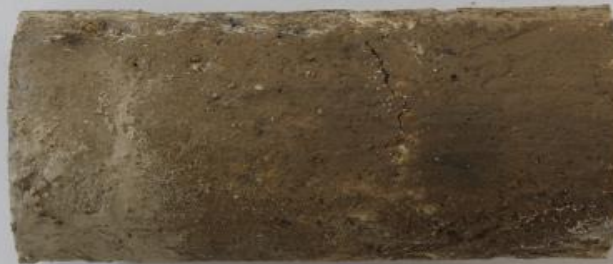
<b>CLIENT:</b>	Ground Control Engineering	
<b>PROJECT:</b>	Rasp Mine - Broken Hill	<b>BEFORE TEST</b>
<b>LAB SAMPLE No.</b>	18090075	<b>DATE:</b> 11/09/18
<b>BOREHOLE:</b>	MLDD3877	<b>DEPTH:</b> 48.60-48.80

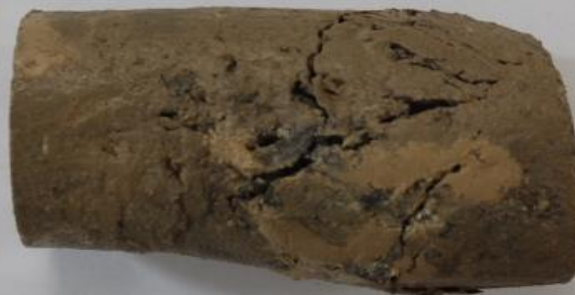
<b>CLIENT:</b>	Ground Control Engineering	
<b>PROJECT:</b>	Rasp Mine - Broken Hill	<b>AFTER TEST</b>
<b>LAB SAMPLE No.</b>	18090075	<b>DATE:</b> 08/10/18
<b>BOREHOLE:</b>	MLDD3877	<b>DEPTH:</b> 48.60-48.80

**Remarks:** Tested as Received  
Sample/s supplied by the client

Effective Pressure	Confining Pressure	Back Pressure	Initial Pore	Failure Pore	Principal Effective Stresses			Deviator Stress	Strain
					$\sigma'_1$	$\sigma'_3$	$\sigma'_1 / \sigma'_3$		
127 kPa	624 kPa	497 kPa	497 kPa	517 kPa	2084 kPa	107 kPa	19.480	1977 kPa	1.14 %
252 kPa	750 kPa	498 kPa	498 kPa	466 kPa	4044 kPa	284 kPa	14.240	3760 kPa	1.61 %
505 kPa	1001 kPa	496 kPa	496 kPa	471 kPa	5490 kPa	530 kPa	10.358	4960 kPa	1.86 %

Interpretation between stages :	1 to 2	2 to 3	1 to 3
Cohesion C' (kPa) :	135.2	489.9	240.1
Angle of Shear Resistance $\Phi'$ (Degrees) :	56.5	45.2	51.4
Failure Criteria:	Peak Principal Stress Ratio

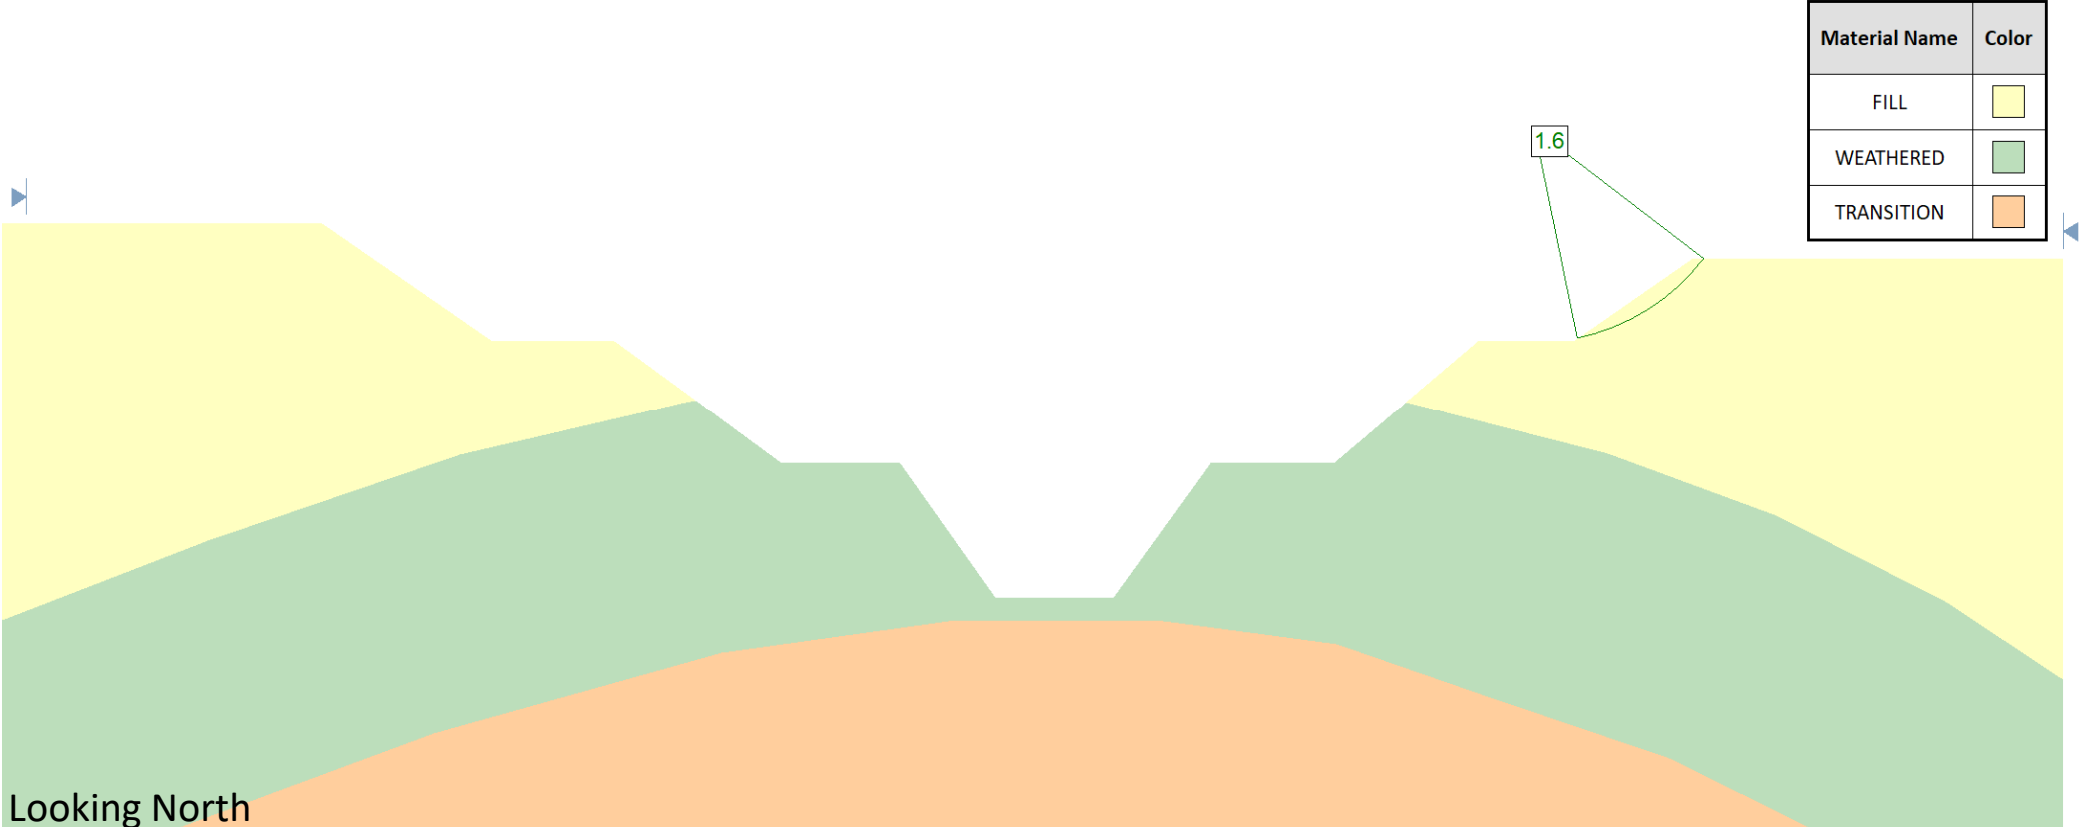
East Wall  
Model Results - Factor of Safety

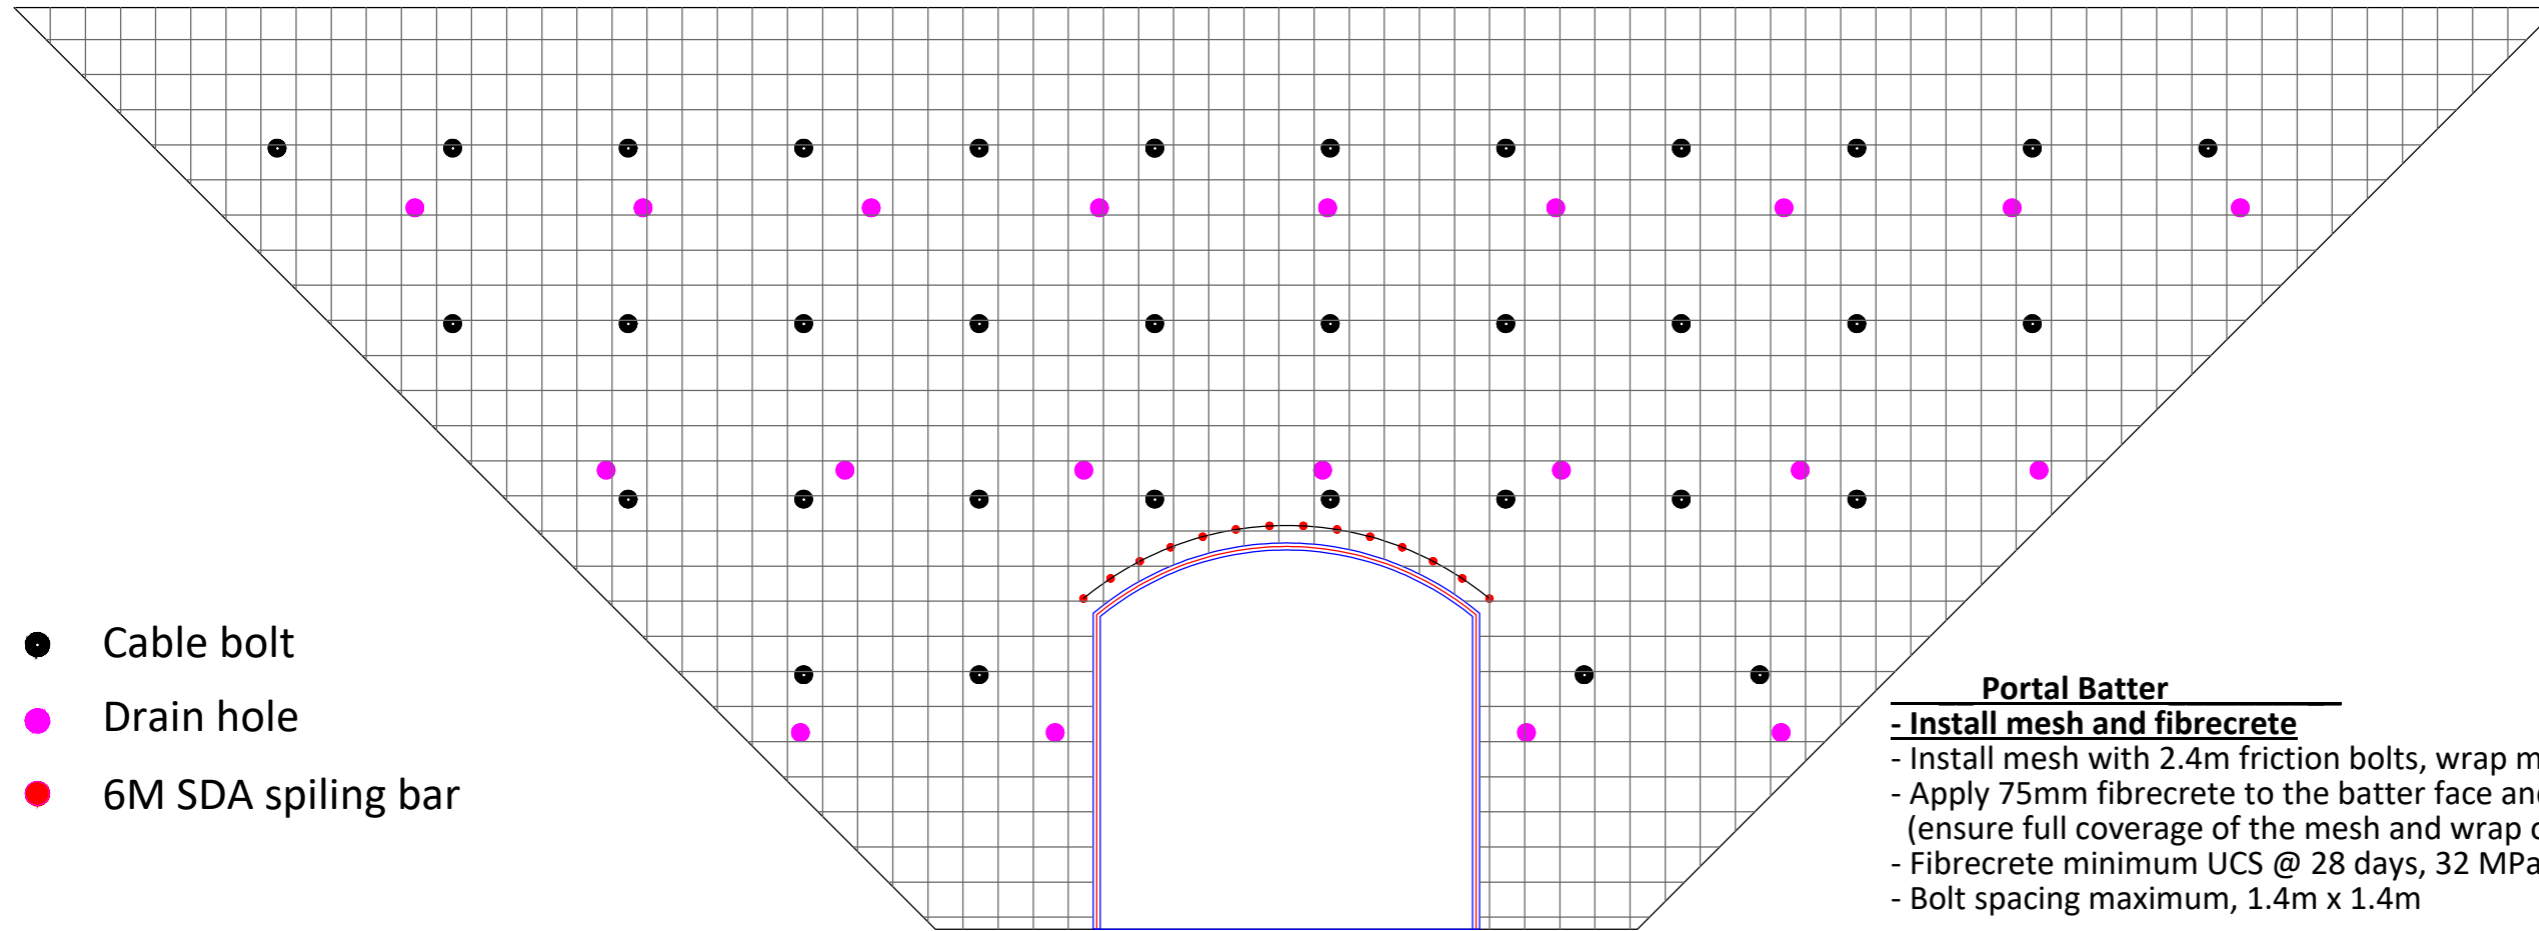
# PORTAL FACE GROUND SUPPORT REQUIREMENTS

- Cable bolt
- Drain hole
- 6M SDA spiling bar
