# ENDEAVOR MINE

## JUNE 2019 MONTHLY ENVIRONMENTAL REPORT

For Month Ending 30 June 2019

Name of Operation	Endeavor Mine
Name of Licensee	Endeavor Operations Pty Ltd
Environmental Protection Licence	No: 1301
Reporting Period Start Date	1 June 2019
Reporting End Date	30 June 2019
Author	Dr Keith Halford
Approver	Phil Gilligan

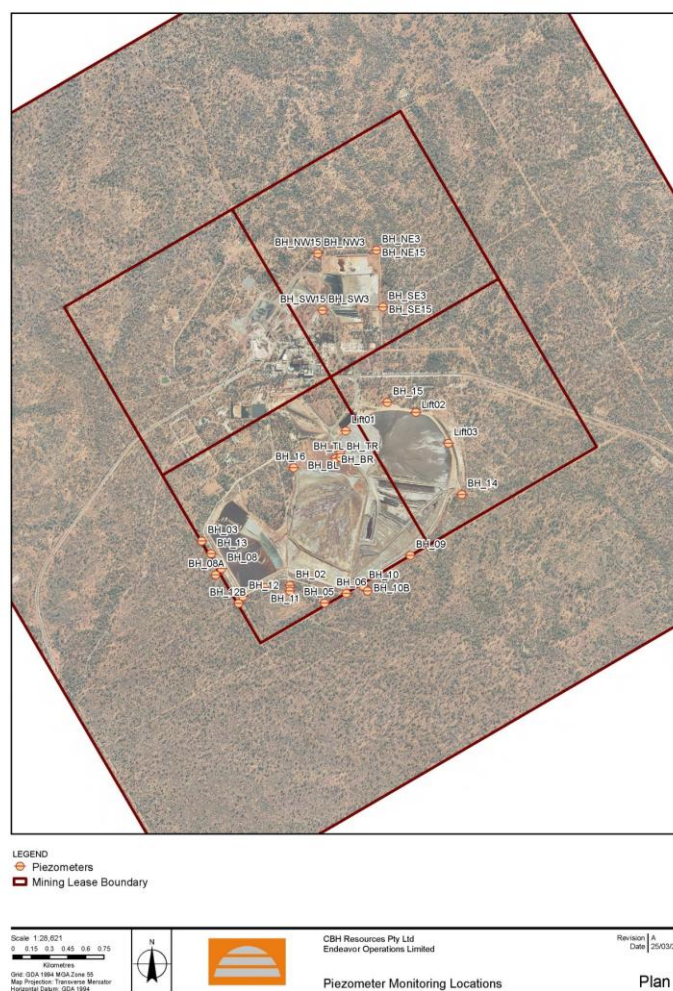
Figure 4-1: Location of the Piezometer Monitoring Locations

Endeavor Mine's groundwater monitoring locations are concentrated around the perimeter of the Central Tailings Discharge (CTD) and the Sector 5 Tailings Storage Facility (CTF), while surface water monitoring locations are focused on water storages that could potentially discharge to environment during a major rain or storm event. Table 4-1 describes the monitoring stations where Figure 4-1 shows the locations of the piezometers. Depending on availability of water or flow, unfortunately on some occasions, piezometers cannot be monitored as a result of being dry.

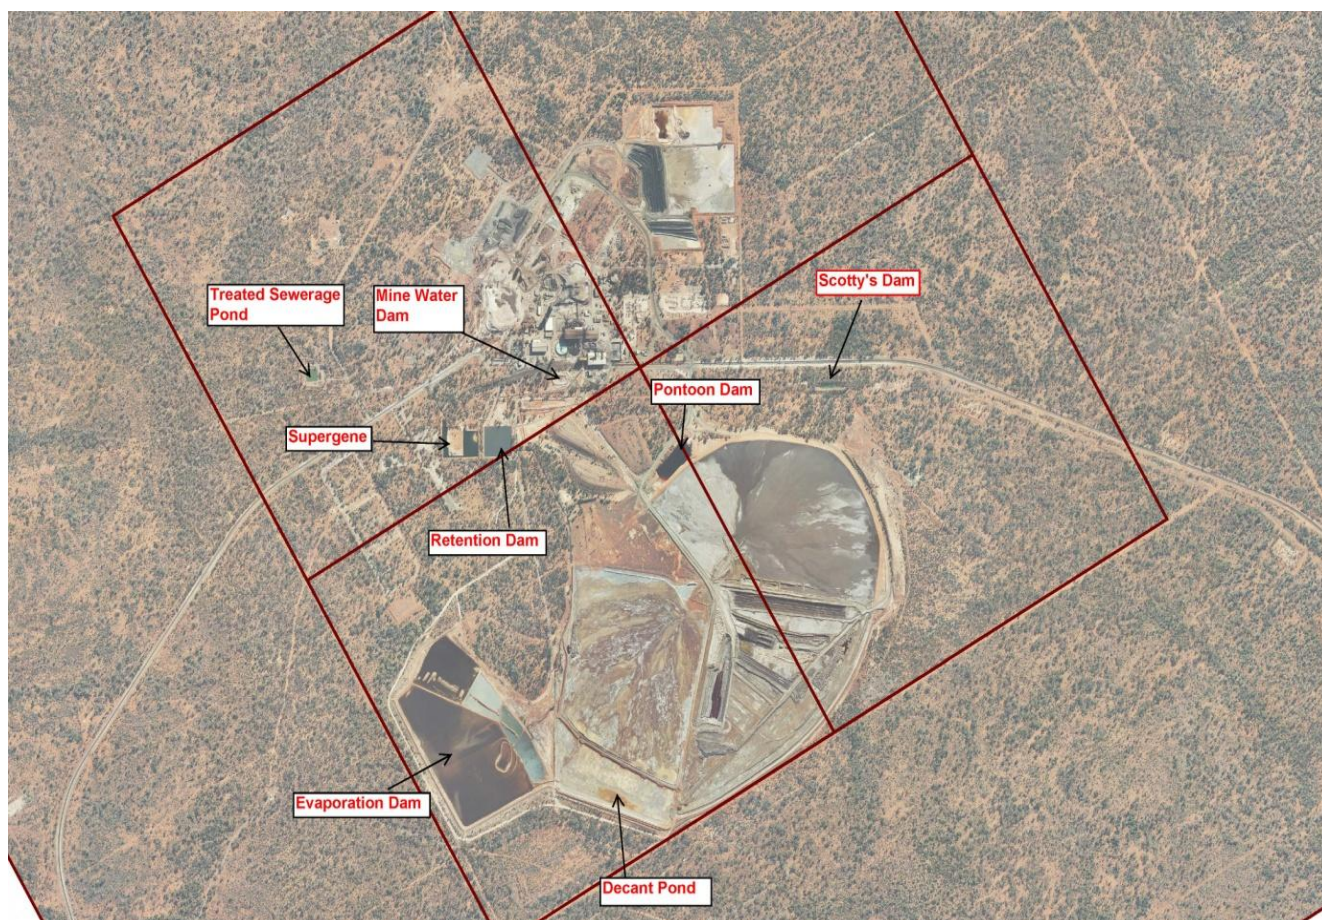
Figure 5-1: The Endeavor Mine: Main Water Storages

Figure 5-1 shows the location of the surface water dams on site that are monitored for water quality bi-annually.

Due to the drought and low rainfall, it is difficult to access water in most of the dams with the exception of the Retention Dam but was not collected as it's not representative. Access to the water's edge is hazardous. If rain occurs during July and it is safe, samples will be collected.

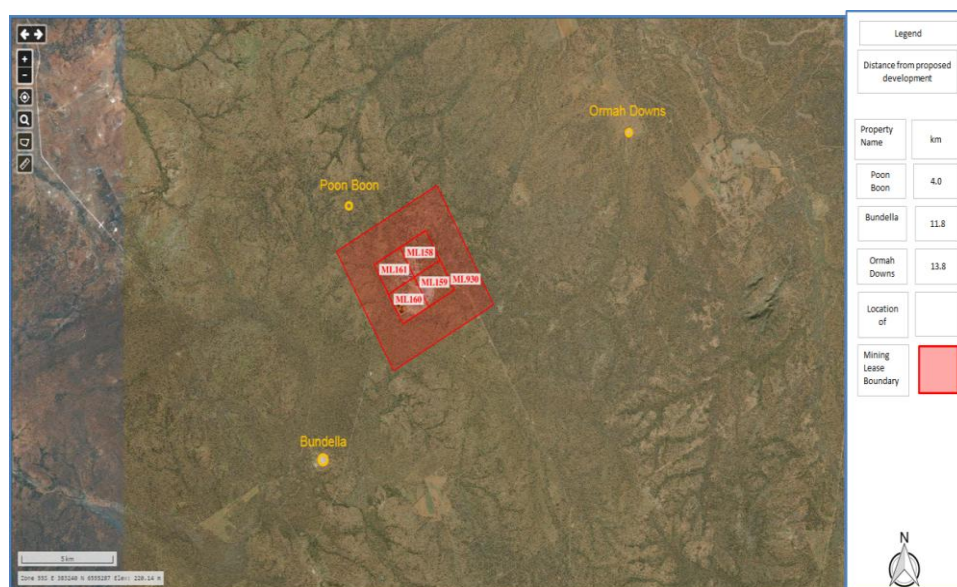
Figure 7-1: Closest Neighbours to Endeavor Mine

Potential Monitoring locations will include neighbouring properties. Figure 7-1Error! Reference source not found. shows the location of the neighbouring properties.
