Broken Hill Operations Pty Ltd ABN 95 103 555 862

Rasp Mine

Annual Review

1 January 2022 – 31 December 2022

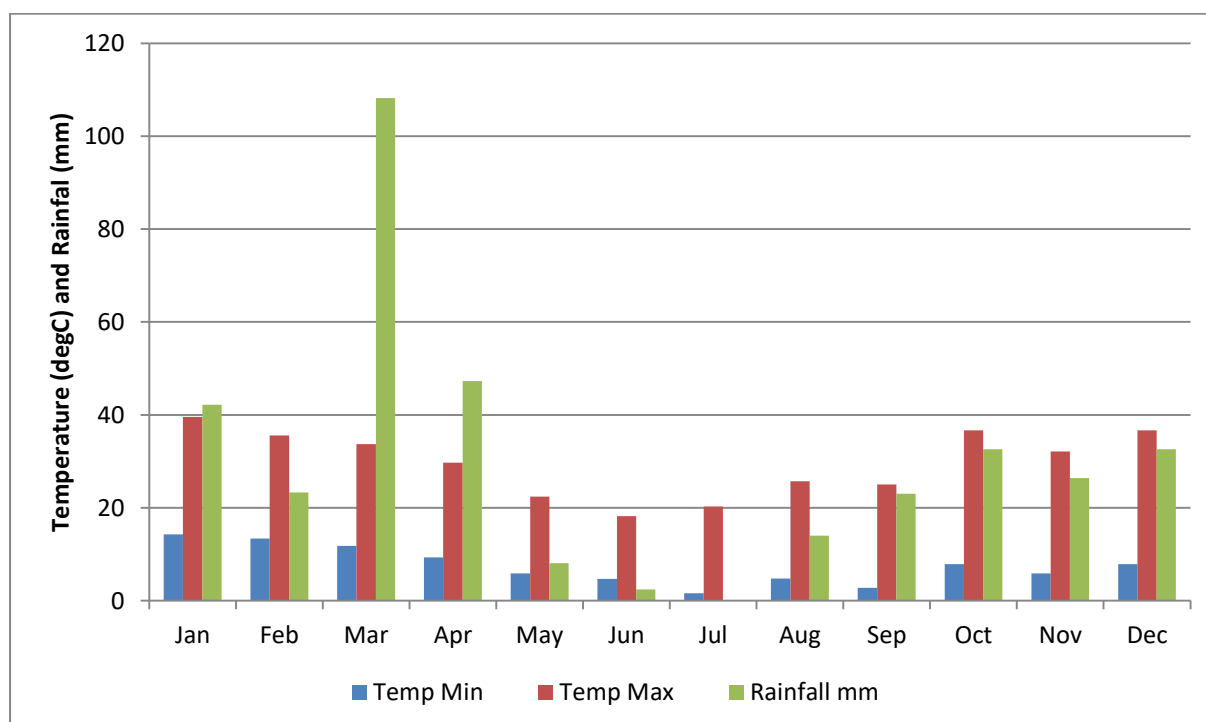
Figure 5-5-1 Weather Data for the Reporting Period

Temperatures and rainfall in the reporting period remained consistent with the BoM's long-term averages, with rainfall (373.6mm) for the period was higher than the BoM's long-term annual average of 246mm. There were 59 rain days for the period. Winds were predominantly from the south with high winds experienced throughout the year.

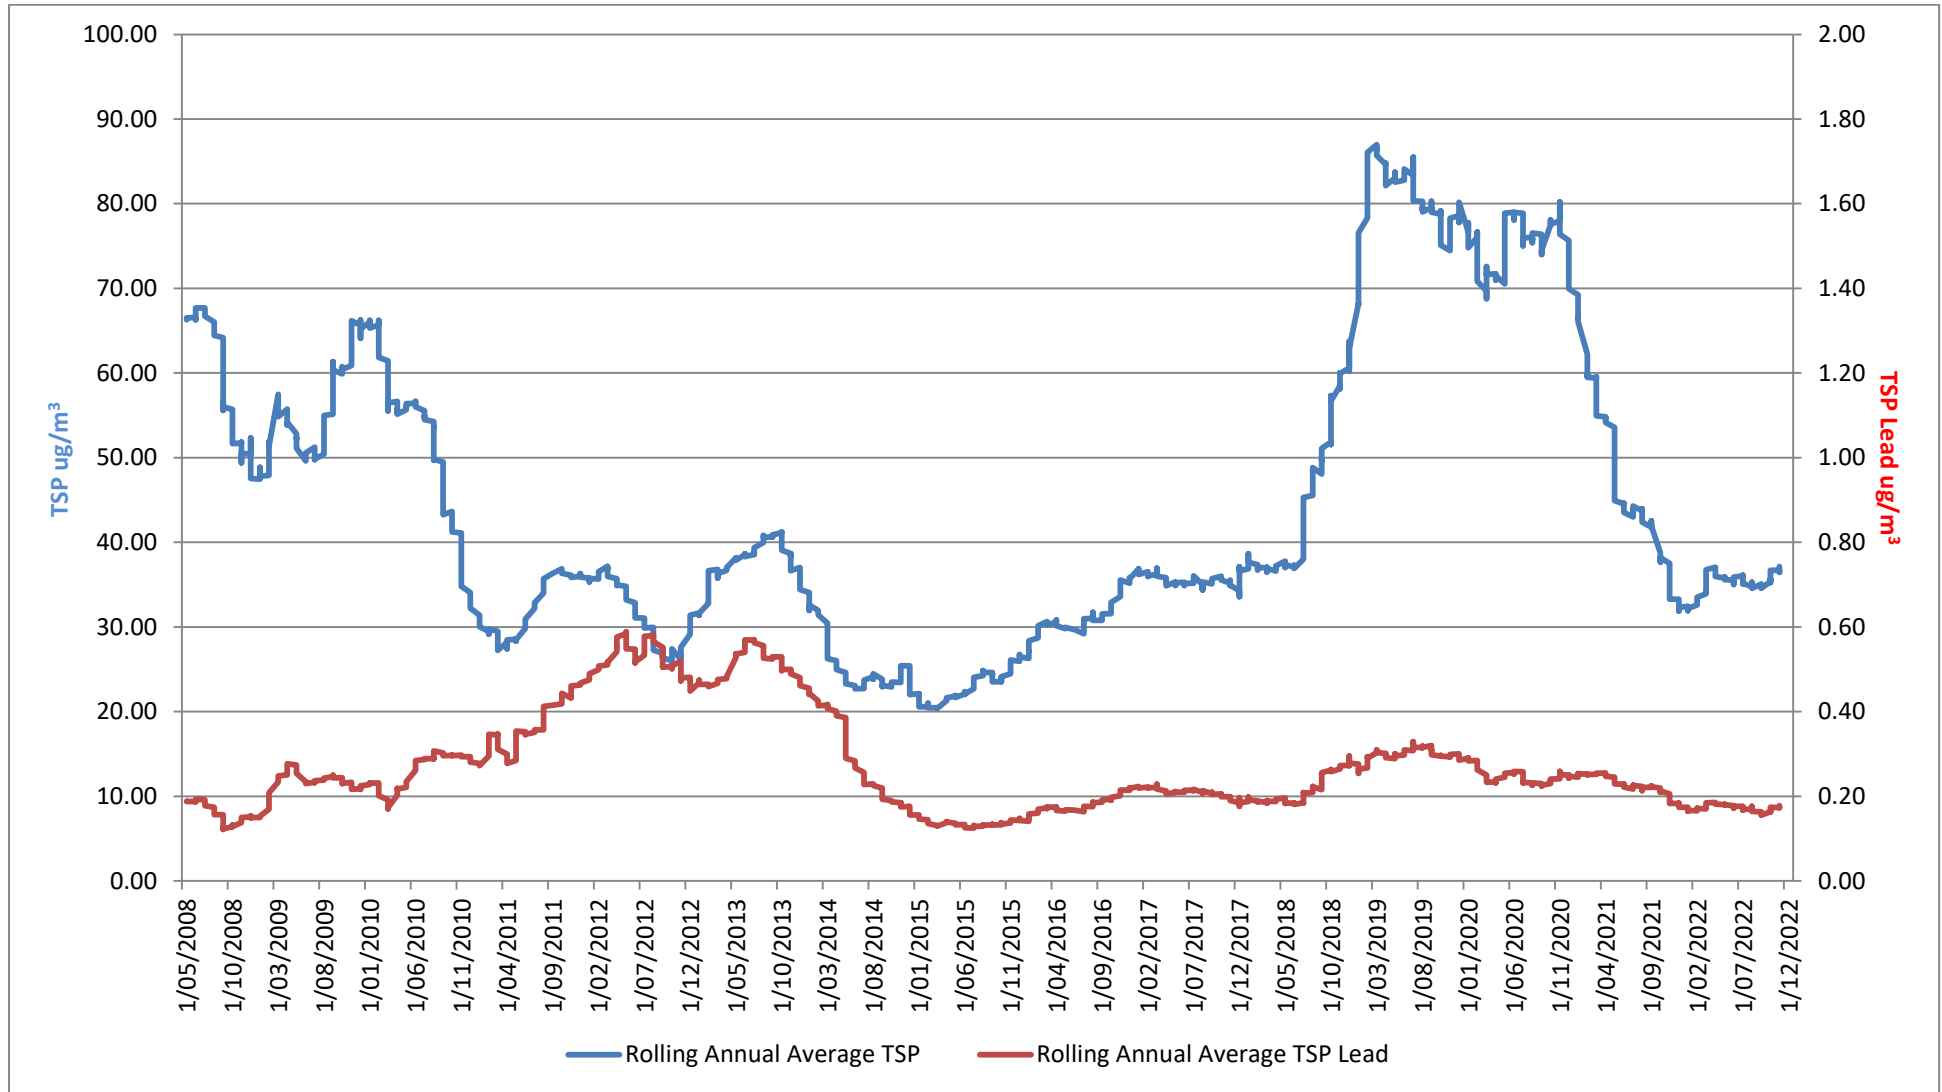
Figure 5-9 HVAS TSP and TSP-Lead Results for the Period 2008 to 2022

As can be seen in **Figure 5-9**, there is an increase in dust levels recorded in HVAS after 2016 due to the period of drought. Dust levels decreased at the beginning of 2022 due to the heavy rainfall and increased towards the end of the reporting period due to the hotter and windier weather. Lead levels have fallen with slight elevation in levels towards the end of the period. This can indicate contribution from site activities but it has been found that lead levels can be elevated at this location on the southern boundary of the site when winds are predominantly from the South.

Figure 5-9 provides a summary of TSP and TSP-lead results from 2008 to 2022. Rolling annual averages for TSP are well below the annual average criteria of 90µg/m³ and EPA threshold of 0.5 µg/m³ for TSP-lead.

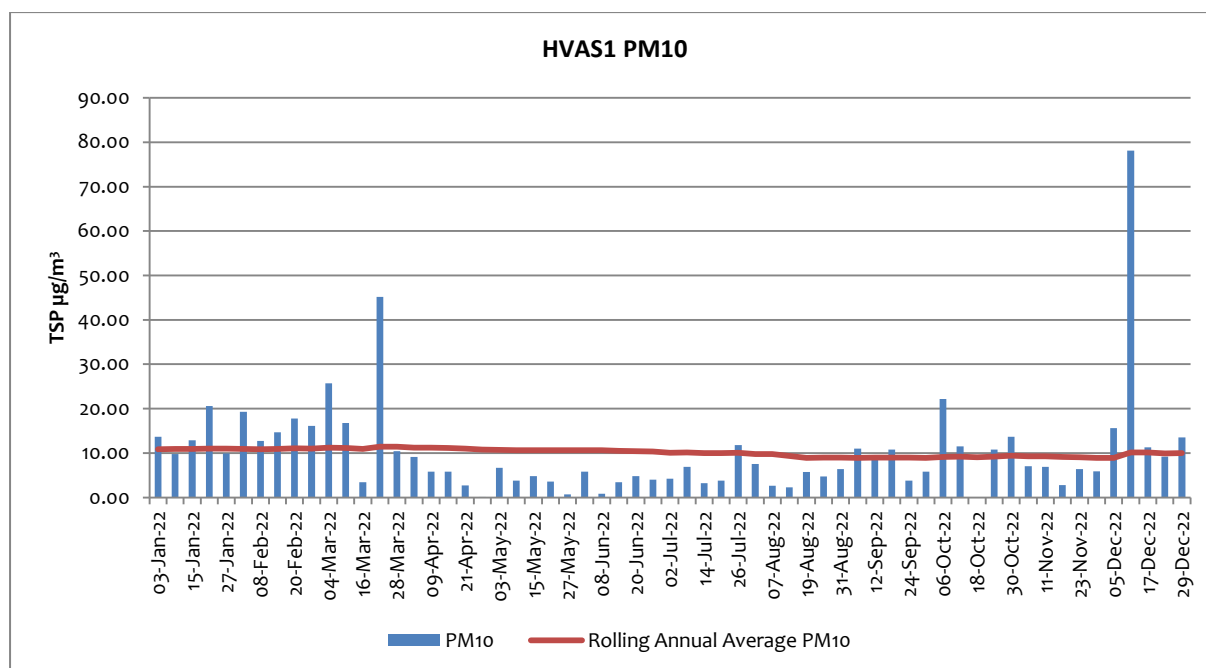
Figure 5-10 HVAS1 PM₁₀ Results for the Reporting Period

The highest PM₁₀ dust level for December was 78.10 µg/m³ on 11 December when winds were predominantly from the SW and a dust storm moved through the region.

HVAS1 is used for sampling PM₁₀ and PM₁₀-lead. The average annual PM₁₀ level recorded at this monitoring point at the end of the reporting period was 10.0 µg/m³, which has decreased from the previous reporting period of 11.0 µg/m³ and is well below the background level of 29.1µg/m³ reported in the EA. The average annual PM₁₀ level calculation includes data collected during extreme events. Results for the reporting period are shown in **Figure 5-10** which indicates that the rolling annual average for PM₁₀ is below the criteria of 25 µg/m³, and has remained consistently low during the reporting period.
