**REPORT**

# Rasp Mine - Tailings and Waste Rock Management for MOD 6

1896230-R-054-Rev1

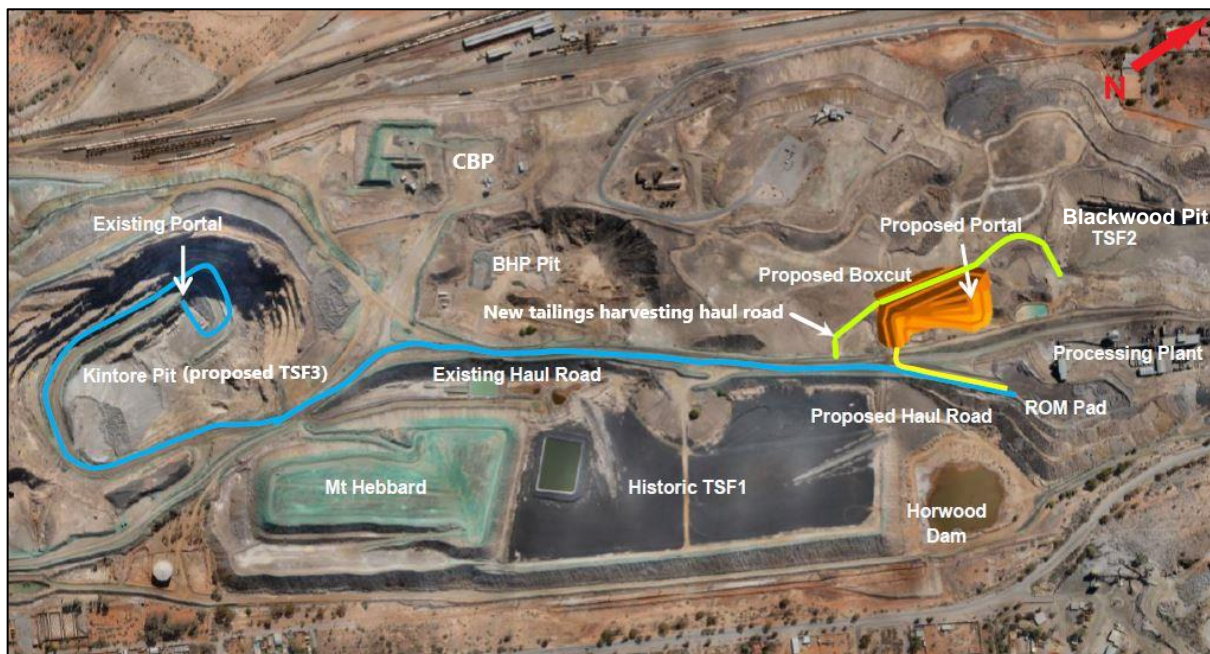
**Figure 1: Tailings and Waste Rock Management Layout**

and placed in compacted layers within the central part of TSF3. The proposed tailings and waste rock management layout is presented in Figure 1.

Waste rock from mining operations is intended to be co-disposed in TSF3 and placed over the bottom and sides of the pit. The bottom layer of waste rock is proposed to include a seepage drainage network with a robust outlet system through the filled portal decline through an engineered concrete plug to the underground mine workings water management system. To help reduce the risk of the drainage network being impacted by fines from the tailings in the event of upset conditions related to drainage via the portal, additional measures are proposed to be incorporated in TSF3. Additional measures may comprise installation of a riser pipe to enable pumped extraction of seepage collected in the drainage network and/or the installation of a layer of non-woven separation geotextile over the waste rock in the base of the pit and extended up the sides of the rockfill surround to control the risk of potential migration of fines from the tailings into the drainage layer if the bottom of the pit was to become saturated.

The site has been mined for over 135 years leaving the site highly disturbed with a number of heritage buildings and structures within the site. The majority of the site is covered with historic waste rock or tailings material, and there is minimal topsoil and vegetation. TSF3 is located in the western half of the site, as identified on Figure 1.

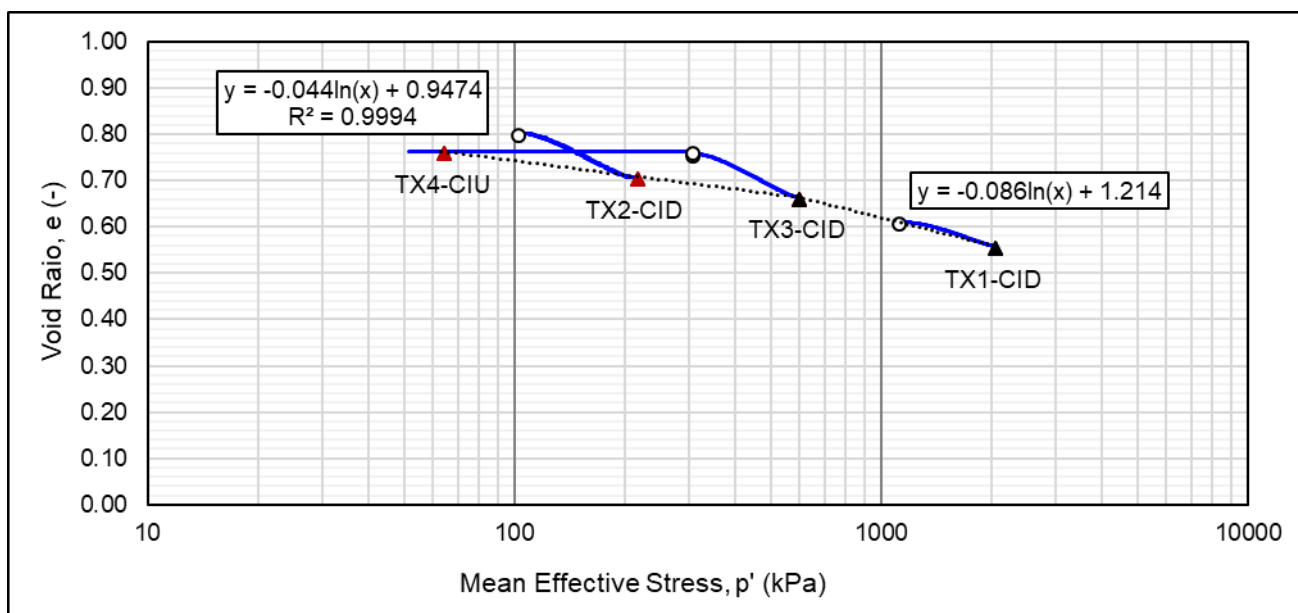
**Figure 5: Critical state line for full stream tailings**

- The slope of the critical state line is consistent to a stress of approximately 600 kPa. From this stress, the CSL seems to curve from the conventional semi-logarithmic representation. It is noted that several materials present curvature of the CSL (e.g. Jefferies and Been 2015, Verdugo 1992) and the natural logarithmic trend representation is more a convenient engineering approximation rather than an intrinsic material property.
- The slope of the CSL and its location in the  $e$ - $p'$  space is the result of a combination of factors, such as the particle size uniformity, fine content, plasticity and particle shape. For example, a material with a

uniform gradation has been observed to produce steeper and higher CSLs than materials that are well-graded, despite having similar fines content (e.g. Jefferies and Been, 2015).

The critical state line (CSL) is a useful concept to understand geomechanical behaviour of materials. Generally, materials that are looser than the CSL exhibit contractive behaviour during shearing, while those denser than the CSL exhibit dilation. Further, significantly dilative materials are unlikely to exhibit static liquefaction, which occurs when contractive materials are loaded (often under drained conditions) to a shear stress ratio that allows contractive undrained shearing to be triggered. Once the CSL is established, material behaviour can be investigated based on the concept of a state parameter ( $\psi$ ) (Jefferies and Been, 2015). The state parameter is the void ratio difference between the current state of the soil (i.e. prior to shearing) and the critical void ratio at the same mean effective stress. Typically, a material is regarded at risk of contractive behaviour when the state parameter is greater than -0.05. To reduce the potential for liquefaction or shear-related strength loss, it is desirable for a material to maintain a  $\psi < -0.05$  over the operational life of a facility.

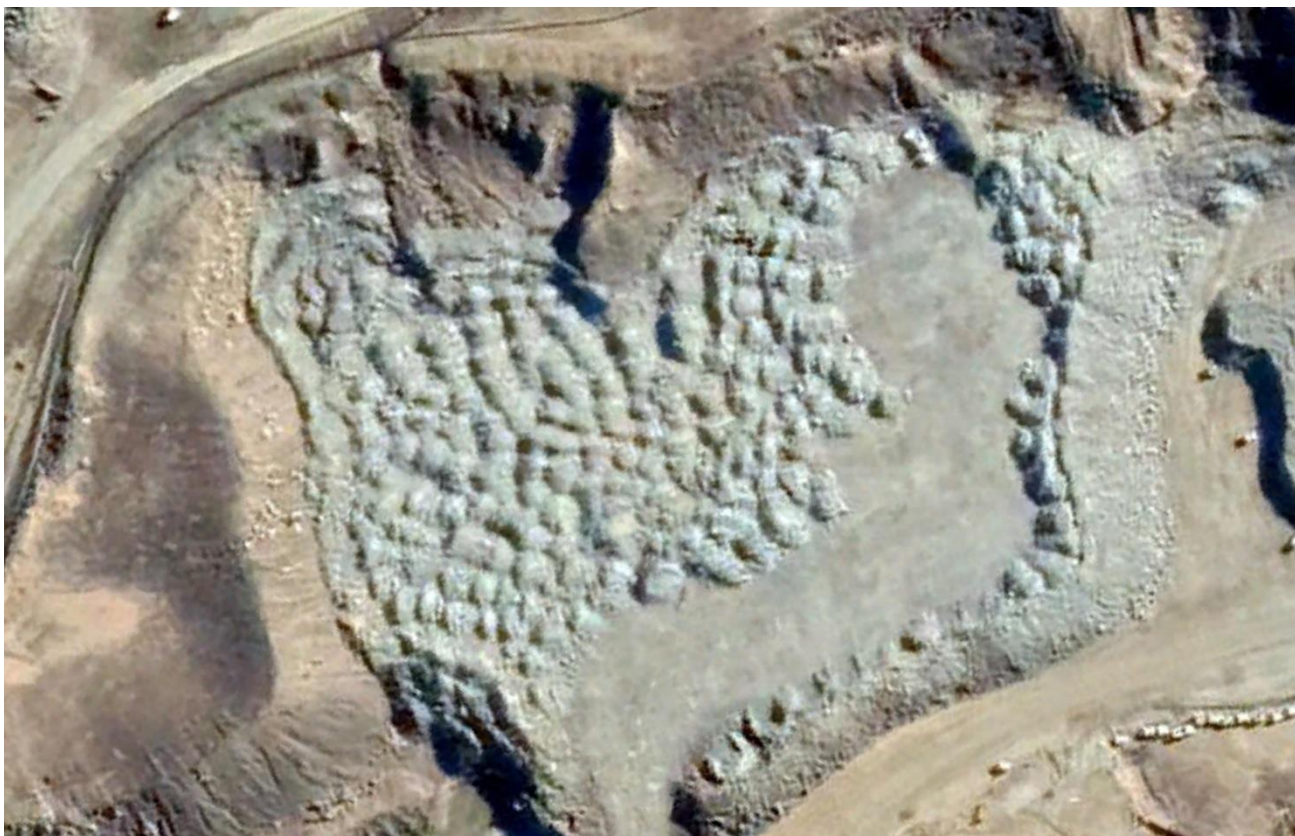
**Figure 14: Indicative Paddock Dumping Layout**

Based on the assumptions presented in Table 12 and a proposed offset dumping arrangement similar to that presented in Figure 14 a minimum fill depth of 700 mm is achieved if the truck loads are dumped within 4 m of one another (centre to centre spacing, in a triangular grid) and dumped loads overlap by approximately 1 m.

A paddock dump placement area of this nature will result in a surface with numerous tightly spaced mounds and depressions between the mounds. During rainfall events any rainfall will gravitate towards the depressions between the mounds. It is estimated based on 1 in 100 ARI rainfall and assuming initial infiltration losses of 15 mm and a continuing loss of 2 mm/hr that standing water contained in the depressions resulting from a 1 in 100 ARI rainfall event will be less than 400 mm depth. Accordingly, runoff from a 1 in 100 ARI rainfall event would be wholly contained within the depressions formed by the paddock dumping mounds. The standing water contained within these depressions will infiltrate the placement area or evaporate.

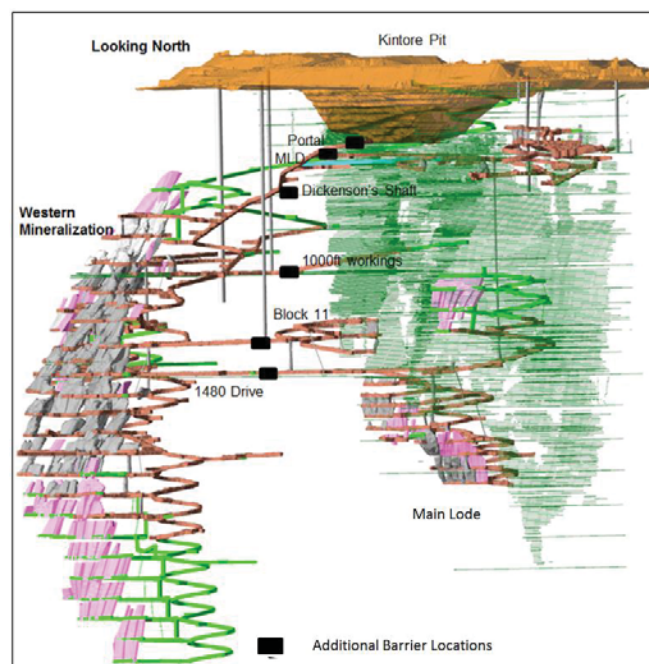
This report details the potential pathways between Rasp Mine's underground workings and Kintore Pit. Also detailed are the locations of the additional barriers required to effectively isolate these pathways from current or future active mine working, if required (Figure 2).

**Figure 2- Additional Barrier Locations**

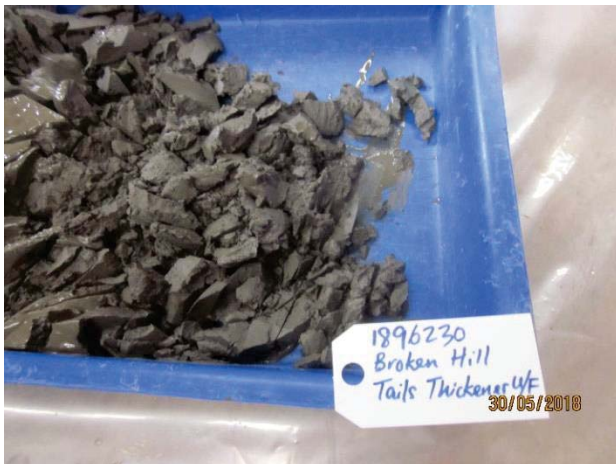
Golder syphoned and collected the water in separate buckets for later use in the critical state line (CSL) triaxial testing (refer to Section 4.2). The material was transferred to a plastic container (see Figure 2) and dried in a 50°C oven.

Figure 2: Material transferred to plastic container for drying at 50°C

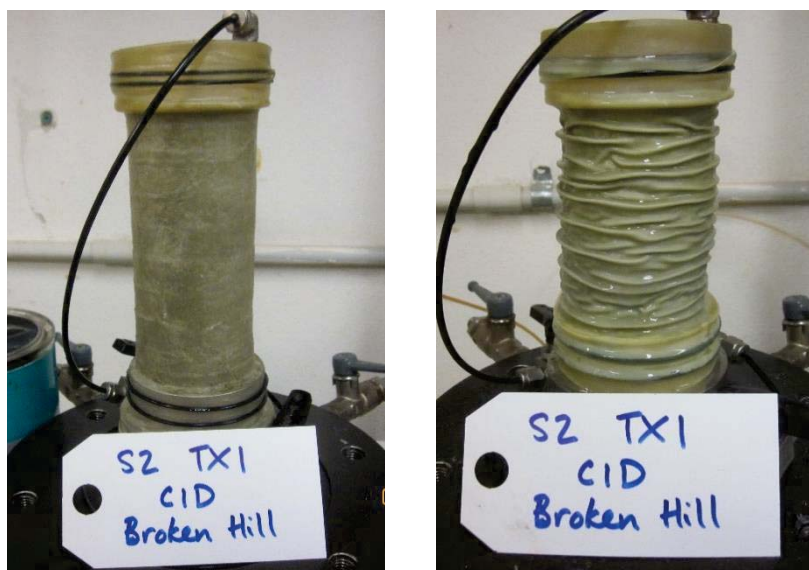
- Once consolidation was complete, samples were sheared, either drained or an undrained depending on the desired test conditions. The samples were sheared to a maximum axial strain of approximately 30%, to enable critical state conditions to be inferred, where possible.

- Each specimen was frozen prior to removal from the triaxial membrane and platens, to improve the accuracy of the GWC measurement. GWC measurement was then carried out in an oven at 110°C.

Figure 3: Example of specimen before and after triaxial test

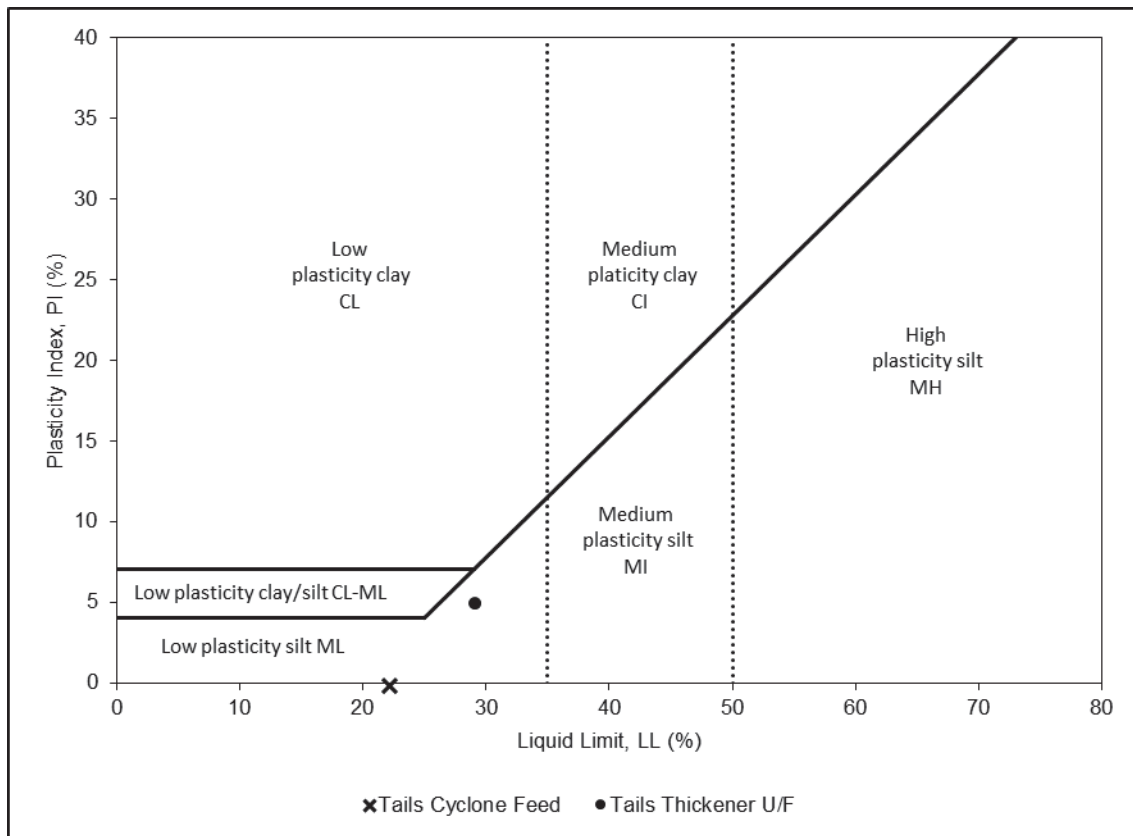
<sup>1</sup> Applying the universal soil classification system (USCS), the Tails Cyclone Feed would be classified as a Silty Sand.

Figure 4: Soil classification based on Atterberg limits

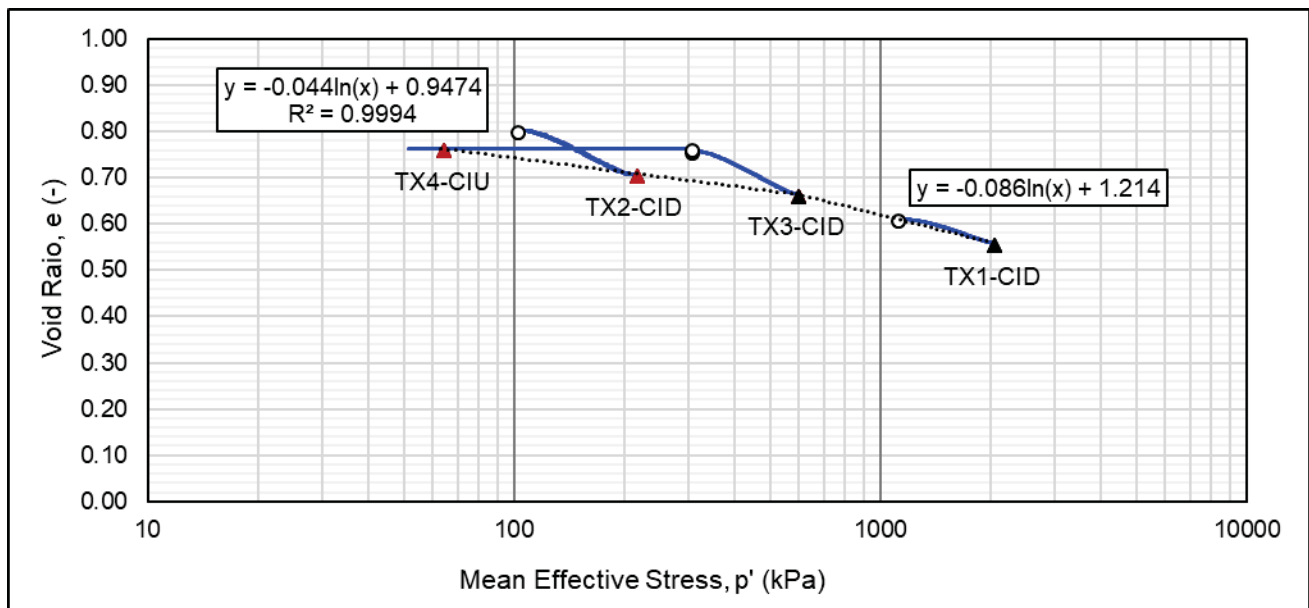
**Figure 5: Critical state line for Tails Cyclone Feed**

The critical state line (CSL) is a useful concept to understand geomechanical behaviour of materials. Generally, materials that are looser than the CSL exhibit contractive behaviour during shearing, while those denser than the CSL exhibit dilation. Further, significantly dilative materials are unlikely to exhibit static liquefaction, which occurs when contractive materials are loaded (often under drained conditions) to a shear stress ratio that allows contractive undrained shearing to be triggered. Once the CSL is established, material behaviour can be investigated based on the concept of a state parameter ( $\psi$ ) (Jefferies and Been, 2015). The state parameter is the void ratio difference between the current state of the soil (i.e. prior to shearing) and the critical void ratio at the same mean effective stress. Typically, a material is regarded at risk of contractive behaviour when the state parameter is greater than -0.05. To reduce the potential for liquefaction or shear-related strength loss, it is desirable for a material to maintain a  $\psi < -0.05$  over the operational life of a facility.

Triaxial ID	Test Type	CSL Parameters		K	Undrained Strength		Critical Friction Angle $\Phi_c$ (°)
		$\Gamma$	$\Lambda$		Peak $S_u/\sigma'_v$	Residual $S_u/\sigma'_v$	
<b>Cyclone Tails Feed</b>							
TX1-1000 kPa	CID	0.9474	0.044	1.00	-	-	33.8
TX2-100 kPa	CID			0.96	-	-	38.9
TX3-300 kPa	CID			0.99	-	-	36.4
TX4-300 kPa	CIU	(1.214)*	(0.086)*	0.99	0.21 ( $\psi=0.066$ )	0.12	34.6
<b>Thickener U/F Tails</b>							
TX1-100 kPa	CID	1.077	0.049	0.96	-	-	37.3
TX2-300 kPa	CID			0.99	-	-	34.2
TX3-1000 kPa	CID			1.00	-	-	32.1
TX4-100 kPa	CIU			0.96	0.21 ( $\psi=0.068$ )	0.12	38.7

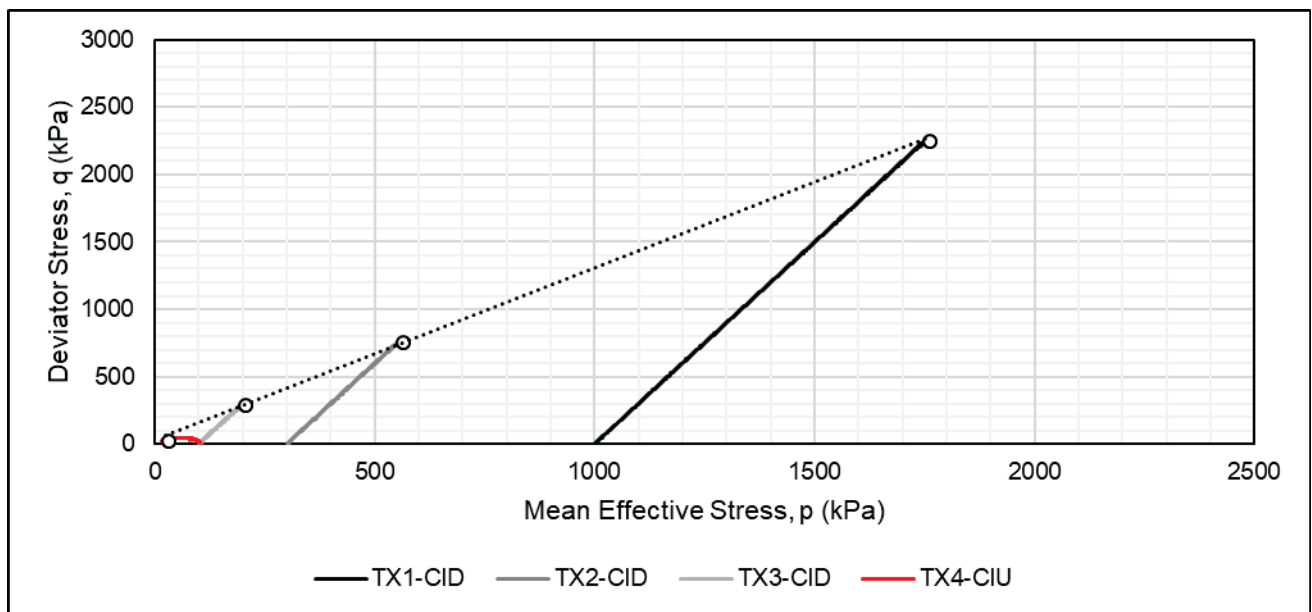
Figure 8: Cambridge plot and critical friction angle for Tails Thickener U/F

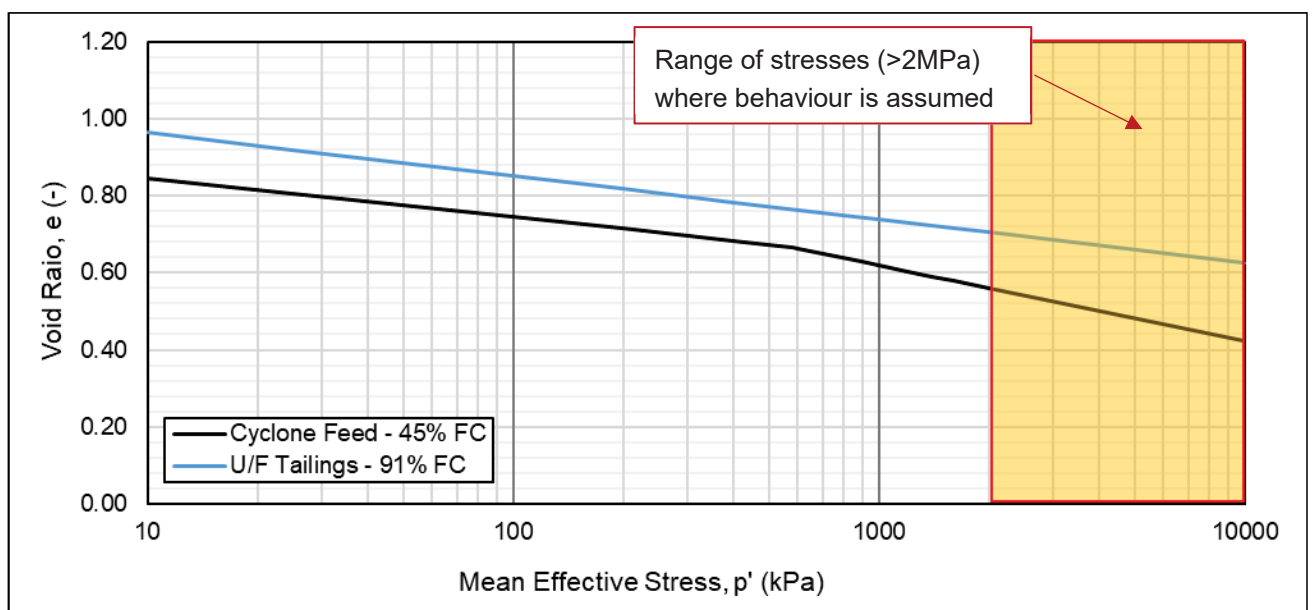
Figure 9: Comparison of CSL from Tails Cyclone Feed and Tails Thickener U/F

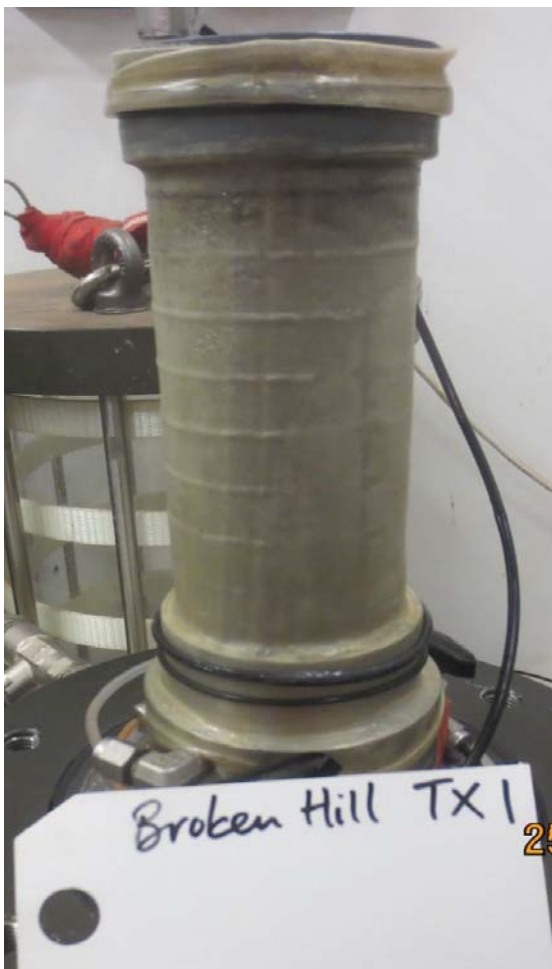
Sample Before Test

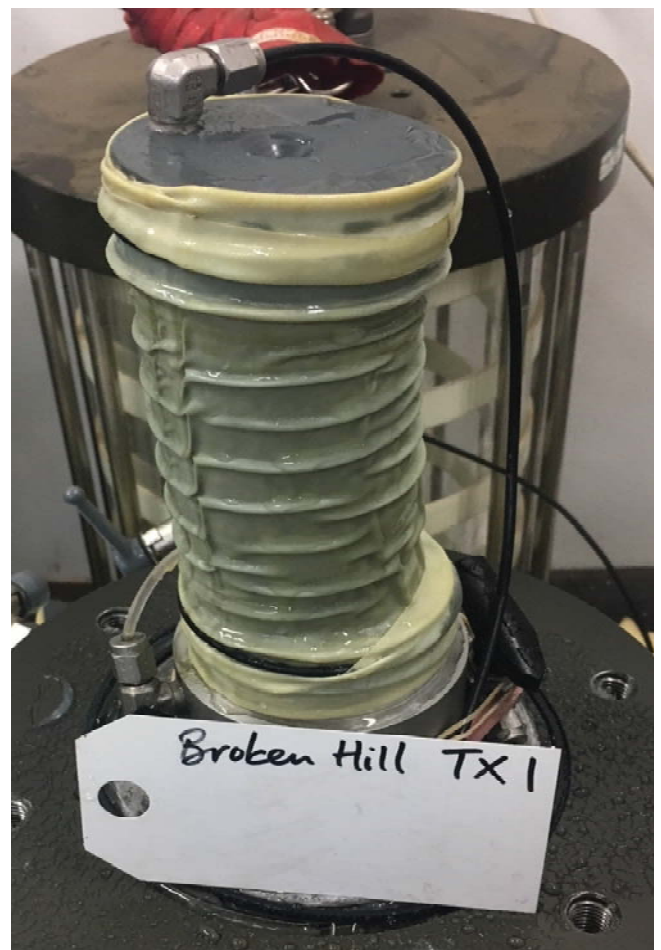
Sample After Test

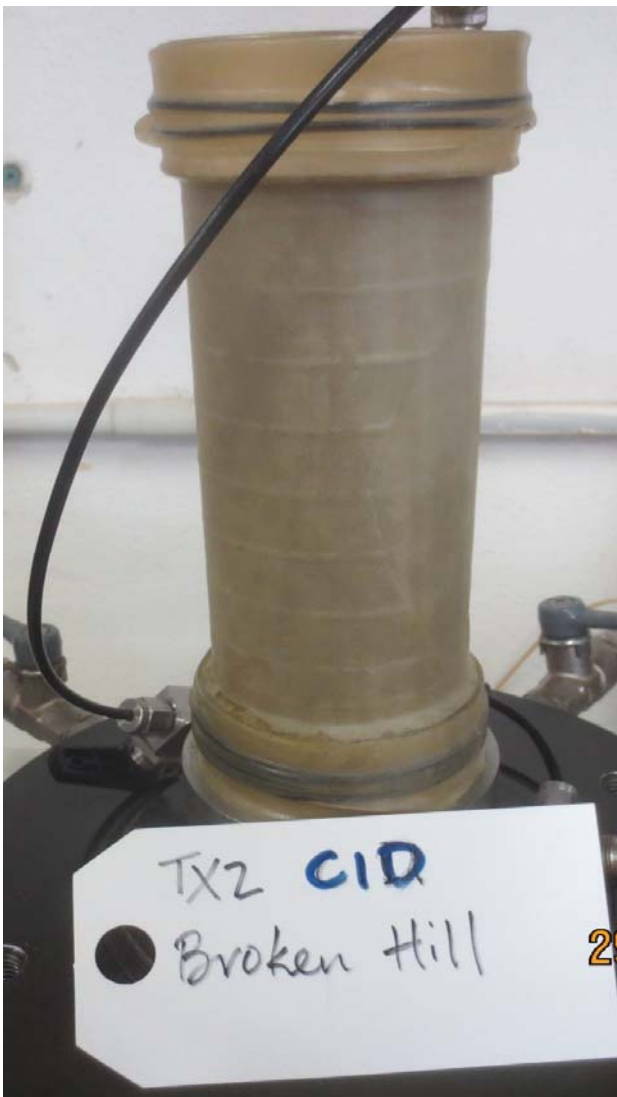
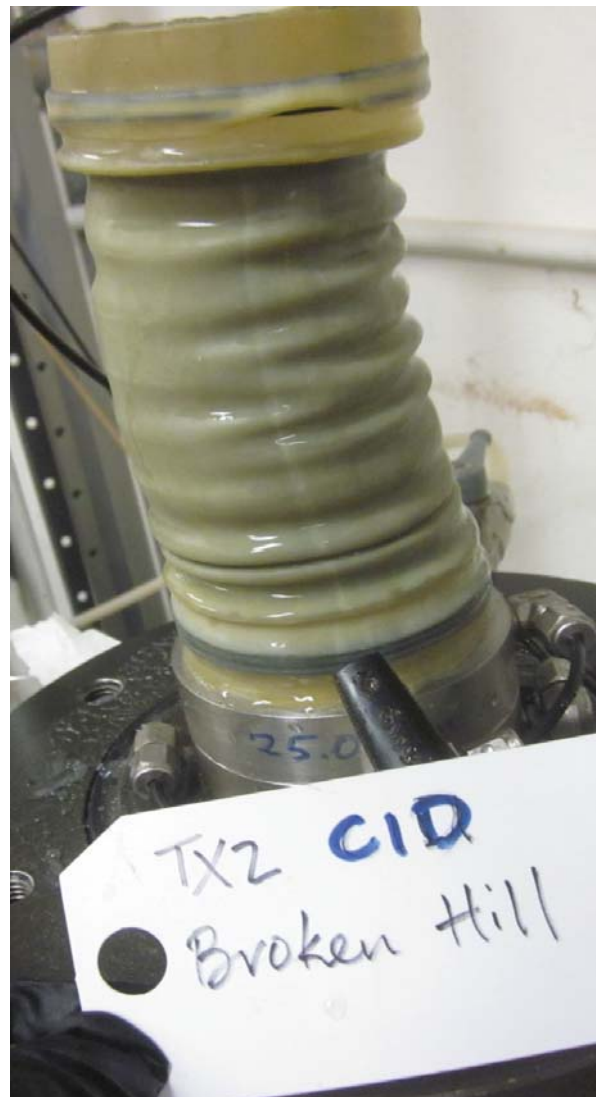
<b>Client:</b>	Broken Hill Operations Pty Ltd	<b>Date:</b>	30/05/2018		
<b>Address:</b>	130 Eyre Street Broken Hill NSW 2880	<b>Project No.:</b>	1896230		
<b>Project:</b>	Kintore Pit (Broken Hill) CSL Testing	<b>Sample ID:</b>	S1 Cyclone Feed - TX2		
Initial Height (mm):	129.8	Final Liquor Content (%):	23.3%	Strain Rate (mm/min):	0.03
Initial Diameter (mm):	61.9	Final Dry Density (t/m <sup>3</sup> ):	1.78	B Response (%):	99%
Trimming GWC (%):	4.8%	Final Void Ratio (-):	0.71	Mean Effective Consolidation Stress (kPa):	101
Initial Dry Density (t/m <sup>3</sup> ):	1.44	Final Liquor Solids Conc. (g/L):	-	Geostatic Stress Ratio $K_0$ (-):	0.96

Sample Before Test

Sample After Test

Sample was moist tamped to a loose condition

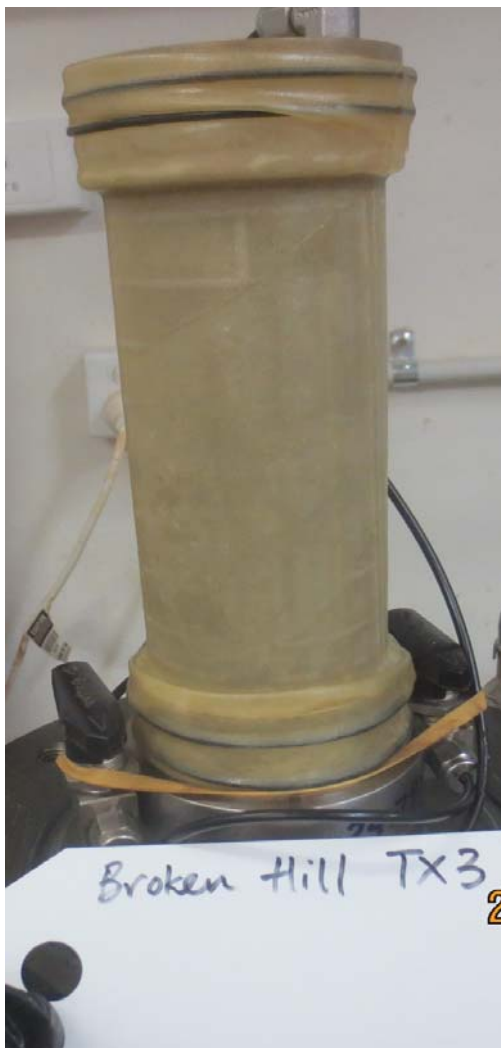
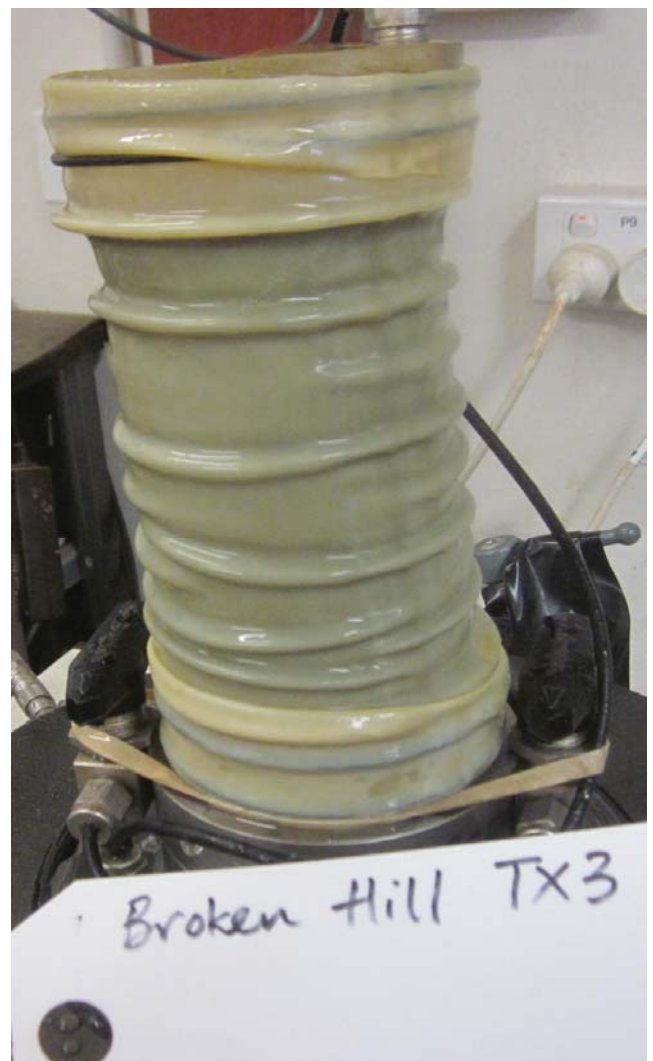
<b>Client:</b>	Broken Hill Operations Pty Ltd	<b>Date:</b>	30/05/2018		
<b>Address:</b>	130 Eyre Street Broken Hill NSW 2880	<b>Project No.:</b>	1896230		
<b>Project:</b>	Kintore Pit (Broken Hill) CSL Testing	<b>Sample ID:</b>	S1 Cyclone Feed - TX3		
Initial Height (mm):	130.4	Final Liquor Content (%):	21.9%	Strain Rate (mm/min):	0.03
Initial Diameter (mm):	61.7	Final Dry Density (t/m <sup>3</sup> ):	1.83	B Response (%):	99%
Trimming GWC (%):	4.8%	Final Void Ratio (-):	0.67	Mean Effective Consolidation Stress (kPa):	300
Initial Dry Density (t/m <sup>3</sup> ):	1.45	Final Liquor Solids Conc. (g/L):	-	Geostatic Stress Ratio $K_0$ (-):	0.99

Sample Before Test

Sample After Test

Sample was moist tamped to a loose condition

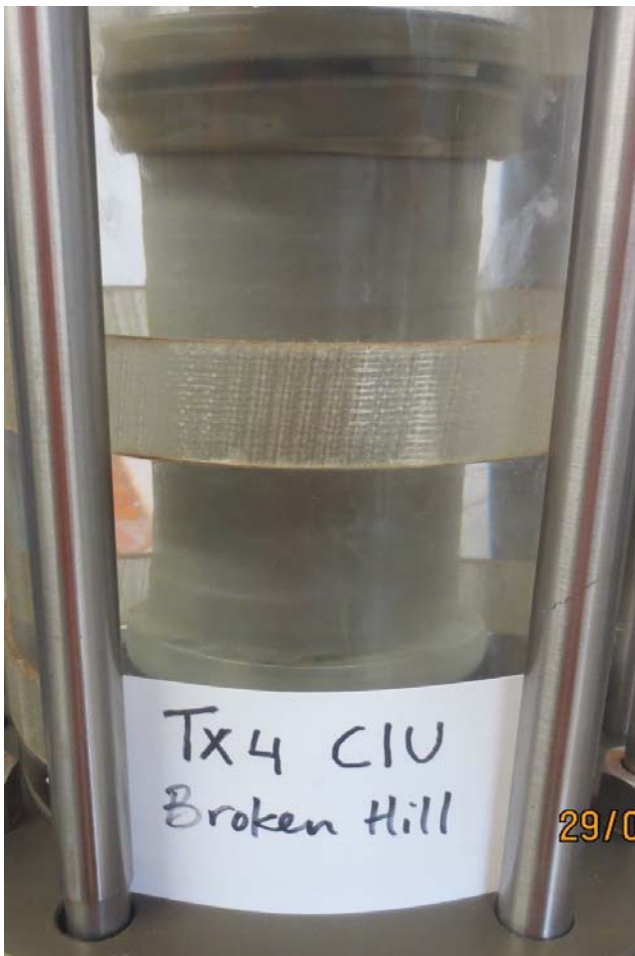
<b>Client:</b>	Broken Hill Operations Pty Ltd	<b>Date:</b>	30/05/2018		
<b>Address:</b>	130 Eyre Street Broken Hill NSW 2880	<b>Project No.:</b>	1896230		
<b>Project:</b>	Kintore Pit (Broken Hill) CSL Testing	<b>Sample ID:</b>	S1 Cyclone Feed - TX4		
Initial Height (mm):	129.1	Final Liquor Content (%):	25.1%	Strain Rate (mm/min):	0.03
Initial Diameter (mm):	61.8	Final Dry Density (t/m <sup>3</sup> ):	1.72	B Response (%):	99%
Trimming GWC (%):	4.8%	Final Void Ratio (-):	0.76	Mean Effective Consolidation Stress (kPa):	301
Initial Dry Density (t/m <sup>3</sup> ):	1.45	Final Liquor Solids Conc. (g/L):	-	Geostatic Stress Ratio $K_0$ (-):	1.00

Sample Before Test

Sample After Test

Preparation Notes:	Sample was moist tamped to a loose condition	Tested by:	K. Koh
		Reviewed by:	R. Fanni
THIS DOCUMENT SHALL ONLY BE REPRODUCED IN FULL

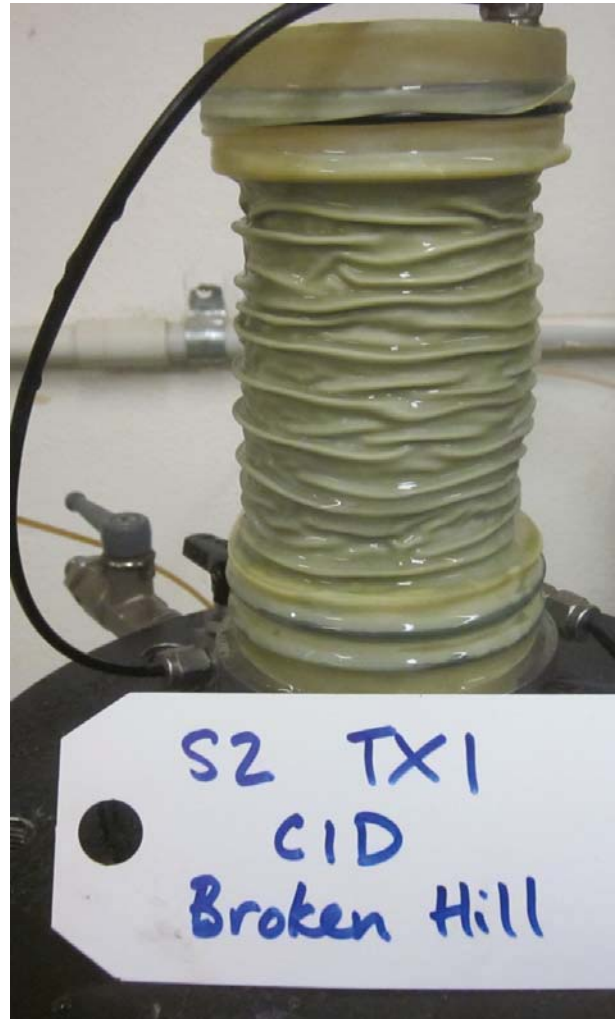
<b>Client:</b>	Broken Hill Operations Pty Ltd		<b>Date:</b>	2/06/2018	
<b>Address:</b>	130 Eyre Street Broken Hill NSW 2880		<b>Project No.:</b>	1896230	
<b>Project:</b>	Kintore Pit (Broken Hill) CSL Testing		<b>Sample ID:</b>	S2 Thickener U/F - TX1	
Initial Height (mm):	128.6	Final Liquor Content (%):	27.2%	Strain Rate (mm/min):	0.03
Initial Diameter (mm):	59.4	Final Dry Density (t/m <sup>3</sup> ):	1.66	B Response (%):	99%
Trimmings GWC (%):	11.4%	Final Void Ratio (-):	0.82	Mean Effective Consolidation Stress (kPa):	101
Initial Dry Density (t/m <sup>3</sup> ):	1.17	Final Liquor Solids Conc. (g/L):	-	Geostatic Stress Ratio $K_0$ (-):	0.96

Sample Before Test

Sample After Test

Sample was moist tamped to a loose condition

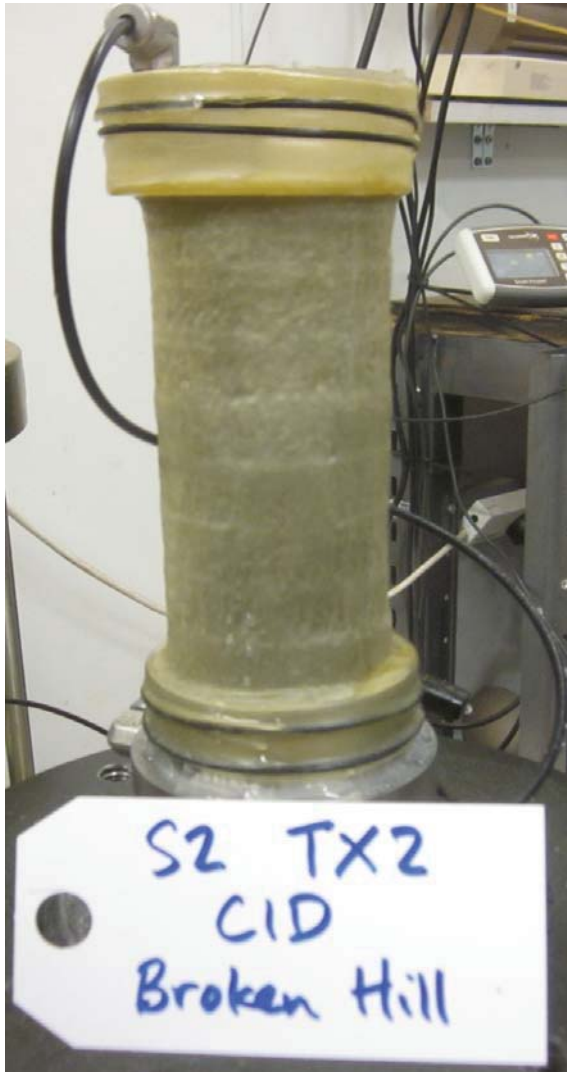
<b>Client:</b>	Broken Hill Operations Pty Ltd		<b>Date:</b>	3/06/2018	
<b>Address:</b>	130 Eyre Street Broken Hill NSW 2880		<b>Project No.:</b>	1896230	
<b>Project:</b>	Kintore Pit (Broken Hill) CSL Testing		<b>Sample ID:</b>	S2 Thickener U/F - TX2	
Initial Height (mm):	123.8	Final Liquor Content (%):	25.5%	Strain Rate (mm/min):	0.03
Initial Diameter (mm):	56.3	Final Dry Density (t/m <sup>3</sup> ):	1.70	B Response (%):	99%
Trimmings GWC (%):	11.4%	Final Void Ratio (-):	0.77	Mean Effective Consolidation Stress (kPa):	301
Initial Dry Density (t/m <sup>3</sup> ):	1.23	Final Liquor Solids Conc. (g/L):	-	Geostatic Stress Ratio $K_0$ (-):	0.99

Sample Before Test

Sample After Test

Sample was moist tamped to a loose condition

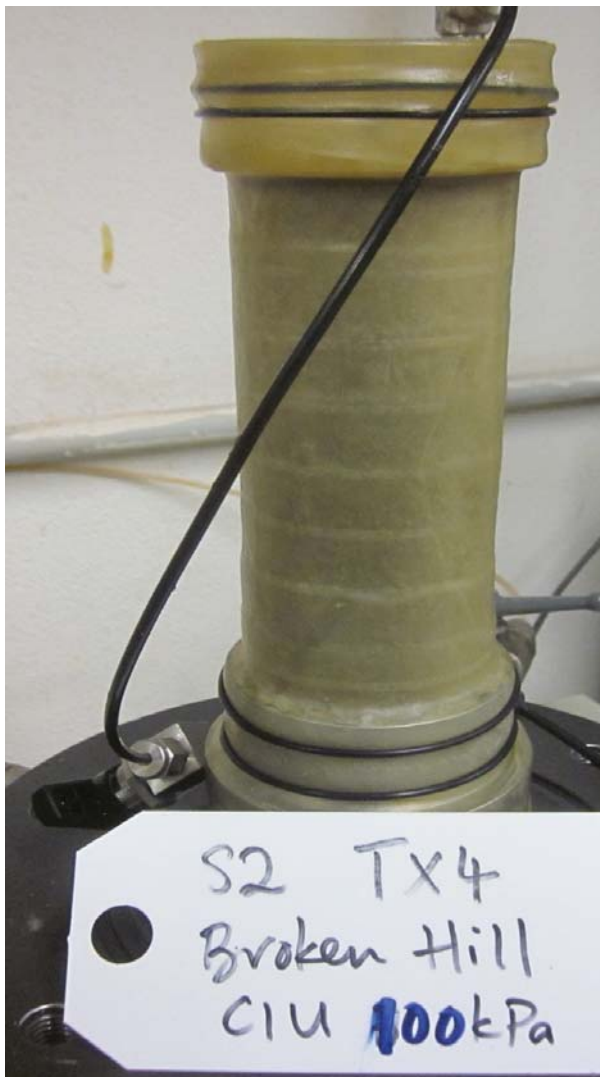
Sample Before Test

<b>Client:</b>	Broken Hill Operations Pty Ltd	<b>Date:</b>	5/06/2018		
<b>Address:</b>	130 Eyre Street Broken Hill NSW 2880	<b>Project No.:</b>	1896230		
<b>Project:</b>	Kintore Pit (Broken Hill) CSL Testing	<b>Sample ID:</b>	S2 Thickener U/F - TX4		
Initial Height (mm):	128.2	Final Liquor Content (%):	30.4%	Strain Rate (mm/min):	0.03
Initial Diameter (mm):	59.4	Final Dry Density (t/m <sup>3</sup> ):	1.57	B Response (%):	99%
Trimming GWC (%):	11.4%	Final Void Ratio (-):	0.92	Mean Effective Consolidation Stress (kPa):	102
Initial Dry Density (t/m <sup>3</sup> ):	1.18	Final Liquor Solids Conc. (g/L):	-	Geostatic Stress Ratio $K_0$ (-):	0.96

Sample was moist tamped to a loose condition

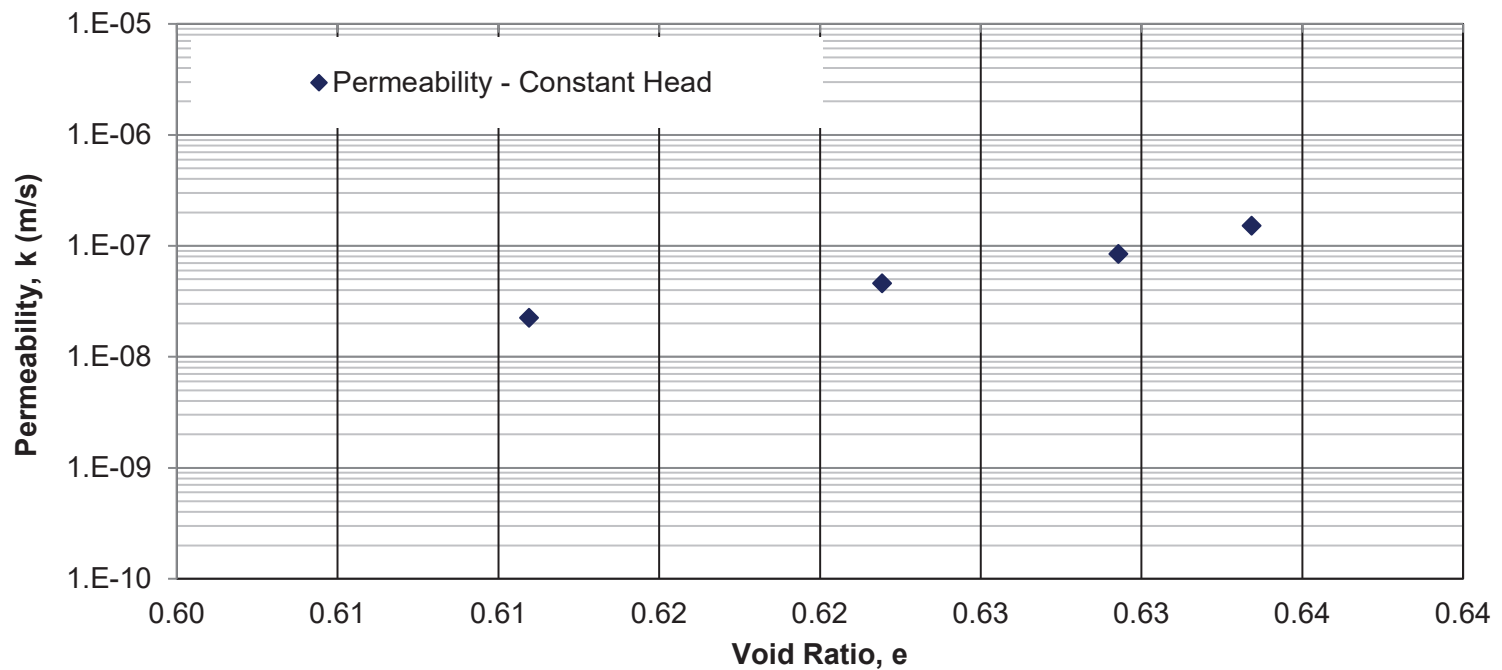
**Test procedure:** In-house  
**Specimen Type:** Tailings  
**Test Conditions:** Top drainage of specimen while undergoing compression  
**Sample Diameter (mm):** 71

Type: Decant fluid  
Initial dry density  $t/m^3$ : 1.85  
Suspended solids concentration (g/l): Not determined

**Notes:**  
Coefficient of consolidation calculated from the constant head permeability testing.

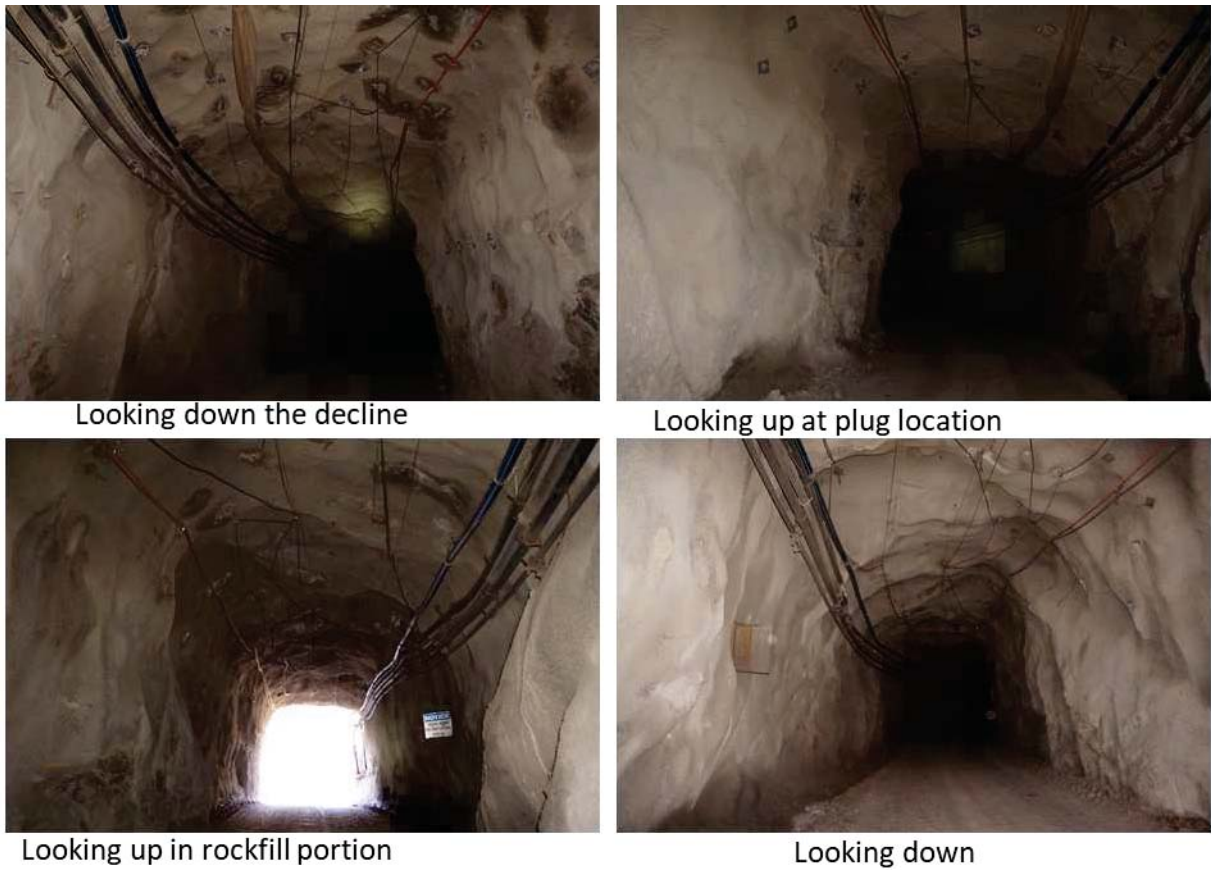
Figure 4: Photos of Portal Plug location

The proposed Portal plug is located at coordinate of 972m N, 1365mE and 10226 m RL below the existing mine portal elevation in Kintore Pit as shown in Figure 3. Photographs of the tunnel area to be plugged are presented in Figure 4.

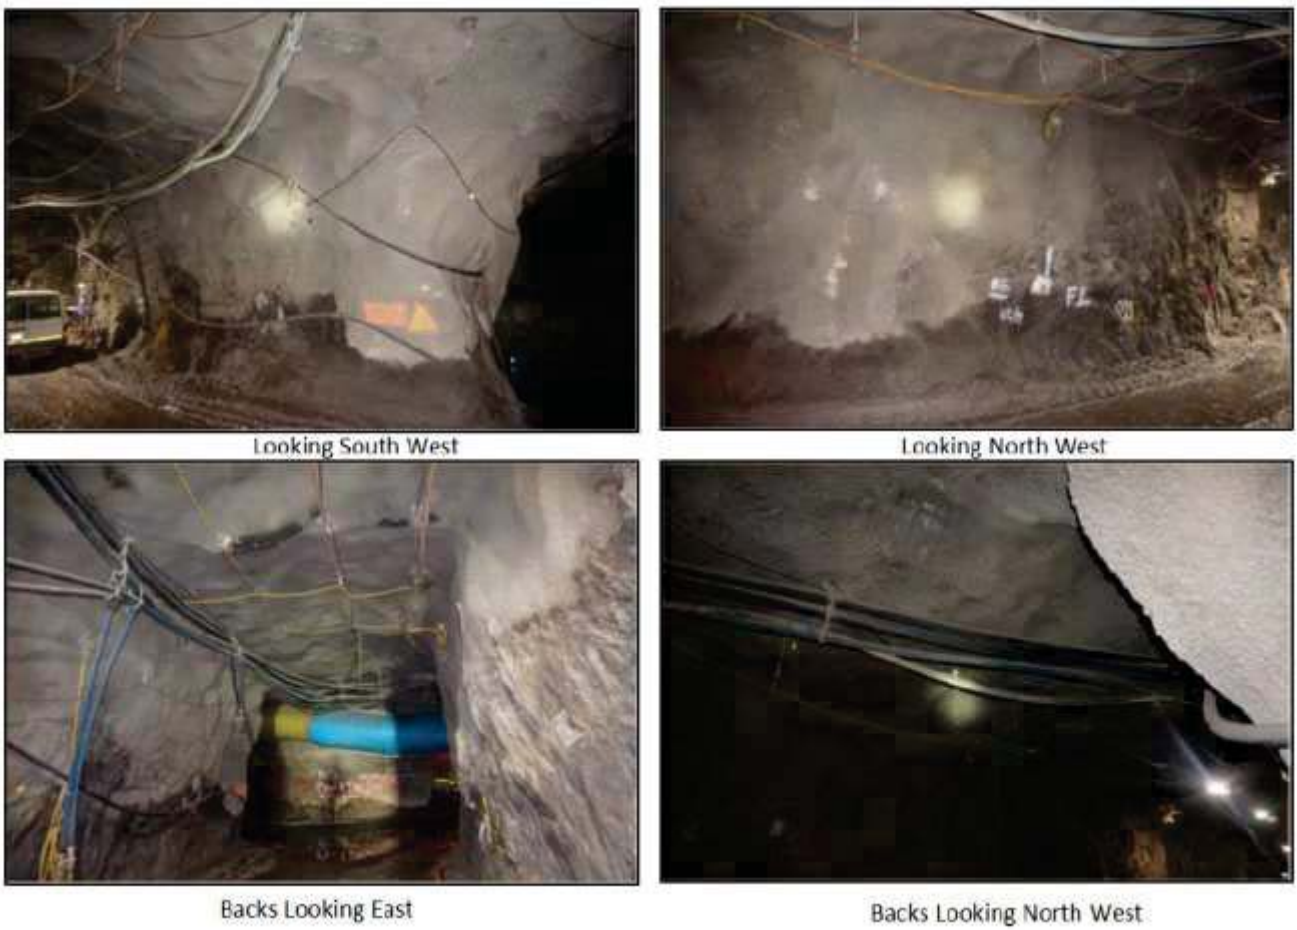
Figure 9 shows the location of 1000 ft Level East of Parkbay plug. Photographs of the proposed tunnel sections to be plugged is presented in Figure 10. Photographs show damp area due to presence of sump in this area. It is understood that the tailing pressure will be applied from right side of the plug (as shown on below figures).

Figure 10: Photos of 1000 ft Level East of Parkbay Mine Plug Location (extract from inrush report)

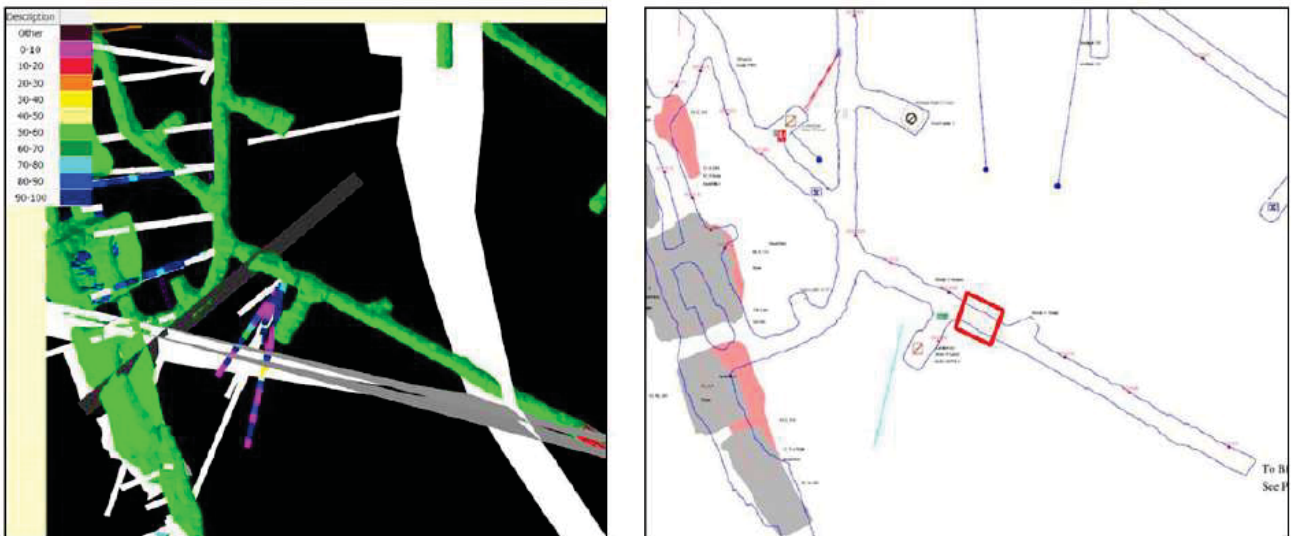
Location of Block 11 plug is presented in layout plan shown in Figure 11. The tunnel section to be plugged is presented in photographs shown in Figure 12.

Figure 11: Location of Block 11 Mine Plug (extract from inrush report)

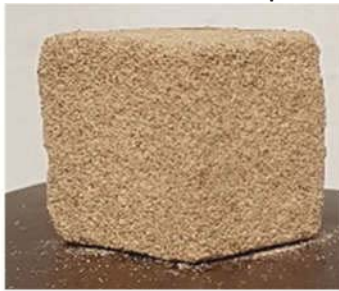
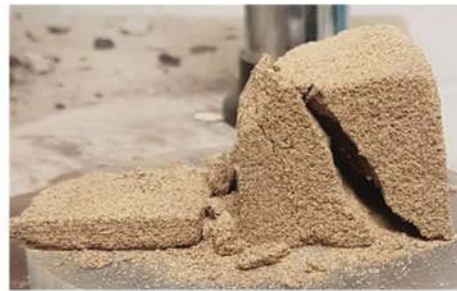
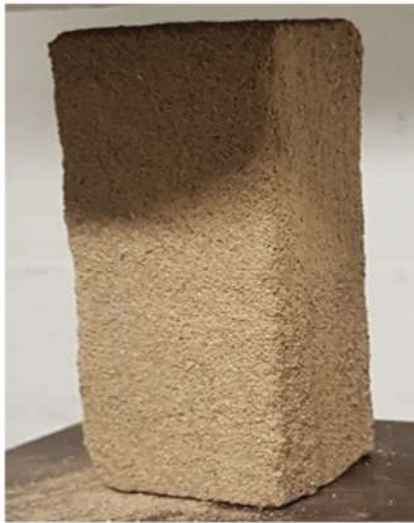
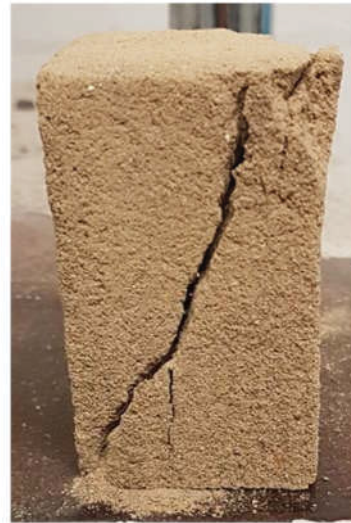
Figure 5 Unsaturated UCS test samples

Intact sample

Crushed sample

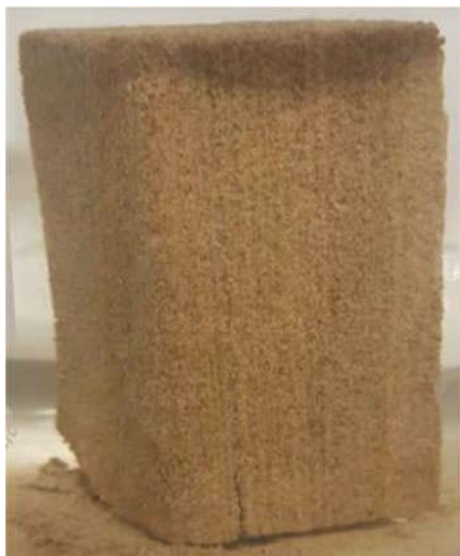
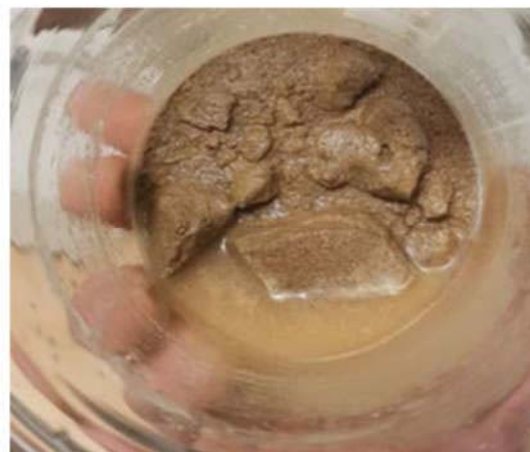
Figure 6 Saturated UCS test results

Intact sample

Crushed sample

The insitu material was successfully tested under dry conditions, however, total disintegration and strength loss was observed under saturated conditions.
