**REPORT**

# Rasp Mine - Tailings and Waste Rock Management for MOD 6

1896230-R-054-Rev1

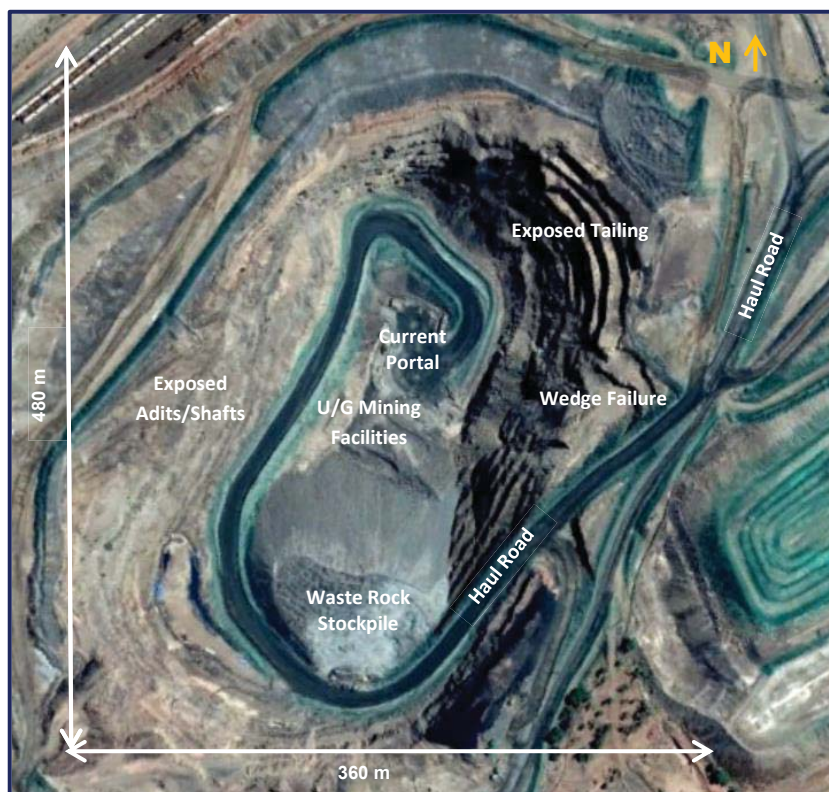
**Figure 2-1 Kintore Pit**

Kintore Pit (the Pit) is a large open pit mined in the 1970s currently used for underground mining access via a mine portal and decline and is located to the west of CML7, **Figure 1-1**. The Pit is approximately 100 m deep (RL210 to RL310) on the southern perimeter and approximately 480 m (north to south) by 360 m (east to west), **Figure 2-1**. Waste rock is used to fill underground voids and is stored in the Pit when there are no suitable voids available. On average 159,000 t per year has been stored in the Pit since mining commenced in 2012 to the end of 2019 (**Table 1-2**). An additional 135,000 t is planned to be placed during 2020 bringing the total stored in Kintore Pit to 1,410,989 t. This material will remain in the Pit. The current Haul Road will remain to provide access to the Pit.

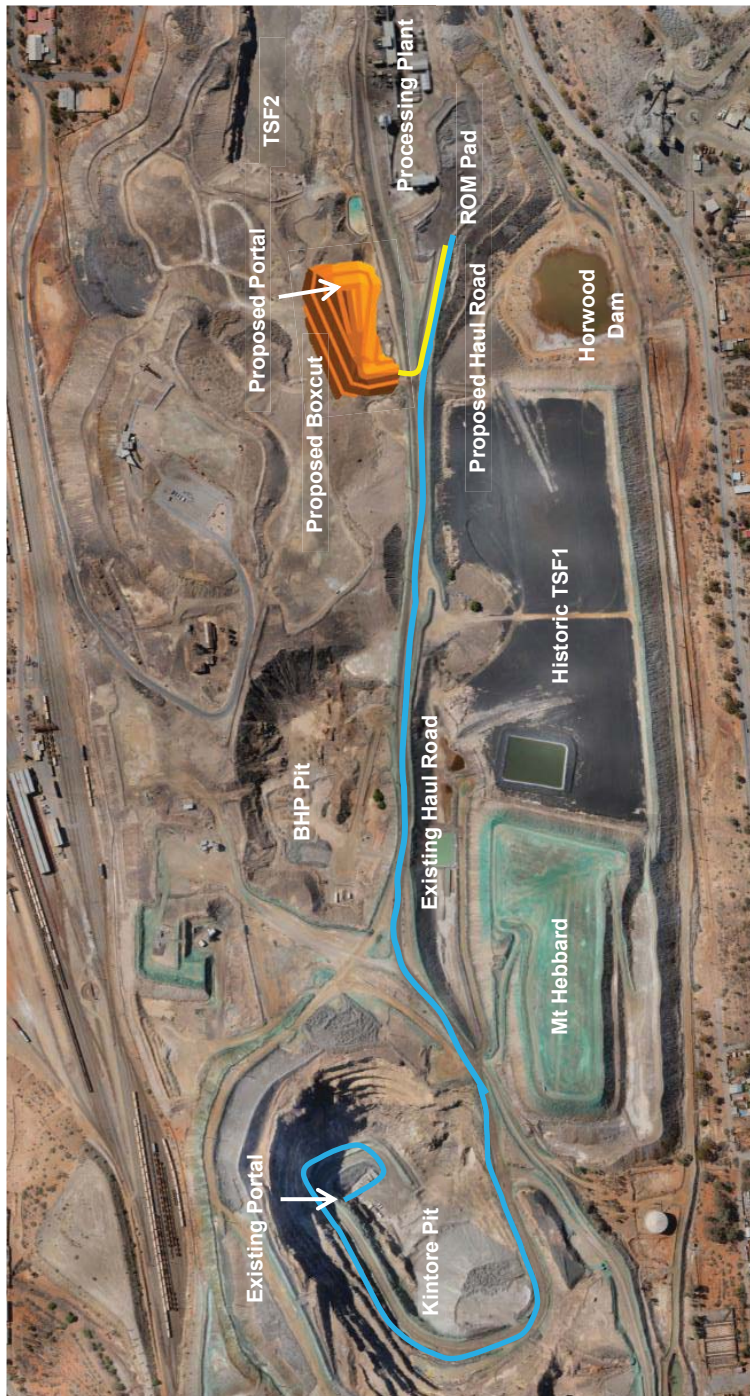
**Figure 2-2 Indicative Proposed Portal Location**

It is proposed to access underground mine workings via a new portal to be located adjacent to the Haul Road north-west of TSF1, **Figure 2-2**.

This will require the construction of a boxcut to obtain the required depth to connect to competent rock. The Haul Road will be realigned to meet this boxcut. The decline will be located to the northeast of the boxcut heading northwest to join existing and planned underground development.

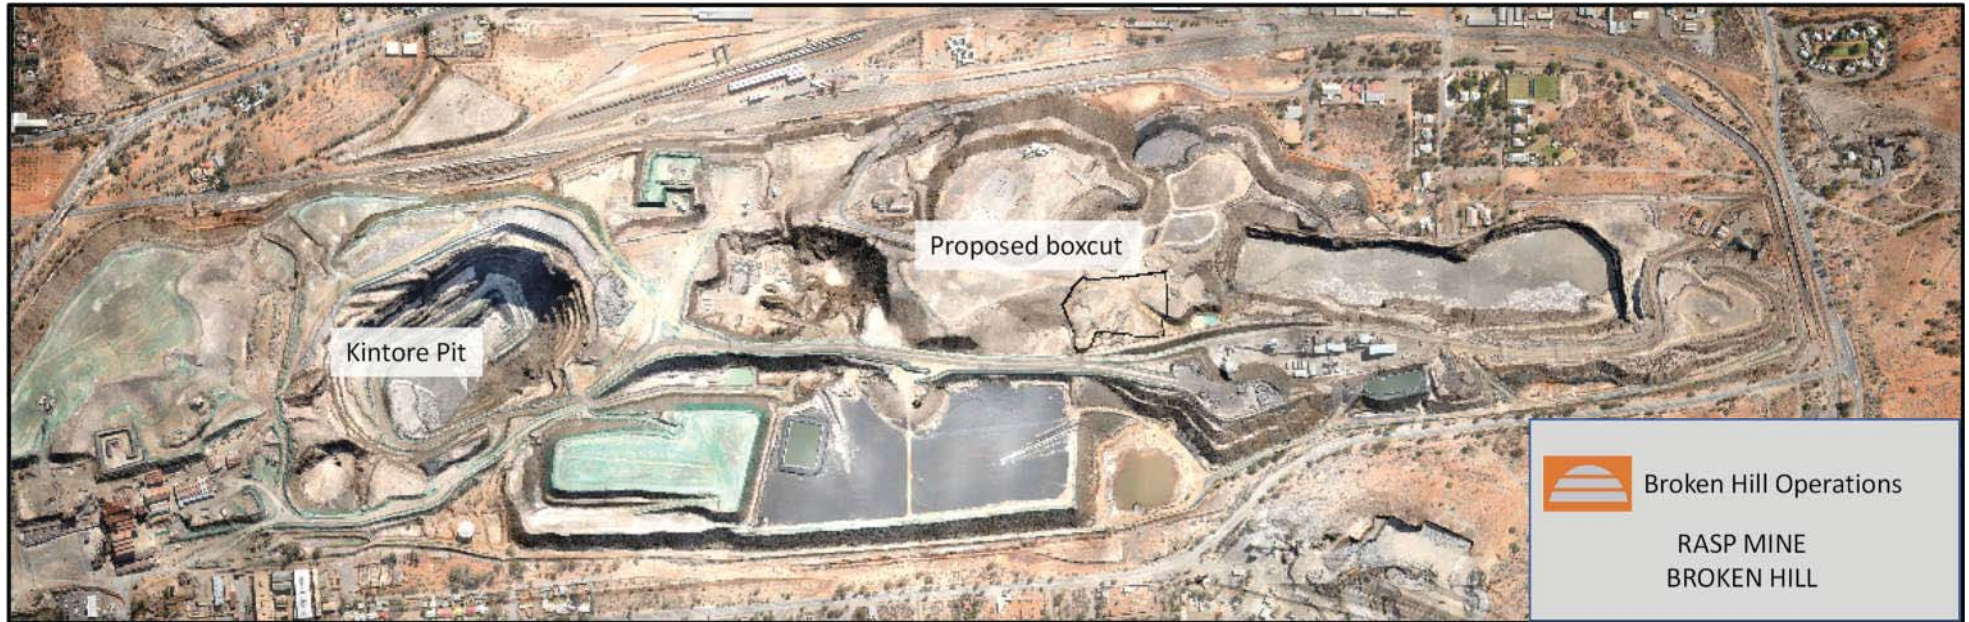
Figure 1 Kintore pit and box cut design outline within existing topography.

Figure 1 shows the location of the current portal location and proposed boxcut excavation

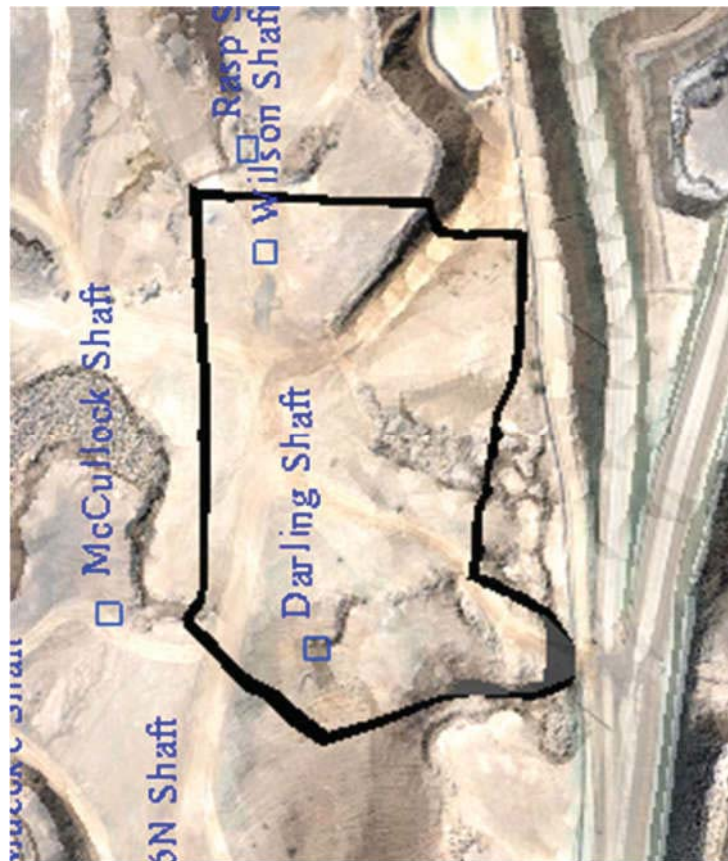
**Figure 4 Wilson and Darling Shaft locations – plan view**

The location for the boxcut does not intersect known underground workings apart from the Wilson and Darling Shafts located on what will be the western wall of the boxcut. These shafts originally connected the underground workings to the surface; however, it is believed that these shafts were filled after abandonment. The location of the Wilson and Darling Shafts is shown in Figure 4.

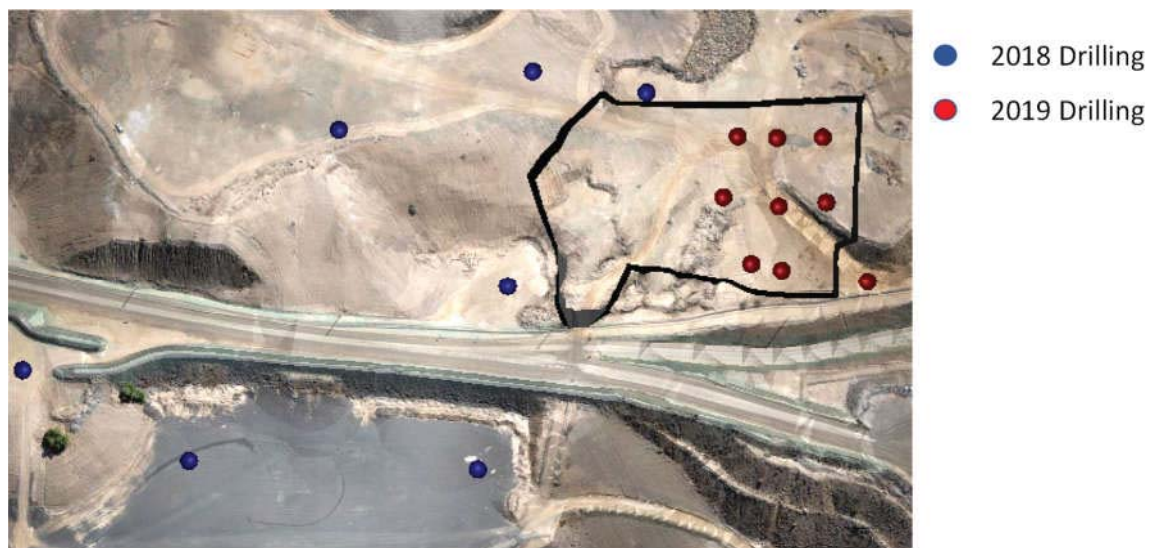
**Figure 5 Plan view of diamond drill investigation holes**

Hole ID	Depth (m)	Dip	Easting (m)	Northing (m)	RL (m)
MLDD3873	45.0	-90.0	9888.6	2351.0	10334.6
MLDD3874	36.0	-90.0	9989.4	2333.6	10325.0
MLDD3875	42.6	-90.0	9985.0	2177.8	10324.6
MLDD3876	44.4	-90.0	9935.2	2085.4	10335.5
MLDD3877	53.6	-90.0	9802.2	2259.7	10354.0
MLDD3878	42.0	-90.0	9771.0	2365.0	10352.0
MLDD3879	42.0	-90.0	9782.4	2426.0	10344.8
MLDD4132	41.0	-90.0	9842.4	2526.1	10343.3
MLDD4133	40.9	-90.0	9806.8	2524.2	10343.0
MLDD4134	40.1	-90.0	9807.2	2499.1	10343.2
MLDD4135	40.0	-90.0	9806.3	2477.5	10343.0
MLDD4136	40.1	-90.0	9806.9	2524.7	10342.9
MLDD4137	40.3	-90.0	9844.6	2500.1	10340.7
MLDD4138	41.0	-90.0	9876.1	2485.0	10342.1
MLDD4139	40.3	-90.0	9879.8	2501.7	10341.8
MLDD4140	40.9	-90.0	9886.0	2548.7	10335.8

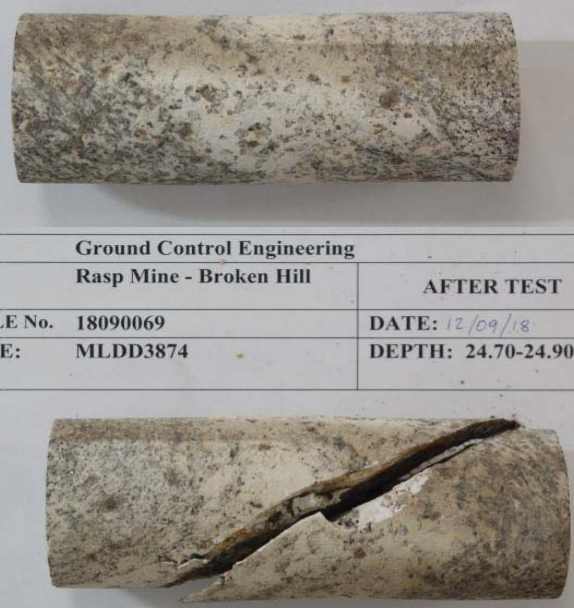
<b>PROJECT:</b>	Rasp Mine - Broken Hill	
<b>LAB SAMPLE No.</b>	18090069	
<b>BOREHOLE:</b>	MLDD3874	
		<b>BEFORE TEST</b>
		DATE: 12/09/18
		DEPTH: 24.70-24.90

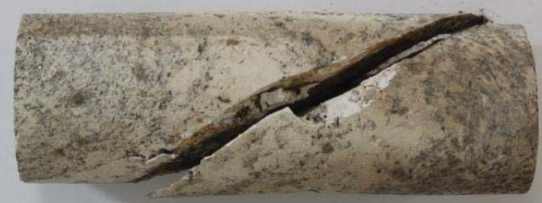
<b>PROJECT:</b>	Rasp Mine - Broken Hill	
<b>LAB SAMPLE No.</b>	18090069	
<b>BOREHOLE:</b>	MLDD3874	
		<b>AFTER TEST</b>
		DATE: 12/09/18
		DEPTH: 24.70-24.90
