# ENDEAVOR MINE

## MONTHLY ENVIRONMENTAL REPORT

For the Month Ending 30 April 2018

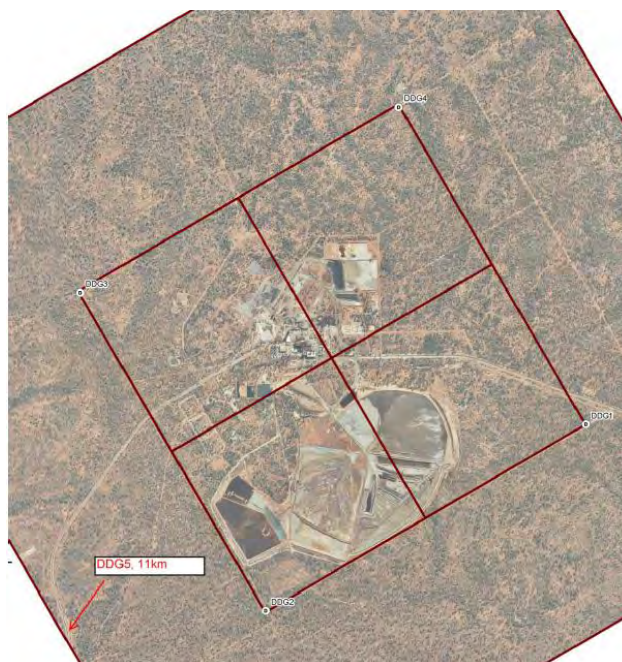
Figure 1: Endeavor Mine Dust Monitoring Locations

As show in the aerial photo (Figure 1), there are 5 dust monitoring locations on the boundary of the lease, with one located 11kms from the site at the turnoff to the Mine site near the Louth Road. This station was positioned to establish background levels.

As shown in Table 4 the results for Total Insoluble Matter (TIM) were very low and did not exceed the limit of 4 g/m<sup>2</sup>/month as set in the *Approved Methods and Guidance for the Modelling and Assessment of Air Pollutants in NSW 2005*. Pb levels were undetectable for 4 of the 5 locations and well within establish guidelines.

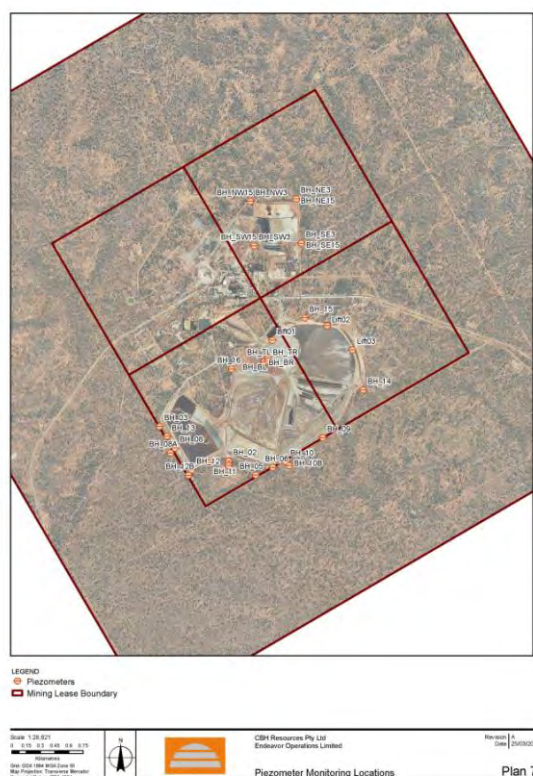
Figure 2: Location of the Piezometer Monitoring Locations

Endeavor Mine's groundwater monitoring locations are concentrated around the perimeter of the Central Tailings Discharge (CTD) and the Sector 5 Tailings Storage Facility (CTF), while surface water monitoring locations are focused on water storages that could potentially discharge to environment during a major rain or storm event. Table 5 describes the monitoring stations where Figure 2 shows the locations of the piezometers. Depending on availability of water or flow, unfortunately on some occasions, piezometers cannot be monitored as a result of being dry.

No Groundwater sampling was undertaken during April 2018. Groundwater Monitoring will resume in June 2018 for the second quarterly monitoring as per EP 1301 Requirements.
