# ENDEAVOR MINE

## MONTHLY ENVIRONMENTAL REPORT

August  
2019

<b>Name of Operation</b>	Endeavor Mine
<b>Name of Licensee</b>	Endeavor Operations Pty Ltd
<b>Environmental Protection Licence</b>	No: 1301
<b>Reporting Period Start Date</b>	1 August 2019
<b>Reporting End Date</b>	31 August 2019
<b>Author</b>	Fabio Perez
<b>Approver</b>	Carlos Vanegas

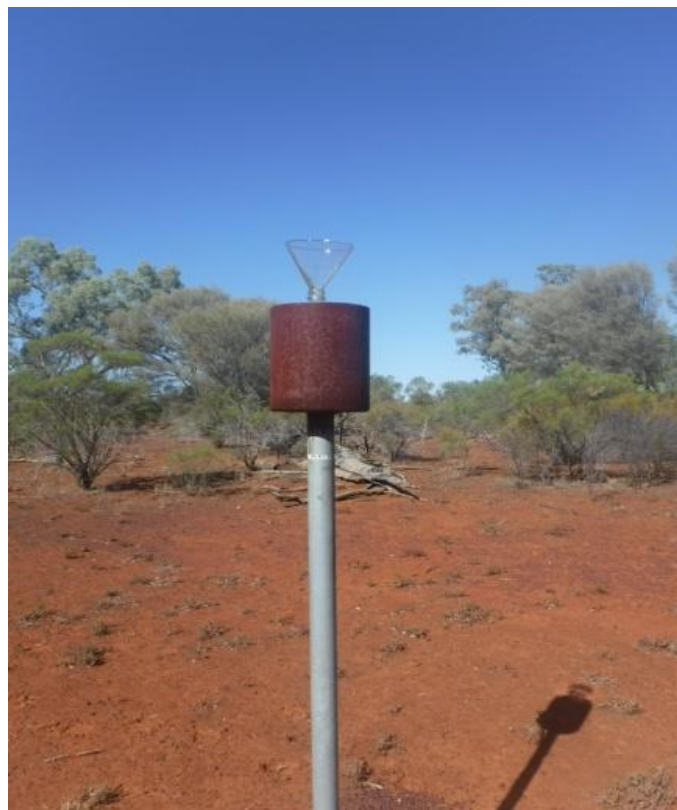
**Figure 3.1** Dust monitoring gauge located in the project

The Endeavor Mine Dust Monitoring Program measures dust deposition rates on a monthly basis at the main mining lease boundary (4 locations) and at a background location located 11km from the operating mine site (DDG 5). EP Licence 1301 does not set limits for dust deposition. However, these results are compared to the recommended limits outlined in *Approved Methods and Guidance for the Modelling and Assessment of Air Pollutants in NSW 2005*. This guidance document recommends that the deposition rate for total insoluble matter when expressed as a 12 month rolling average should not exceed 4 g/m<sup>2</sup>/month and that site activities should not generate dust emissions which result in a dust deposition rate greater than 2 g/m<sup>2</sup>/month above background levels on an annual average. Table 3.1 describes the Pollutant, Units of Measure, Monitoring Frequency and Method of Sampling.
