# ENDEAVOR MINE

## MONTHLY ENVIRONMENTAL REPORT

September  
2019

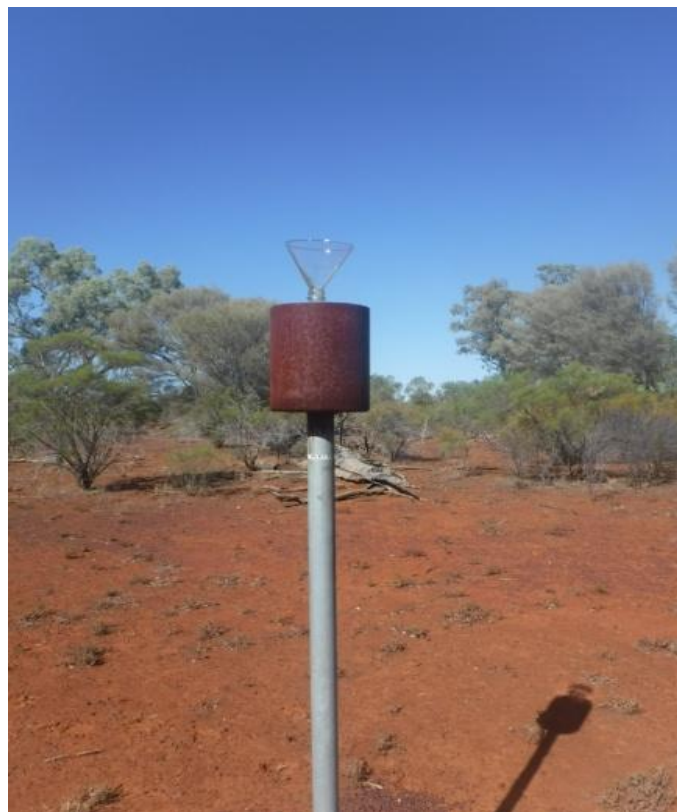
**Figure 3.1** Dust monitoring gauge located in the project

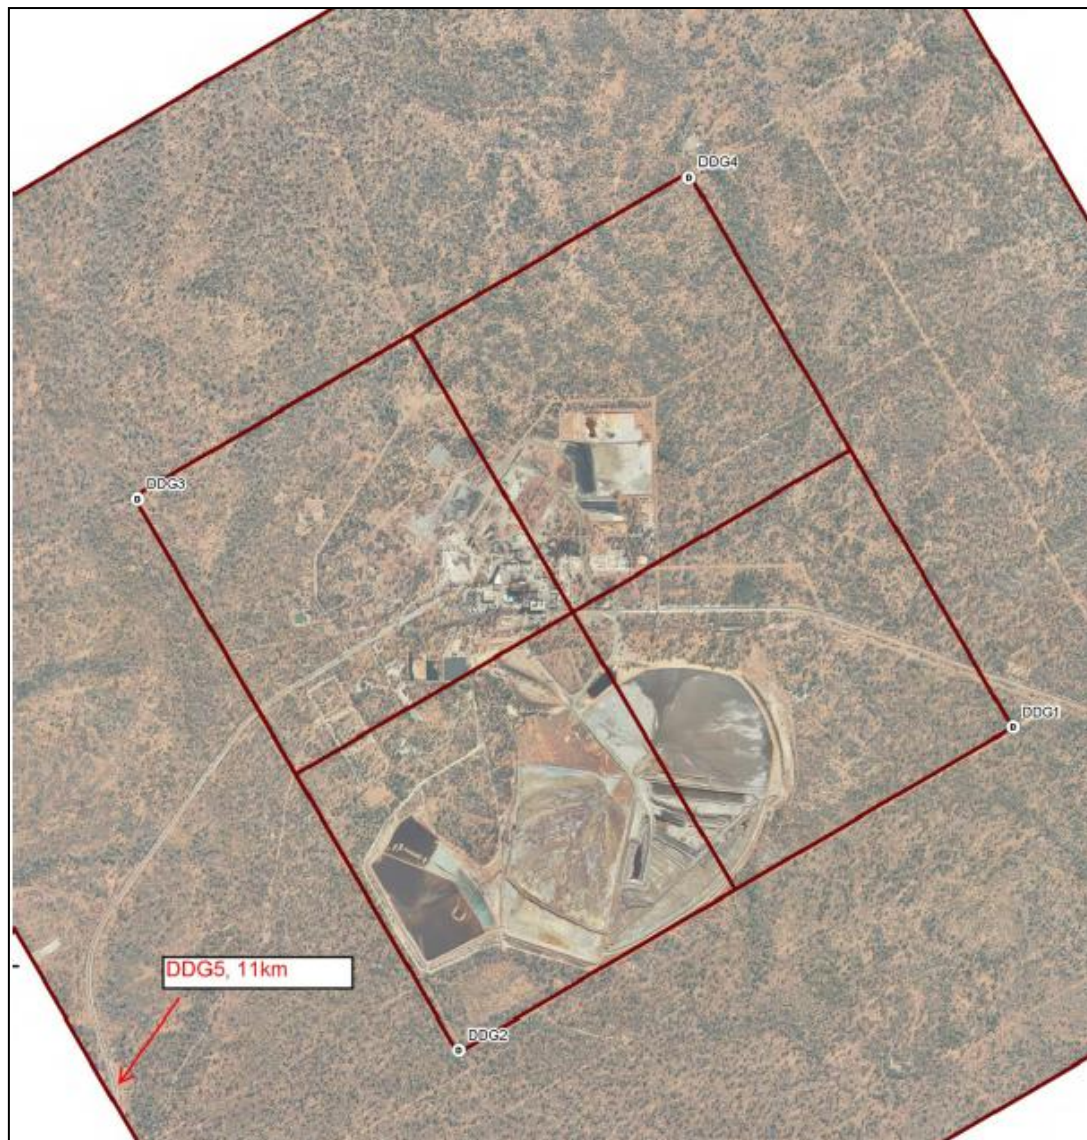
As shown in the satellite image (**Figure 3.2**), there are 5 dust monitoring locations on the boundary of the lease, with one located 11kms from the site at the turnoff to the Mine site near the Louth Road. This station was positioned to establish background levels.

**Figure 3.2 Endeavor Mine Dust Monitoring Locations**

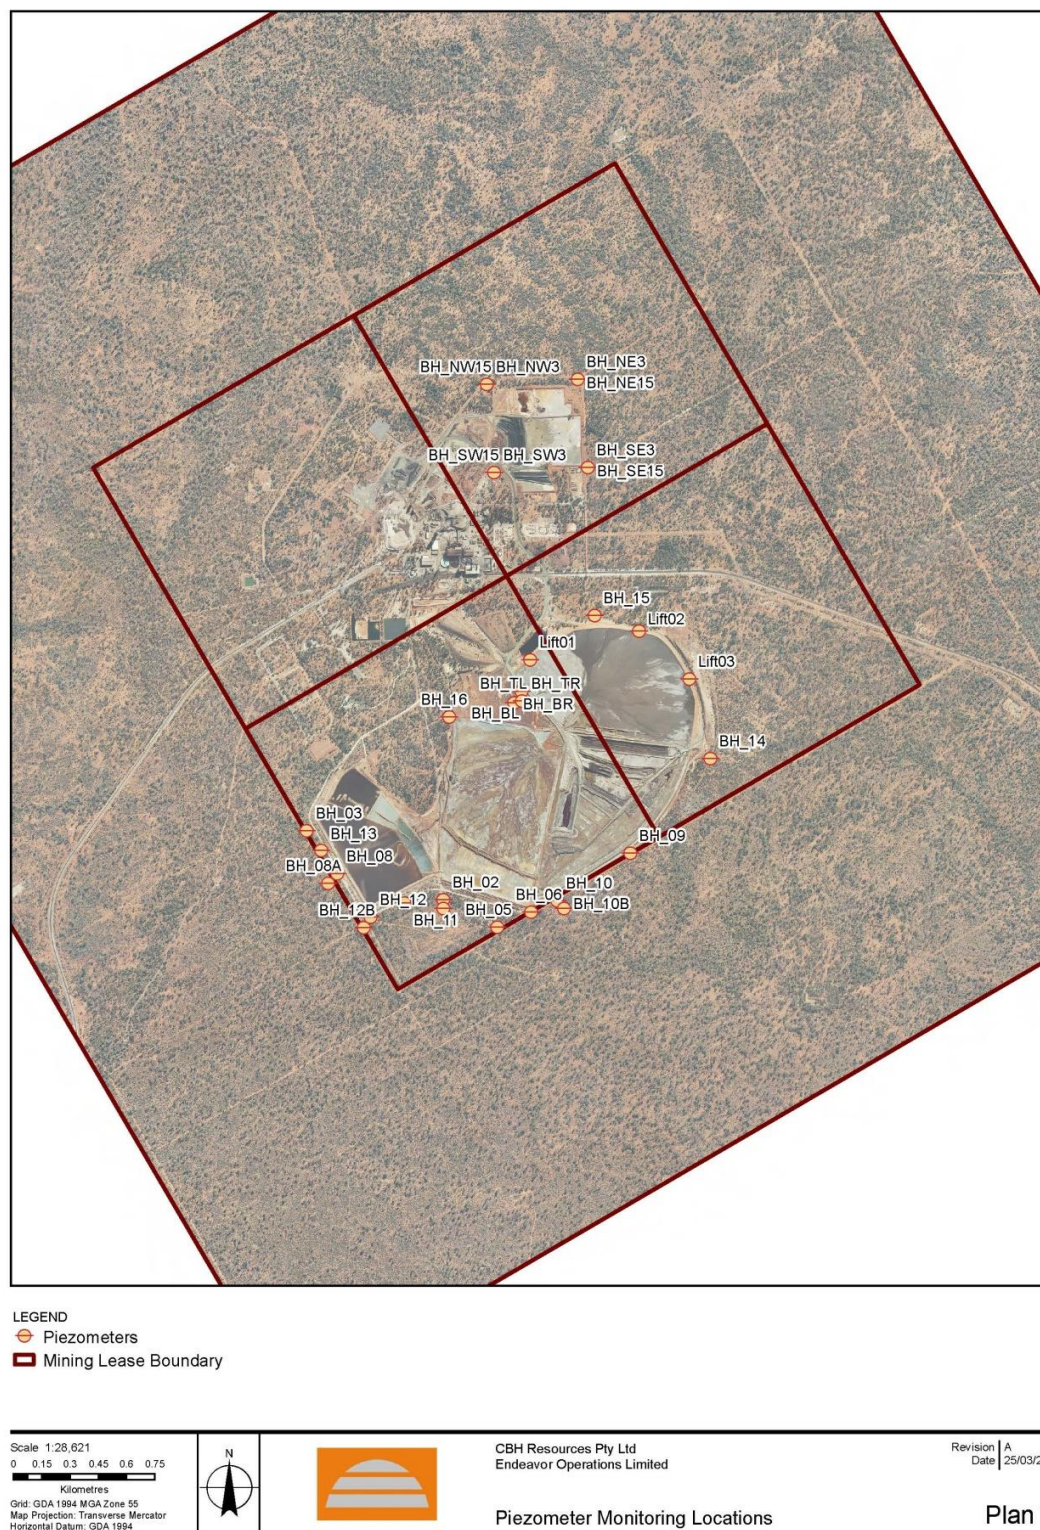
Endeavor Mine’s groundwater monitoring locations are concentrated around the perimeter of the Central Tailings Discharge (CTD) and the Sector 5 Tailings Storage Facility (CTF), while surface water monitoring locations are focused on water storages that could potentially discharge to environment during a major rain or storm event. Table 3.4 describes the monitoring stations, where Figure 3.3 shows the locations of the piezometers. Depending on availability of water or flow, unfortunately on some occasions, piezometers cannot be monitored as a result of being dry. Parameters to be monitored are described in Table 3.5.

**Figure 3.3** Location of the Piezometer Monitoring Locations

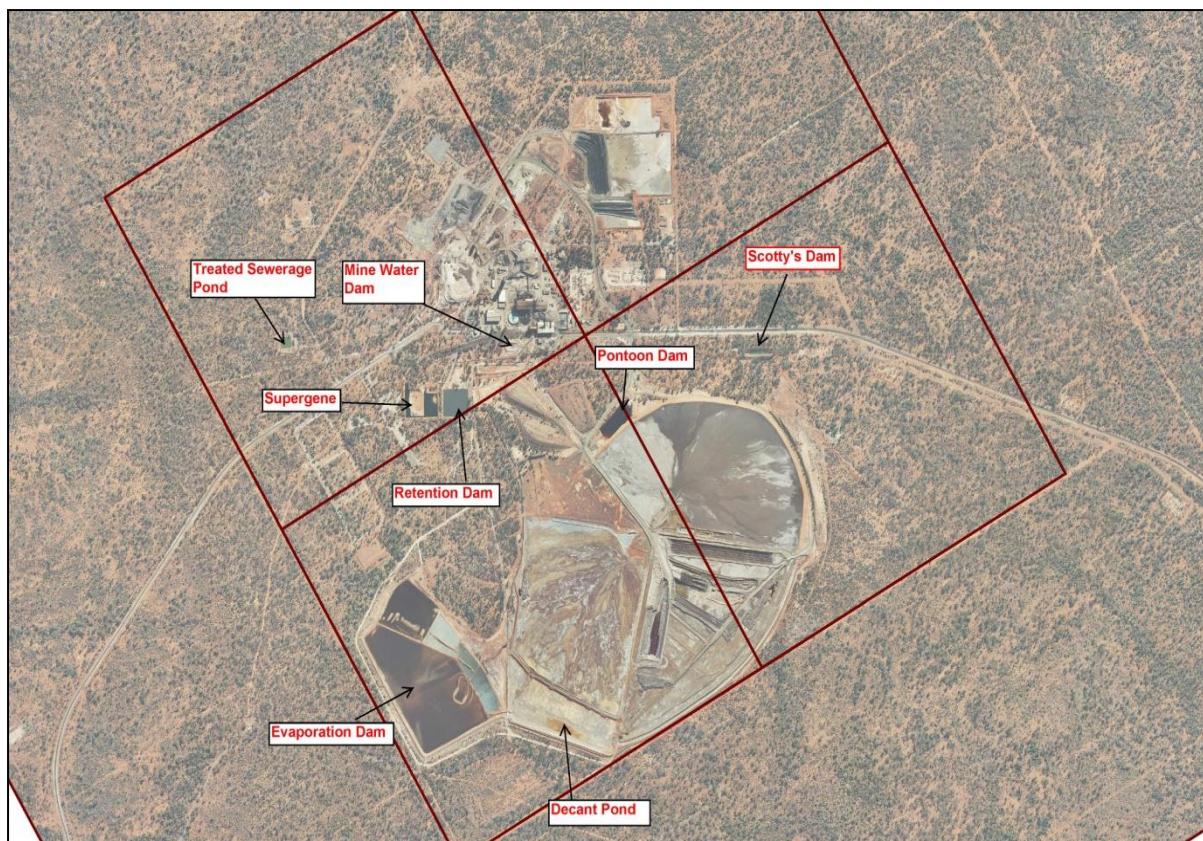
Figure 4.1 shows the location of the surface water dams on site that are monitored for water quality bi-annually.

**Figure 4.1** The Endeavor Mine: Main Water Storages

Due to the drought and low rainfall during the month of August, it is difficult to access water in most of the dams with the exception of the Retention Dam. Access to the water's edge is hazardous. If rain occurs during future months samples will be taken, if possible.
