ENDEAVOR MINE

MONTHLY ENVIRONMENTAL REPORT

October
2019

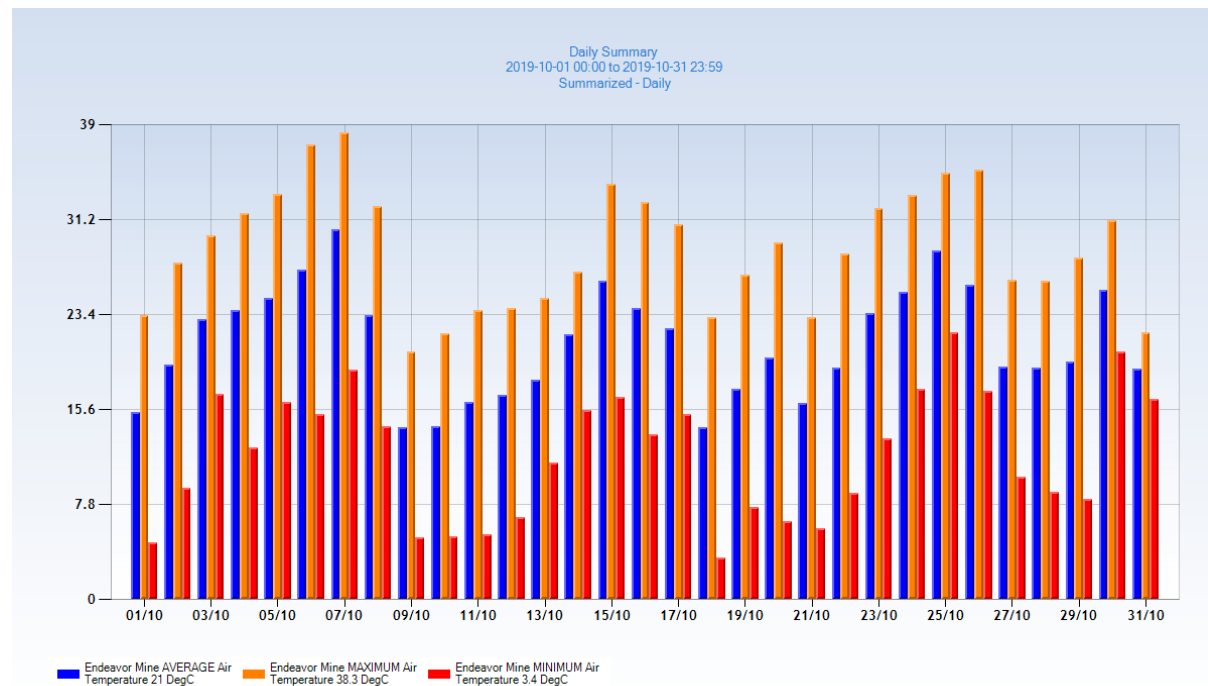
Figure 2.2 Daily Maximum, Minimum and Average Air Temperature for October 2019

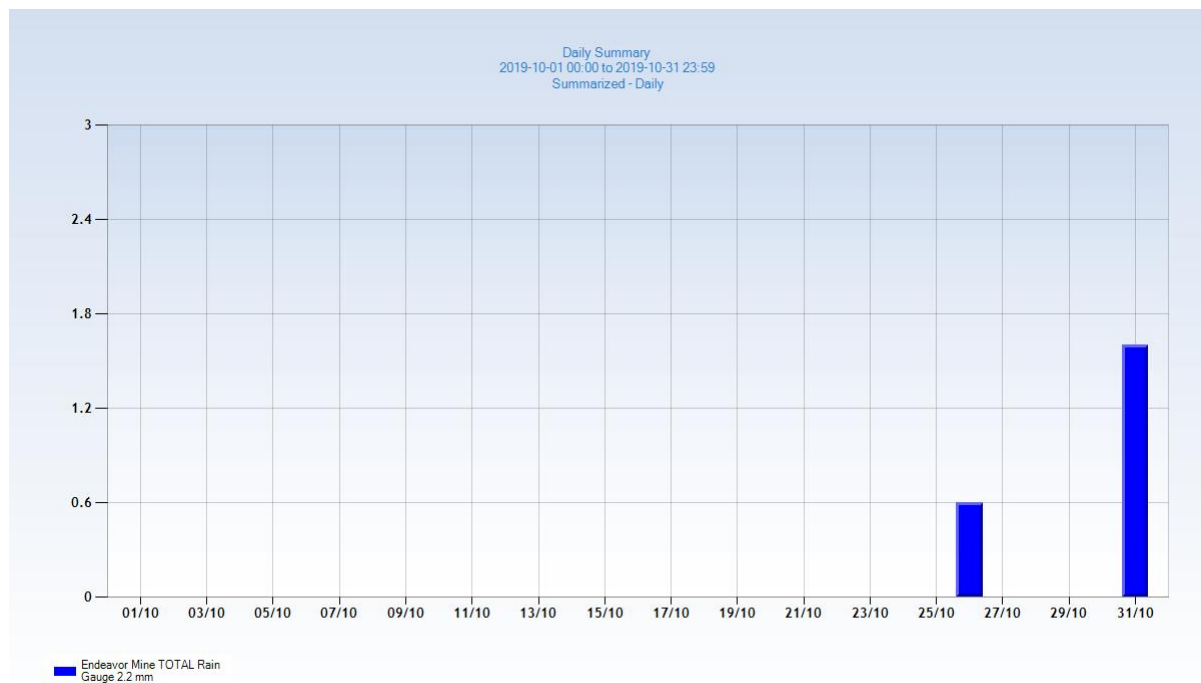
Figure 2.7 Rain Gauge Total for October 2019

There were 2.2 mm of rainfall at Endeavor Mine during October 2019 (Table 2.1). Year to Date (YTD) is shown in Table 2.2. The rain events during the month of October were on the 26th of October with 0.6 mm and on the 31st of October with 1.6mm.

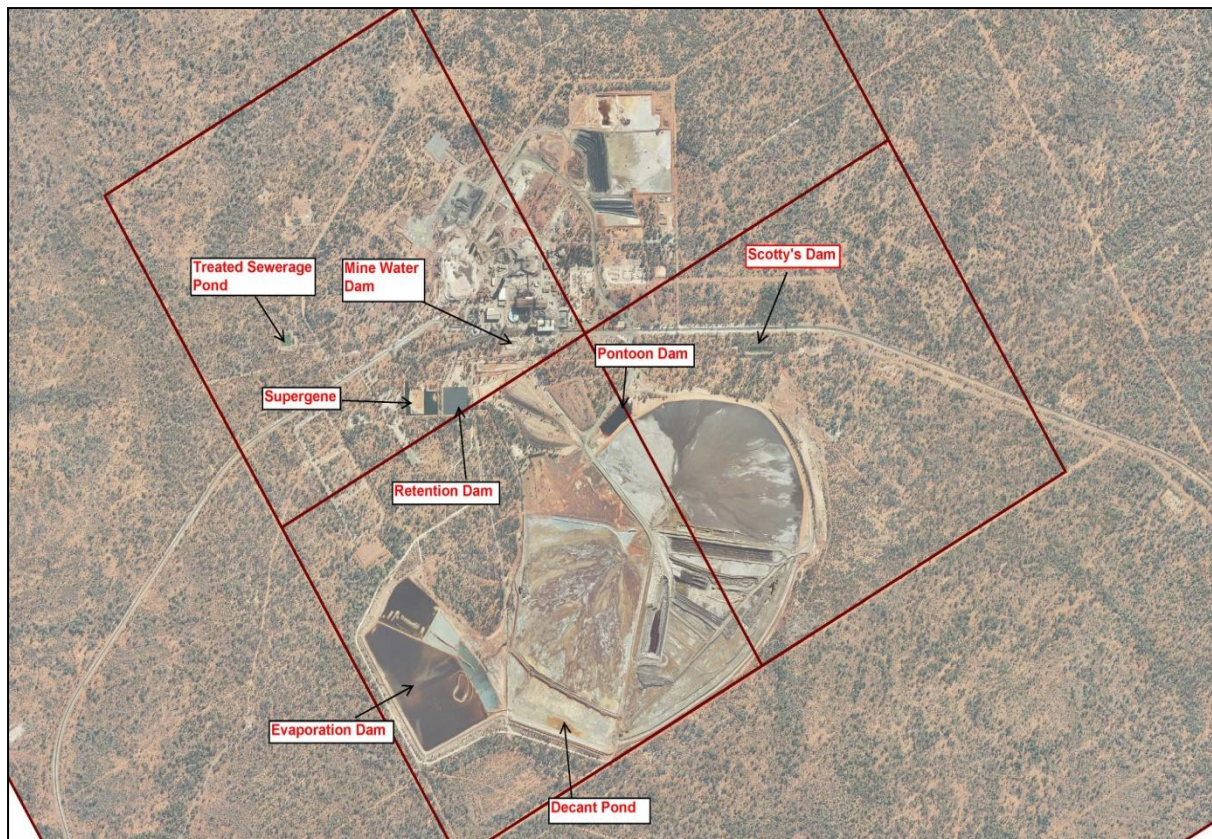
Figure 4.1 shows the location of the surface water dams on site that are monitored for water quality bi-annually.

Figure 4.1 The Endeavor Mine: Main Water Storages
