ENDEAVOR OPERATIONS PTY LTD

ENDEAVOR MINE

MONTHLY ENVIRONMENTAL REPORT

January
2020

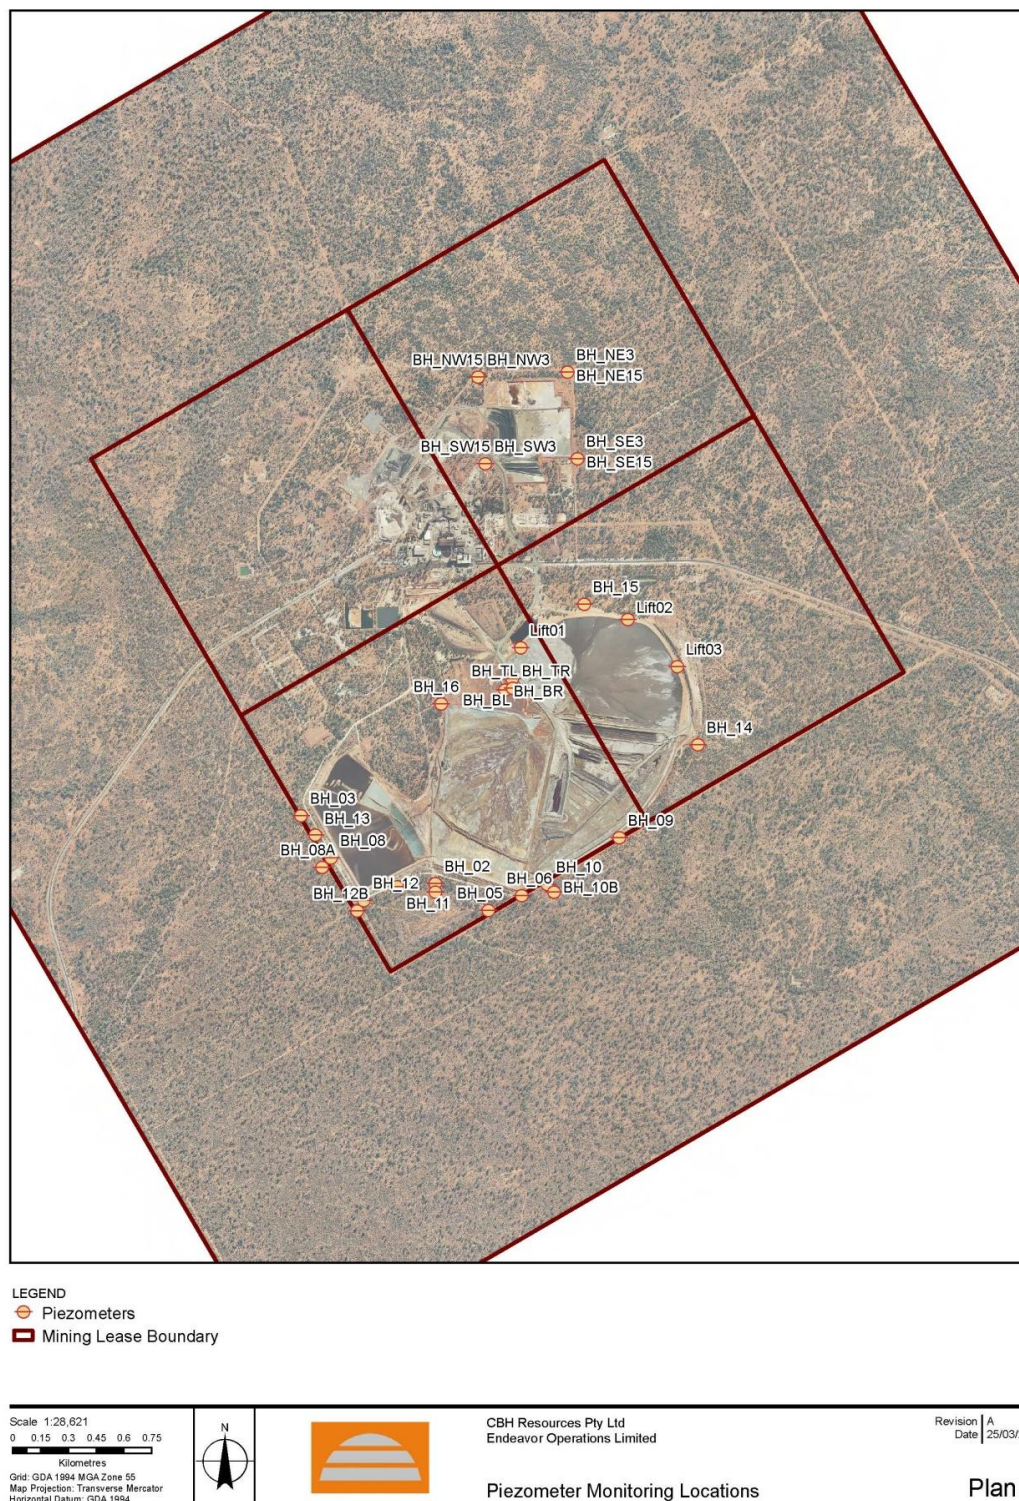
Endeavor Mine’s groundwater monitoring locations are concentrated around the perimeter of the Central Tailings Discharge (CTD) and the Sector 5 Tailings Storage Facility (CTF), while surface water monitoring locations are focused on water storages that could potentially discharge to environment during a major rain or storm event. Table 2-3 describes the monitoring stations, where Figure 2.3 shows the locations of the piezometers. Depending on availability of water or flow, unfortunately on some occasions, piezometers cannot be monitored as a result of being dry. Parameters to be monitored are described in

Figure 2.3 Location of the Piezometer Monitoring Locations
