ENDEAVOR OPERATIONS PTY LTD

ENDEAVOR MINE

MONTHLY ENVIRONMENTAL REPORT

August
2020

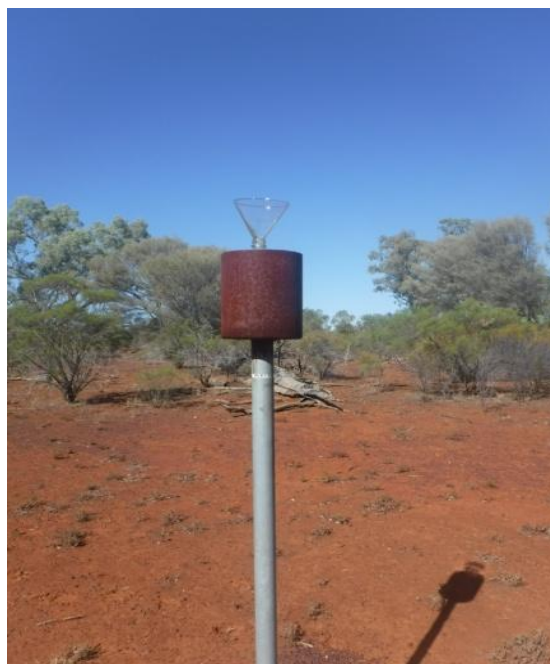
Figure 2.1 Dust monitoring gauge located in the project

Nevertheless, dust deposition on and beyond the boundary of the lease has the potential to cause environmental harm. Therefore Endeavor Mine manages airborne contaminants on site through the use of water sprays and a water trucks with depositional dust monitoring stations strategically located along the boundary of ML158/159/160/161 to measure performance.

The Endeavor Mine Dust Monitoring Program measures dust deposition rates on a monthly basis at the main mining lease boundary (4 locations) and at a background location located 11km from the operating mine site (DDG 5 – Point ID 5). EP Licence 1301 does not set limits for dust deposition. However, these results are compared to the recommended limits outlined in *Approved Methods for the Modelling and Assessment of Air Pollutants in NSW 2016*. This guidance document recommends that the deposition rate for total insoluble matter when expressed as a 12 month rolling average should not exceed 4 g/m²/month and that site activities should not generate dust emissions which result in a dust deposition rate greater than 2 g/m²/month above background levels on a annual average. Table 2-1 describes the Pollutant, Units of Measure, Monitoring Frequency and Method of Sampling.

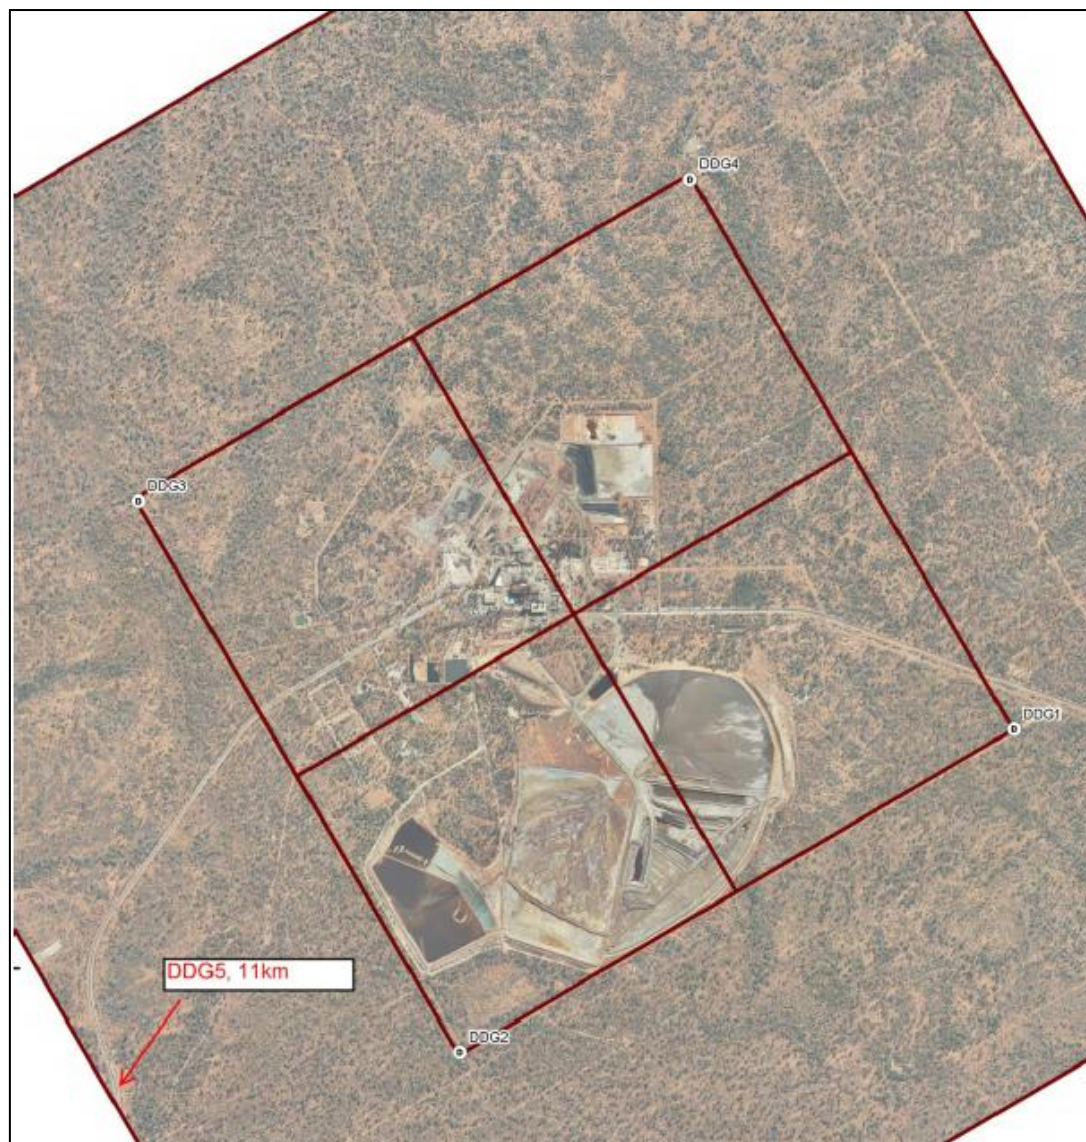
Figure 2.2 Endeavor Mine Dust Monitoring Locations

As shown in the satellite image (Figure 2.2), there are 5 dust monitoring locations on the boundary of the lease, with one located 11kms from the site at the turnoff to the Mine site near the Louth Road. This station was positioned to establish background levels.
