ENDEAVOR MINE

MONTHLY ENVIRONMENTAL REPORT

September
2020

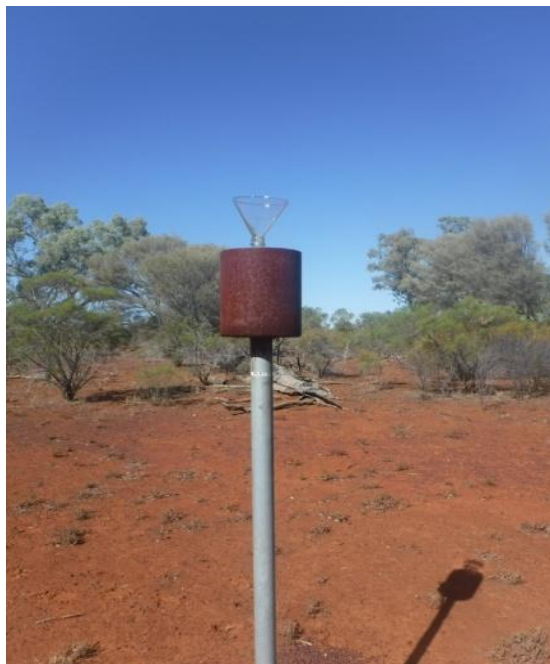
Figure 2.1 Dust monitoring gauge located in the project

Nevertheless, dust deposition on and beyond the boundary of the lease has the potential to cause environmental harm. Therefore Endeavor Mine manages airborne contaminants on site through the use of water sprays and a water trucks with depositional dust monitoring stations strategically located along the boundary of ML158/159/160/161 to measure performance.
