ENDEAVOR MINE

MONTHLY ENVIRONMENTAL REPORT

June
2021

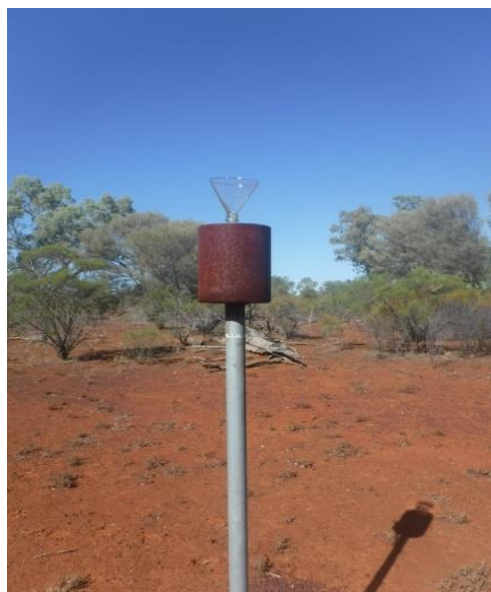
Figure 2.1 Dust monitoring gauge located in the project

Nevertheless, dust deposition on and beyond the boundary of the lease has the potential to cause environmental harm. Therefore Endeavor Mine manages airborne contaminants on site through the use of water sprays and a water trucks with depositional dust monitoring stations strategically located along the boundary of ML158/159/160/161 to measure performance.

The Endeavor Mine Dust Monitoring Program measures dust deposition rates on a monthly basis at the main mining lease boundary (4 locations) and at a background location located 11km from the operating mine site (DDG 5 – Point ID 5). EP Licence 1301 does not set limits for dust deposition. However, these results are compared to the recommended limits outlined in *Approved Methods for the Modelling and Assessment of Air Pollutants in NSW 2016*. This guidance document recommends that the deposition rate for total insoluble matter when expressed as a 12 month rolling average should not exceed 4 g/m²/month and that site activities should not generate dust emissions which result in a dust deposition rate greater than 2 g/m²/month above background levels on a annual average. Table 2-1 describes the Pollutant, Units of Measure, Monitoring Frequency and Method of Sampling.
