ENDEAVOR OPERATIONS PTY LTD

ENDEAVOR MINE

MONTHLY ENVIRONMENTAL REPORT

March
2022

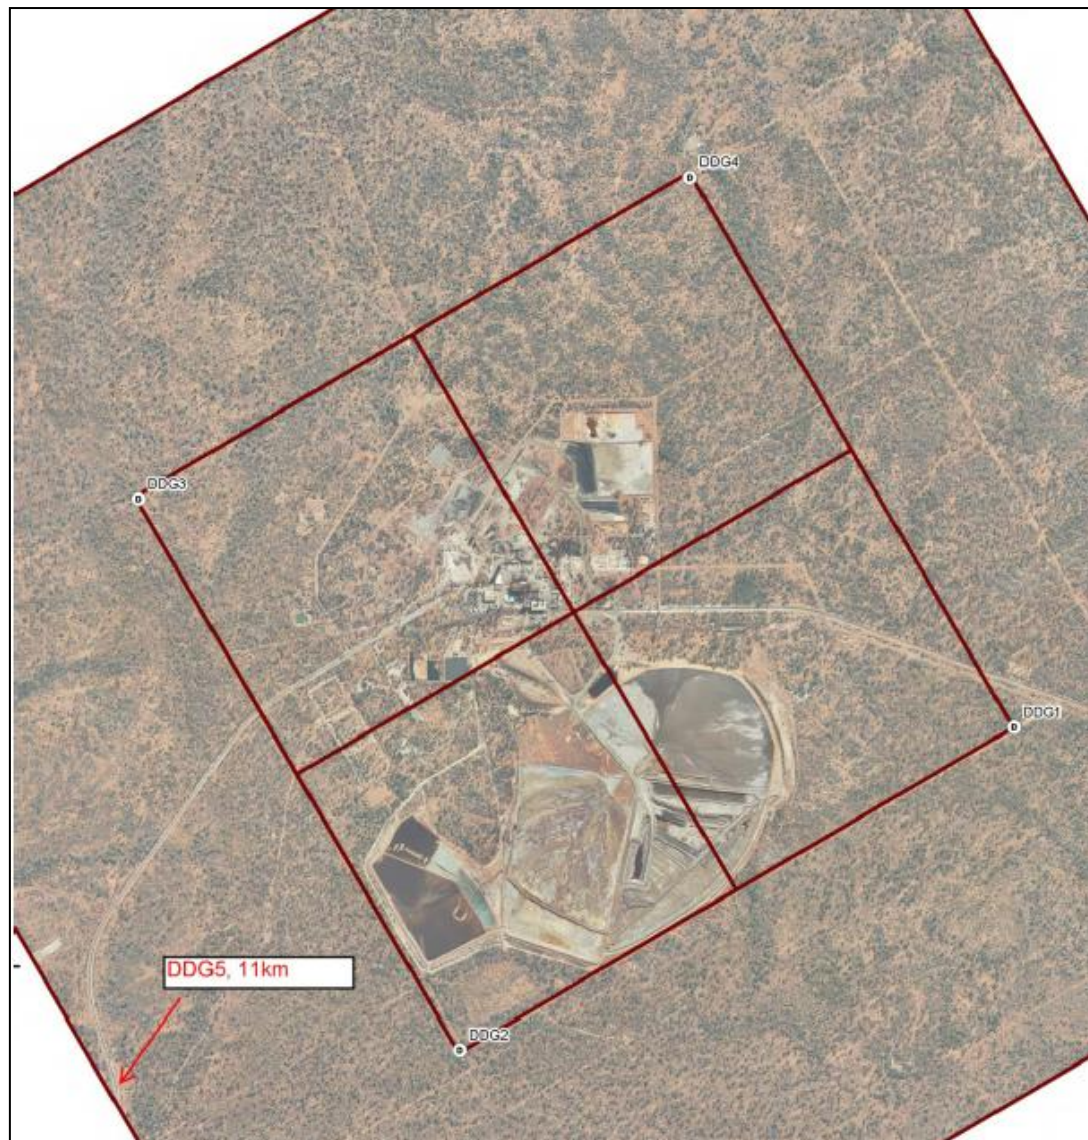
Figure 2.2 Endeavor Mine Dust Monitoring Locations

As shown in the satellite image (Figure 2.2), there are 5 dust monitoring locations on the boundary of the lease, with one located 11kms from the site at the turnoff to the Mine site near the Louth Road. This station was positioned to establish background levels.

This report shows the results from the dust monitoring activities carried out during the month of March 2022 (Table 2-2). All values remain well under the recommended guidance values, DDG4 shows higher values than usual due to the sample being contaminated with insects.

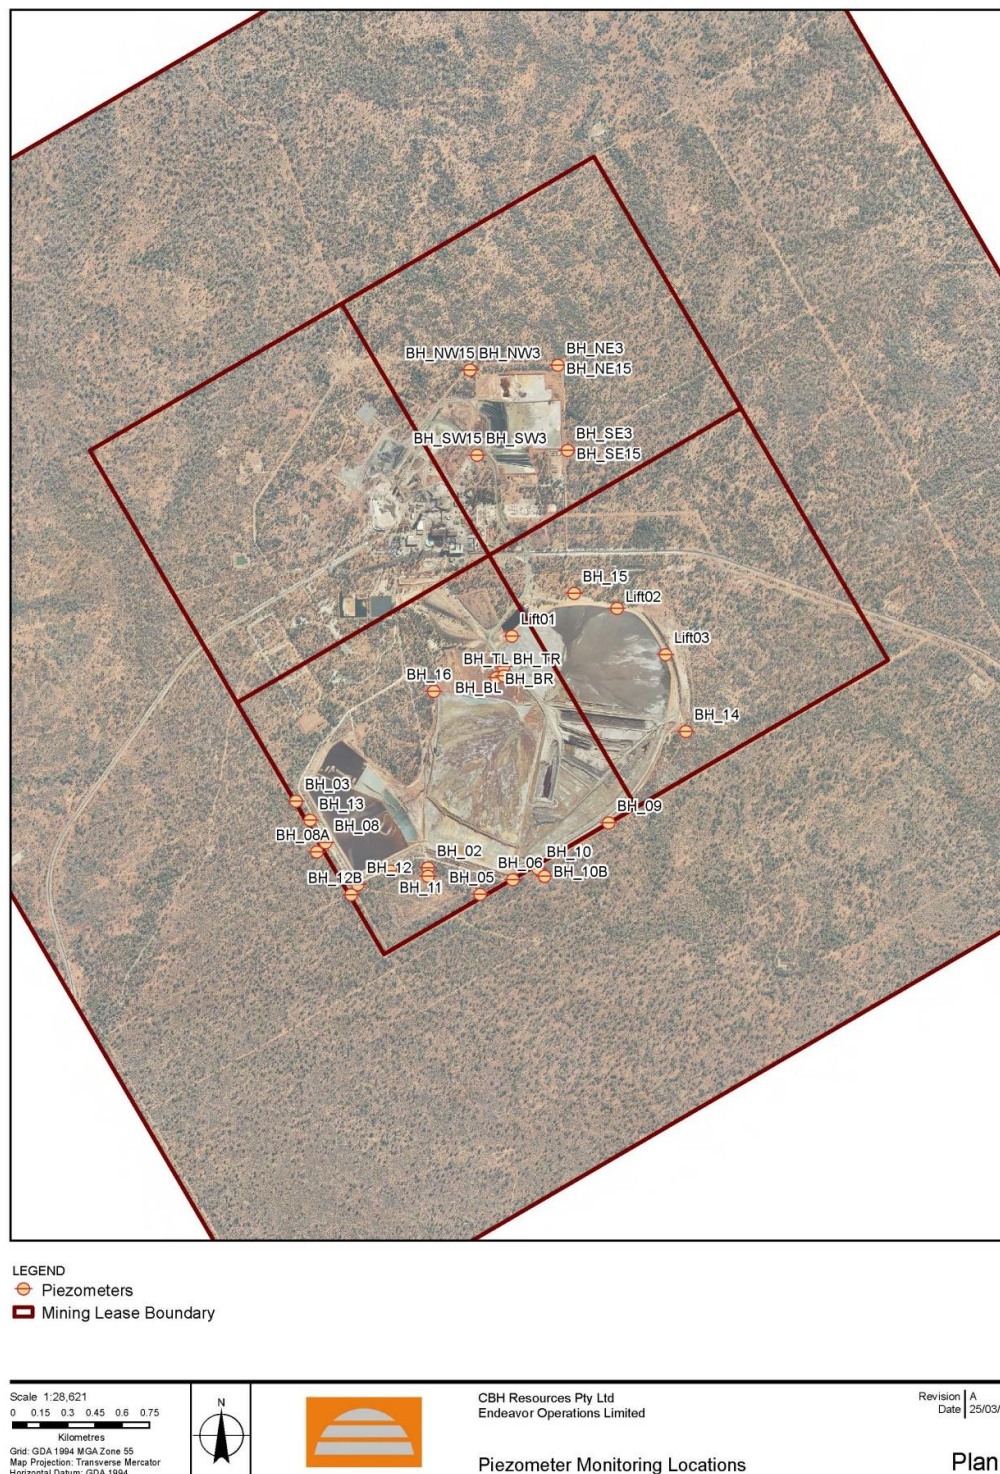
Figure 2.3 Location of the Piezometer Monitoring Locations

Endeavor Mine’s groundwater monitoring locations are concentrated around the perimeter of the Central Tailings Discharge (CTD) and the Sector 5 Tailings Storage Facility (CTF), while surface water monitoring locations are focused on water storages that could potentially discharge to environment during a major rain or storm event. Table 2-3 describes the monitoring stations, where Figure 2.3 shows the locations of the piezometers. Depending on availability of water or flow, unfortunately on some occasions, piezometers cannot be monitored as a result of being dry. Parameters to be monitored are described in

No groundwater monitoring campaign was carried out in March 2022 due to wet weather, possible delays on sample analysis and freights. Campaign will be postponed to early April, weather permitting.
