ENDEAVOR MINE

MONTHLY ENVIRONMENTAL REPORT

July
2022

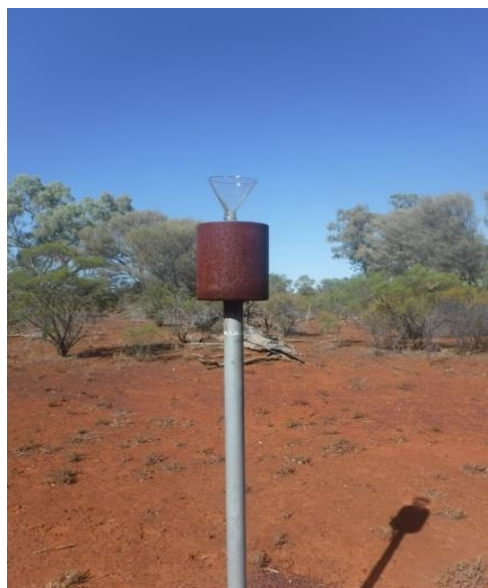
Figure 2.1 Dust monitoring gauge located in the project

Nevertheless, dust deposition on and beyond the boundary of the lease has the potential to cause environmental harm. Therefore Endeavor Mine manages airborne contaminants on site through the use of water sprays and a water trucks with depositional dust monitoring stations strategically located along the boundary of ML158/159/160/161 to measure performance.

The Endeavor Mine Dust Monitoring Program measures dust deposition rates on a monthly basis at the main mining lease boundary (4 locations) and at a background location located 11km from the operating mine site (DDG 5 – Point ID 5). EP Licence 1301 does not set limits for dust deposition. However, these results are compared to the recommended limits outlined in *Approved Methods for the Modelling and Assessment of Air Pollutants in NSW 2016*. This guidance document recommends that the deposition rate for total insoluble matter when expressed as a 12 month rolling average should not exceed 4 g/m²/month and that site activities should not generate dust emissions which result in a dust deposition rate greater than 2 g/m²/month above background levels on a annual average. Table 2-1 describes the Pollutant, Units of Measure, Monitoring Frequency and Method of Sampling.
