# ENDEAVOR MINE

## MONTHLY ENVIRONMENTAL REPORT

November  
2022

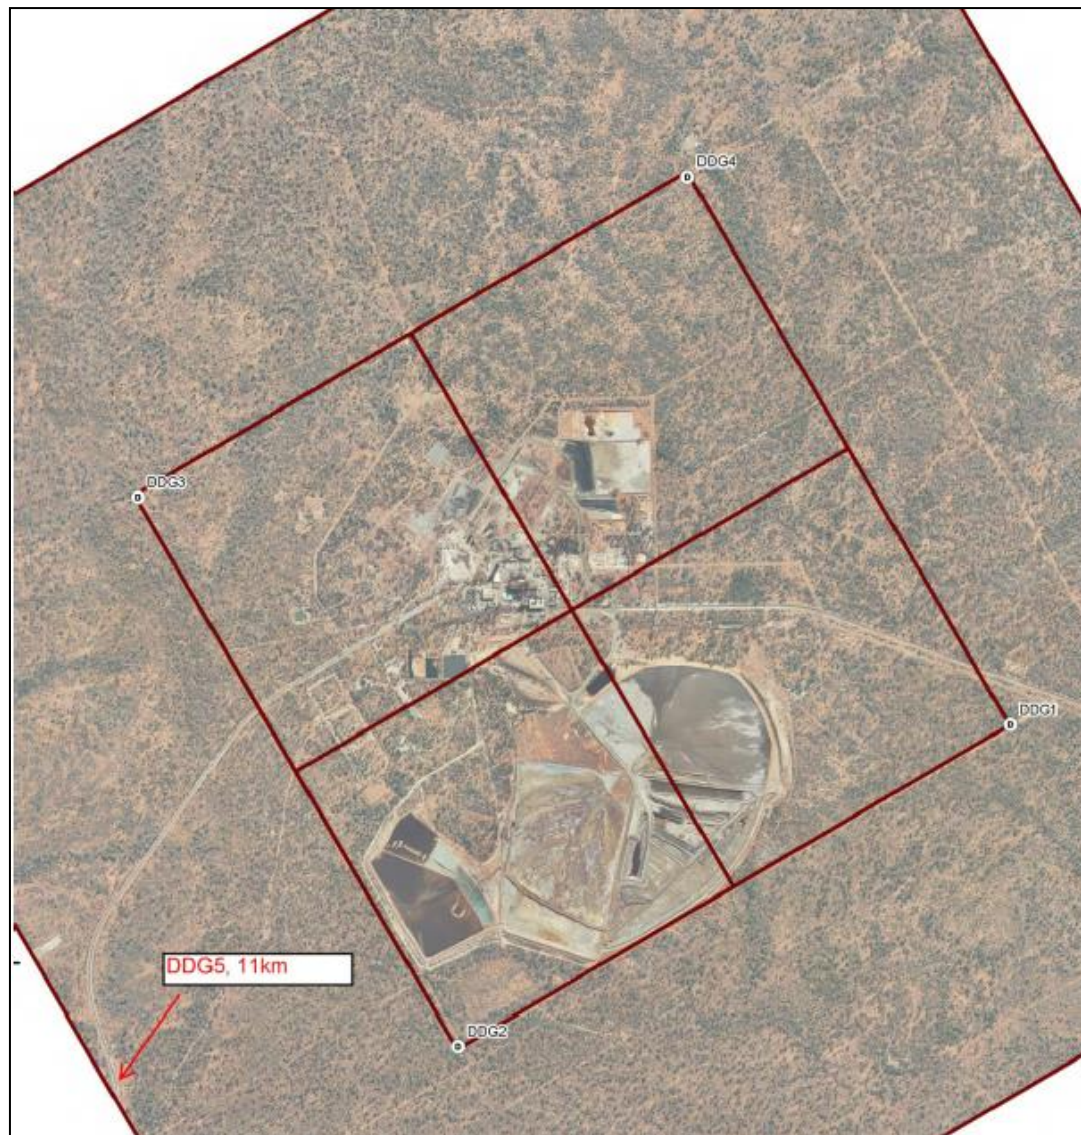
As shown in the satellite image (Figure 2.2), there are 5 dust monitoring locations on the boundary of the lease, with one located 11kms from the site at the turnoff to the Mine site near the Louth Road. This station was positioned to establish background levels.

**Figure 2.2 Endeavor Mine Dust Monitoring Locations**
