# ENDEAVOR MINE

## MONTHLY ENVIRONMENTAL REPORT

December  
2022

<b>Name of Operation</b>	Endeavor Mine
<b>Name of Licensee</b>	Endeavor Operations Pty Ltd
<b>Environmental Protection Licence</b>	No: 1301
<b>Reporting Period Start Date</b>	1 December 2022
<b>Reporting End Date</b>	31 December 2022

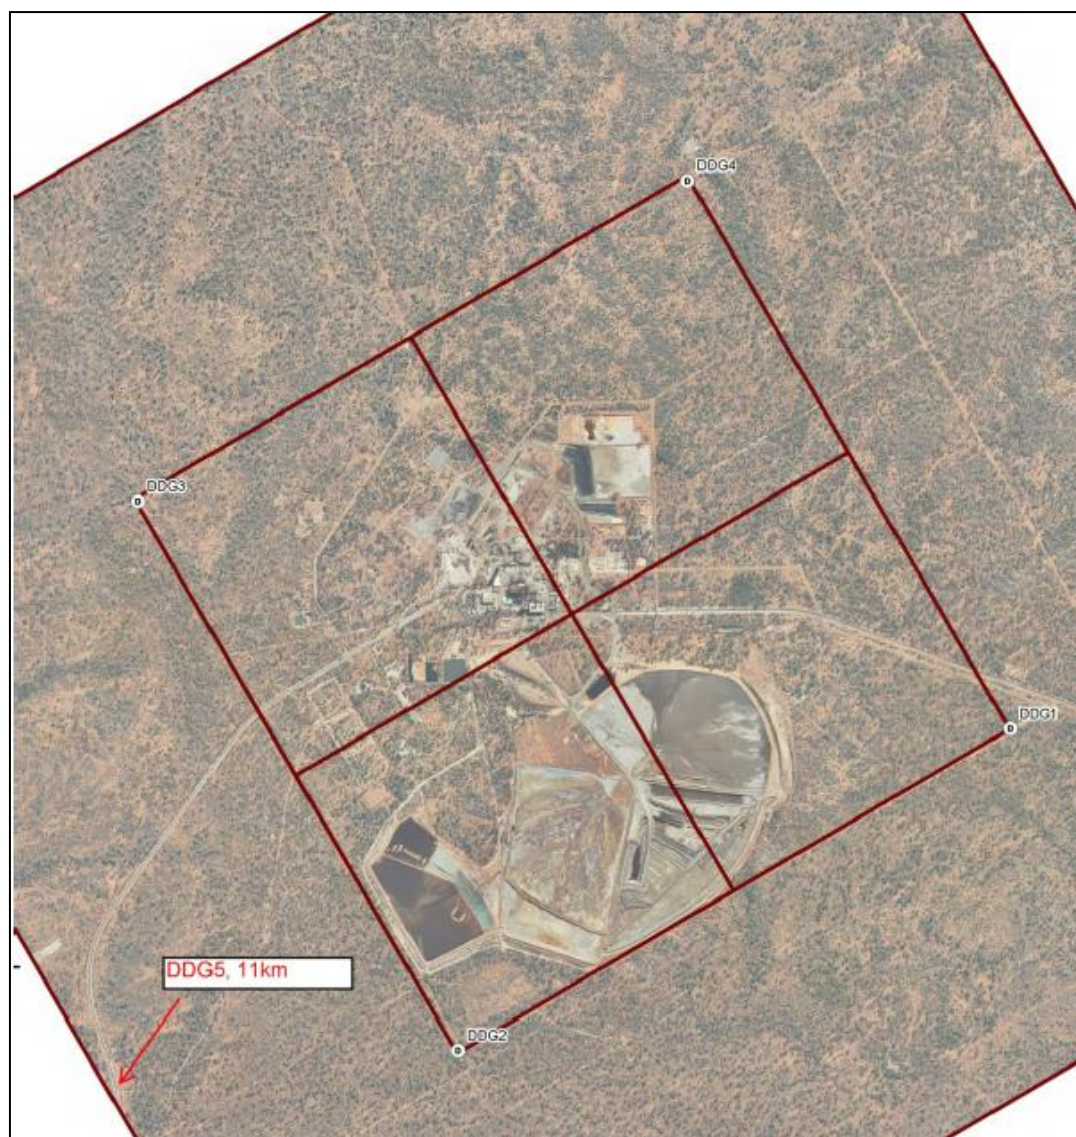
As shown in the satellite image (Figure 2.2), there are 5 dust monitoring locations on the boundary of the lease, with one located 11kms from the site at the turnoff to the Mine site near the Louth Road. This station was positioned to establish background levels.

**Figure 2.2 Endeavor Mine Dust Monitoring Locations**
