ENDEAVOR OPERATIONS PTY LTD

# ENDEAVOR MINE

## MONTHLY ENVIRONMENTAL REPORT

FEBRUARY  
2023

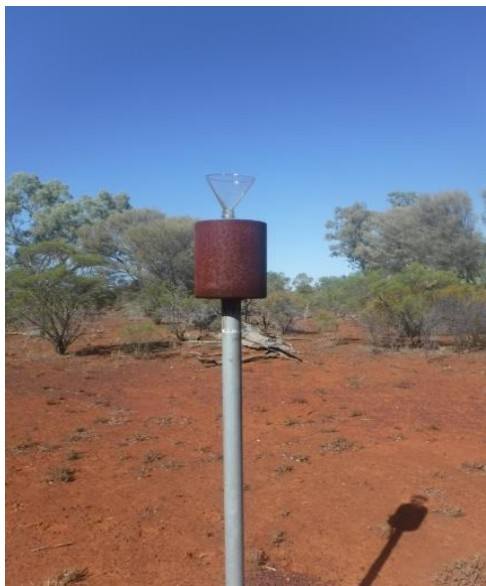
Nevertheless, dust deposition on and beyond the boundary of the lease has the potential to cause environmental harm. Therefore Endeavor Mine manages airborne contaminants on site through the use of water sprays and a water trucks with depositional dust monitoring stations strategically located along the boundary of ML158/159/160/161 to measure performance.

**Figure 2.1** Dust monitoring gauge located in the project

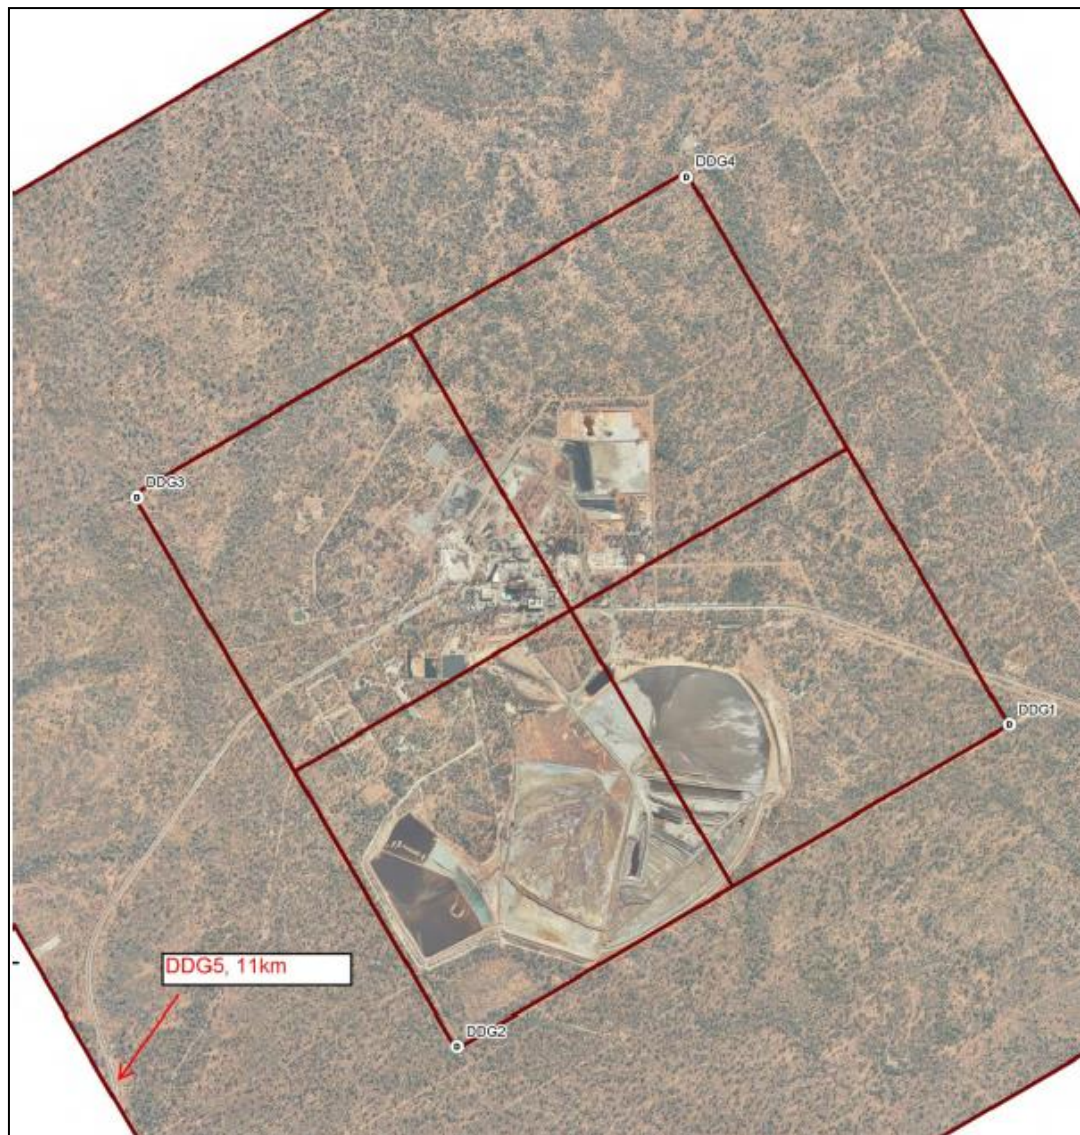
As shown in the satellite image (Figure 2.2), there are 5 dust monitoring locations on the boundary of the lease, with one located 11kms from the site at the turnoff to the Mine site near the Louth Road. This station was positioned to establish background levels.

**Figure 2.2 Endeavor Mine Dust Monitoring Locations**

This report shows the results from the dust monitoring activities carried out during the month of February 2023 (Table 2-2). All values remain well under the recommended guidance values, DDG4 shows higher values than usual due to the sample being contaminated with insects.
