#### **ENDEAVOR OPERATIONS PTY LTD**

### **ENDEAVOR MINE**

# MONTHLY ENVIRONMENTAL REPORT

## January 2024

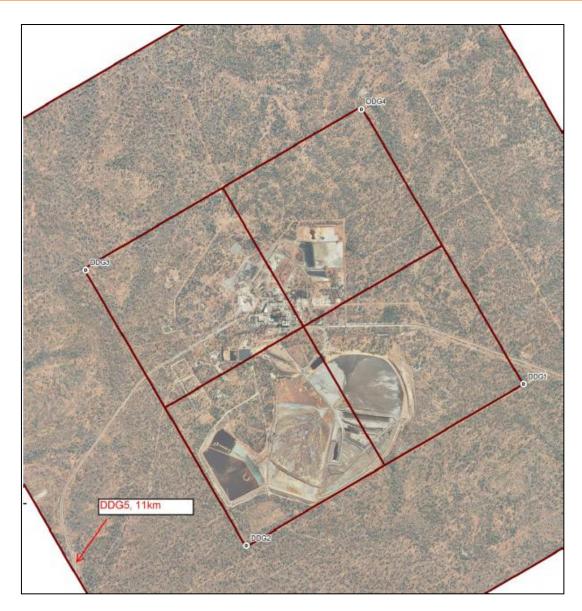
Figure 2.2 Endeavor Mine Dust Monitoring Locations

As shown in the satellite image (Figure 2.2), there are 5 dust monitoring locations on the boundary of the lease, with one located 11kms from the site at the turnoff to the Mine site near the Louth Road. This station was positioned to establish background levels.

The Endeavor Mine Dust Monitoring Program measures dust deposition rates on a monthly basis at the main mining lease boundary (4 locations) and at a background location located 11km from the operating mine site (DDG 5 – Point ID 5). EP Licence 1301 does not set limits for dust deposition. The Endeavor mine has chosen deposition rate for total insoluble matter when expressed as a 12 month rolling average should not exceed  $4 \text{ g/m}^2/\text{month}$  and that site activities should not generate dust emissions which result in a dust deposition rate greater than 2 g/m²/month above background levels on a annual average. Table 2-1 describes the Pollutant, Units of Measure, Monitoring Frequency and Method of Sampling.

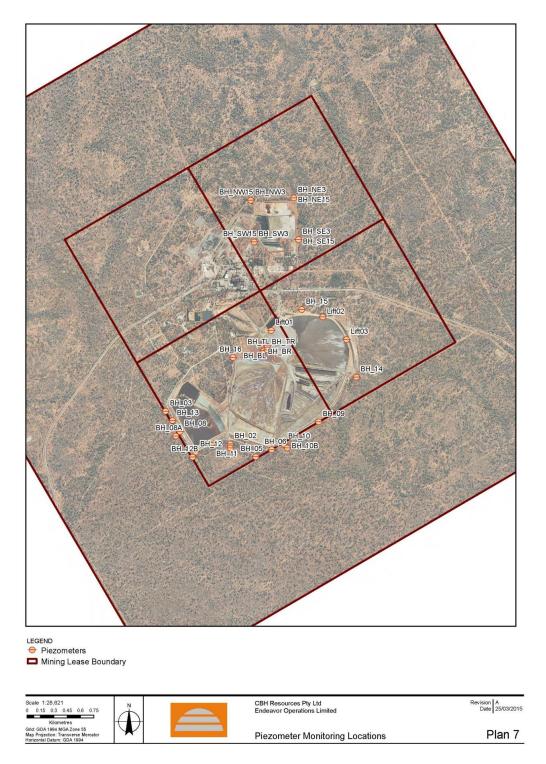
Figure 2.3 Location of the Piezometer Monitoring Locations

Endeavor Mine's groundwater monitoring locations are concentrated around the perimeter of the Central Tailings Discharge (CTD) and the Sector 5 Tailings Storage Facility (CTF), while surface water monitoring locations are focused on water storages that could potentially discharge to environment during a major rain or storm event. Table 2-3 describes the monitoring stations, where Figure 2.3 shows the locations of the piezometers. Depending on availability of water or flow, unfortunately on some occasions, piezometers cannot be monitored as a result of being dry. Parameters to be monitored are described in
