# ENDEAVOR MINE

## MONTHLY ENVIRONMENTAL REPORT

March  
2024

Name of Operation	Endeavor Mine
Name of Licensee	Endeavor Operations Pty Ltd
Environmental Protection Licence	No: 1301
Reporting Period Start Date	1 March 2024
Reporting End Date	31 March 2024

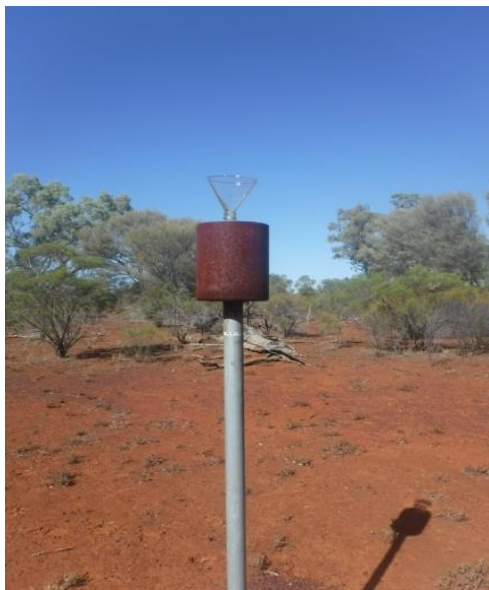
**Figure 2.1** Dust monitoring gauge located in the project

Nevertheless, dust deposition on and beyond the boundary of the lease has the potential to cause environmental harm. Therefore Endeavor Mine manages airborne contaminants on site through the use of water sprays and a water trucks with depositional dust monitoring stations strategically located along the boundary of ML158/159/160/161 to measure performance.

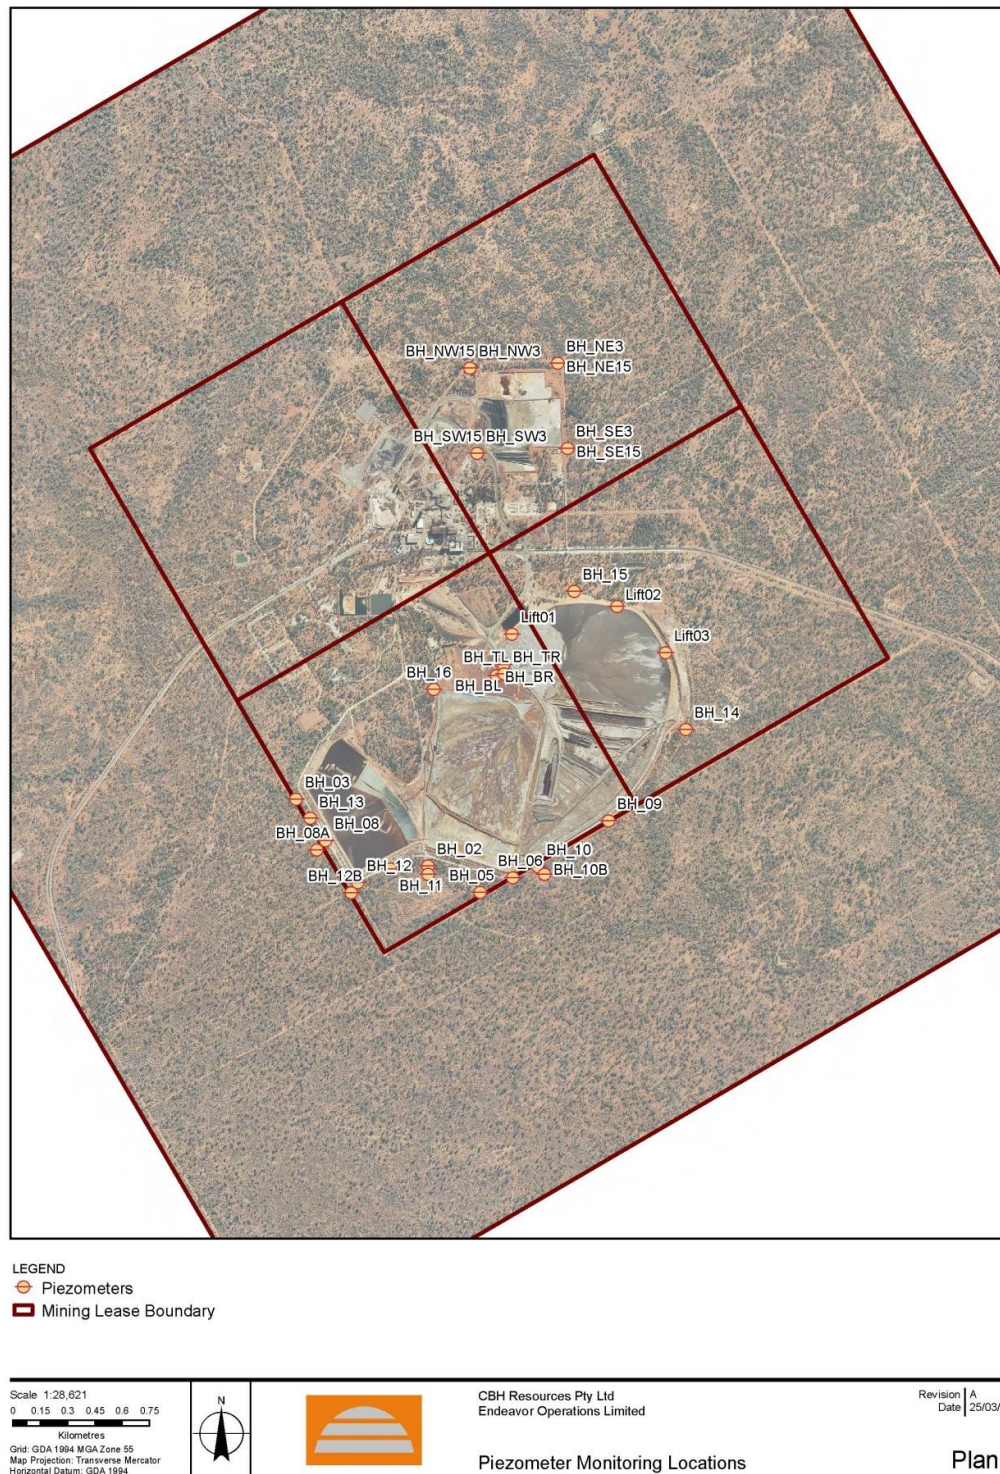
**Figure 2.3** Location of the Piezometer Monitoring Locations

Endeavor Mine’s groundwater monitoring locations are concentrated around the perimeter of the Central Tailings Discharge (CTD) and the Sector 5 Tailings Storage Facility (CTF), while surface water monitoring locations are focused on water storages that could potentially discharge to environment during a major rain or storm event. Table 2-3 describes the monitoring stations, where Figure 2.3 shows the locations of the piezometers. Depending on availability of water or flow, unfortunately on some occasions, piezometers cannot be monitored as a result of being dry. Parameters to be monitored are described in
