ENDEAVOR OPERATIONS PTY LTD

ENDEAVOR MINE

SEPTEMBER 2018 MONTHLY ENVIRONMENTAL REPORT

For Month Ending 30 September 2018

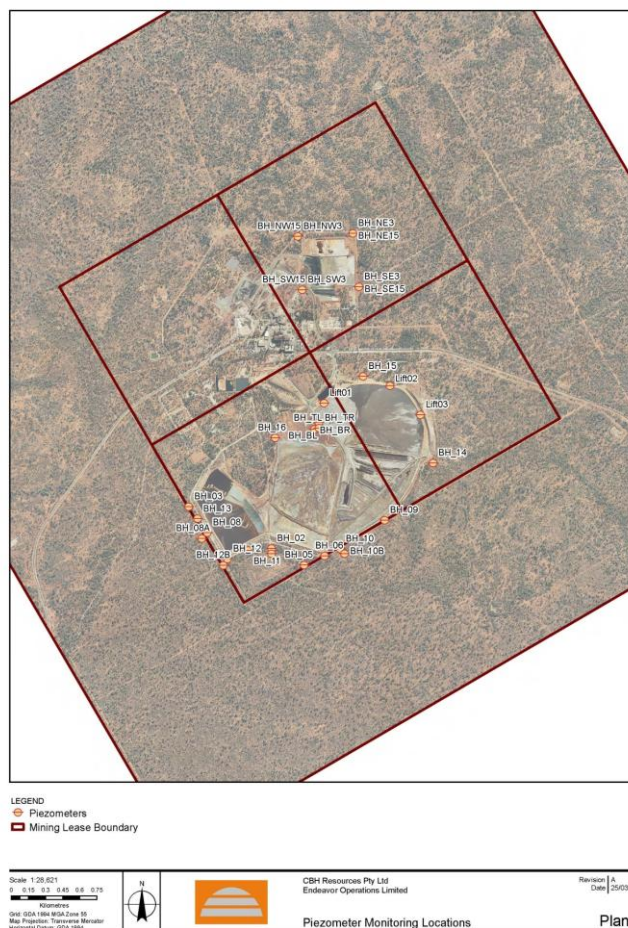
Figure 2: Location of the Piezometer Monitoring Locations

Endeavor Mine’s groundwater monitoring locations are concentrated around the perimeter of the Central Tailings Discharge (CTD) and the Sector 5 Tailings Storage Facility (CTF), while surface water monitoring locations are focused on water storages that could potentially discharge to environment during a major rain or storm event. Table 5 describes the monitoring stations where Figure 2 shows the locations of the piezometers. Depending on availability of water or flow, unfortunately on some occasions, piezometers cannot be monitored as a result of being dry.

No Groundwater Piezometers were sampled during September. It is planned to undertake Groundwater and Standing Water Level assessments during October 2018.

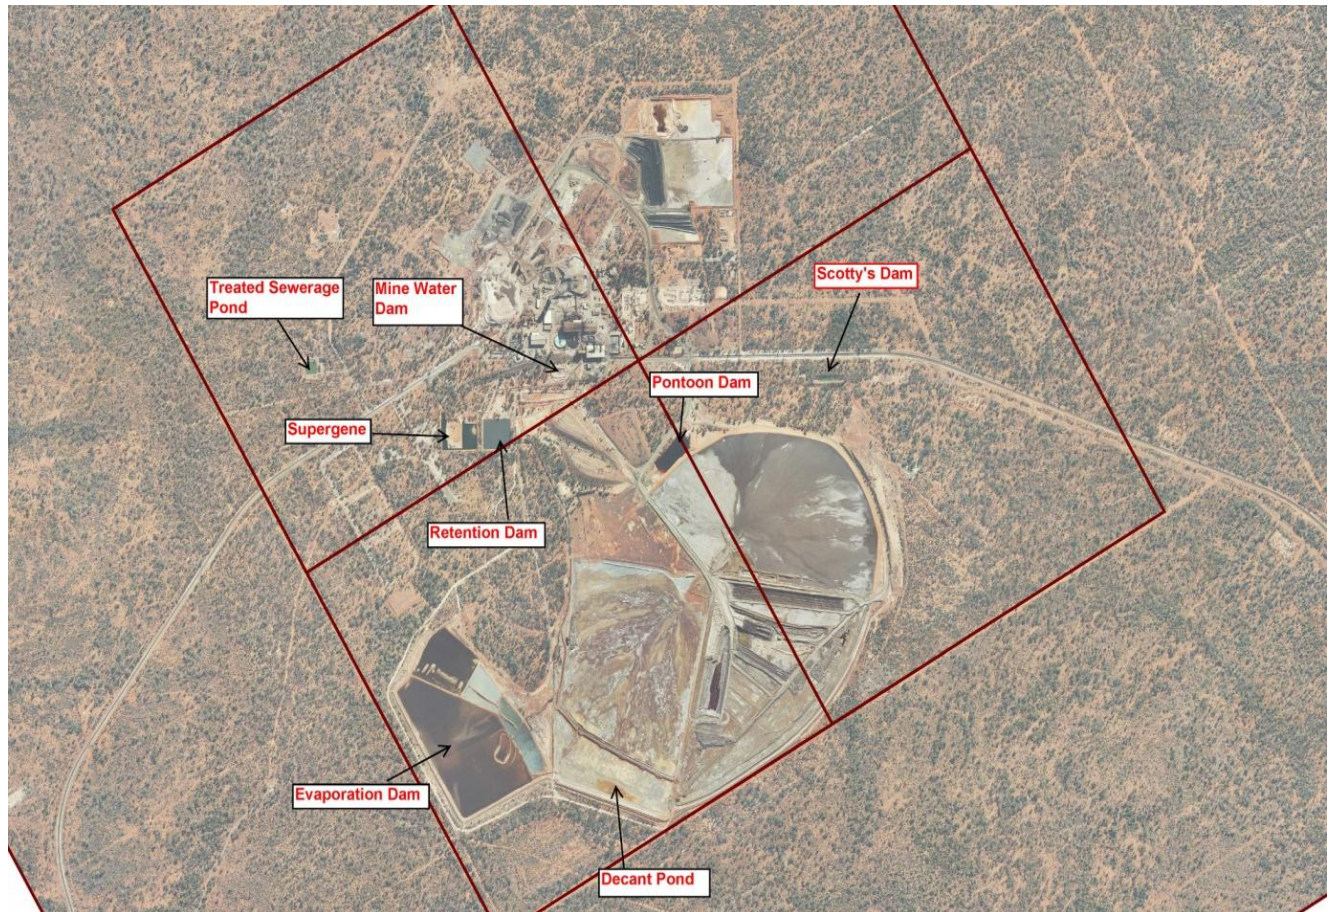
Figure 3: The Endeavor Mine: Main Water Storages

Figure 3 shows the location of the surface water dams on site that are monitored for water quality bi-annually.

Due to the drought, it is difficult to access most of the dams with the exception of the Retention Dam. Access to the water is making access too dangerous. If rain occurs during October and it is safe, samples will be collected.

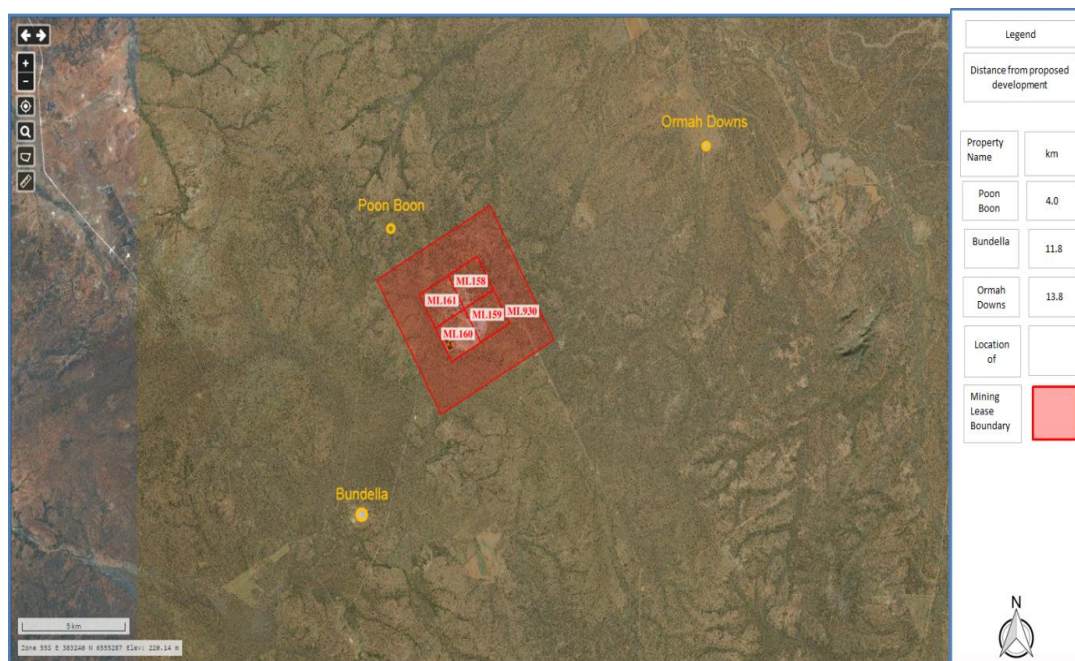
Figure 4: Closest Neighbours to Endeavor Mine

Potential Monitoring locations will include neighbouring properties. Figure 4 shows the location of the neighbouring properties.

No noise complaints were registered during September 2018. The Noise Management Action Plan was not activated. Year to date, Endeavor Mine has received no complaints regarding noise or any other nuisance issue.
