ENDEAVOR OPERATIONS PTY LTD

ENDEAVOR MINE

OCTOBER 2018 MONTHLY ENVIRONMENTAL REPORT

For Month Ending 31 October 2018

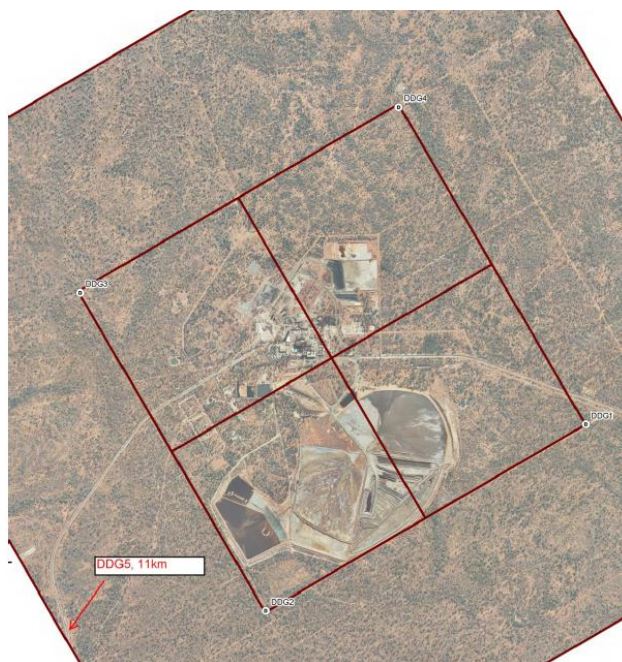
Figure 1: Endeavor Mine Dust Monitoring Locations

As shown in the satellite image (Figure 1), there are 5 dust monitoring locations on the boundary of the lease, with one located 11kms from the site at the turnoff to the Mine site near the Louth Road. This station was positioned to establish background levels.

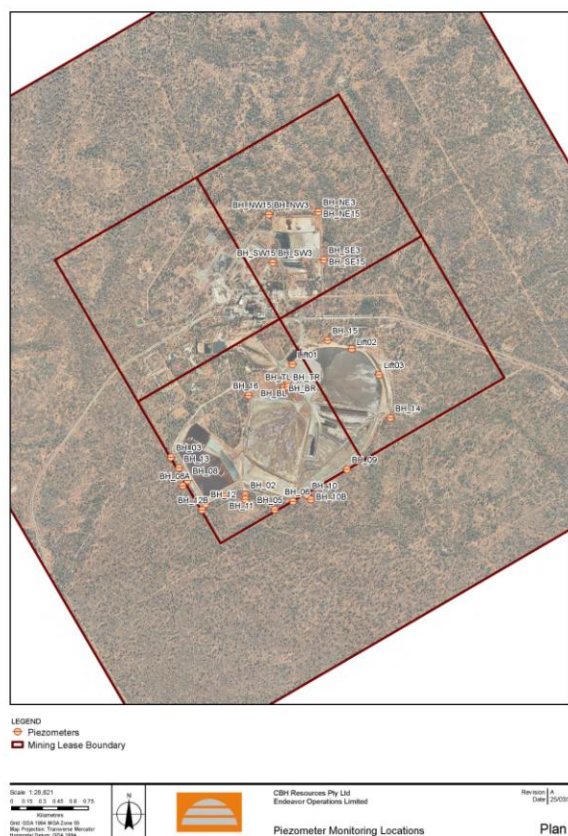
Figure 4.1: : Location of the Piezometer Monitoring Locations

Endeavor Mine's groundwater monitoring locations are concentrated around the perimeter of the Central Tailings Discharge (CTD) and the Sector 5 Tailings Storage Facility (CTF), while surface water monitoring locations are focused on water storages that could potentially discharge to environment during a major rain or storm event. Table 4.1 describes the monitoring stations where Figure 2 shows the locations of the piezometers. Depending on availability of water or flow, unfortunately on some occasions, piezometers cannot be monitored as a result of being dry.

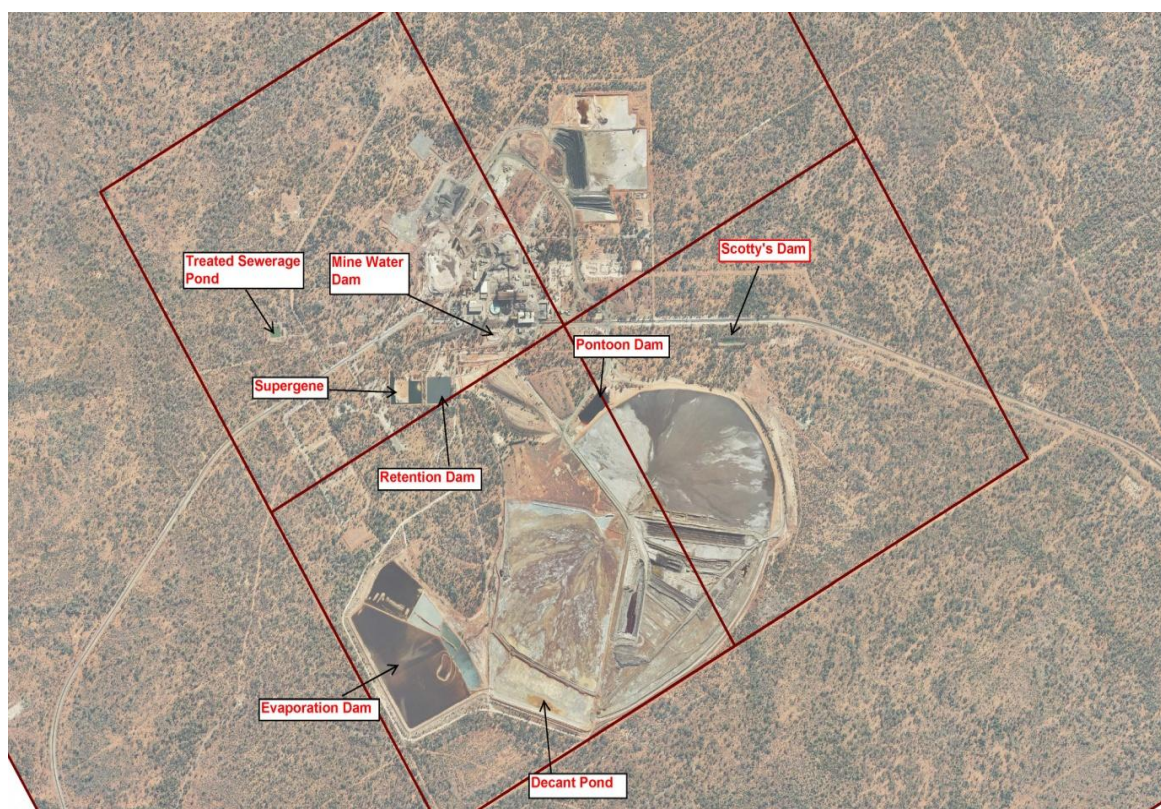
Figure 5.1: The Endeavor Mine: Main Water Storages

Figure 5.1 shows the location of the surface water dams on site that are monitored for water quality bi-annually.

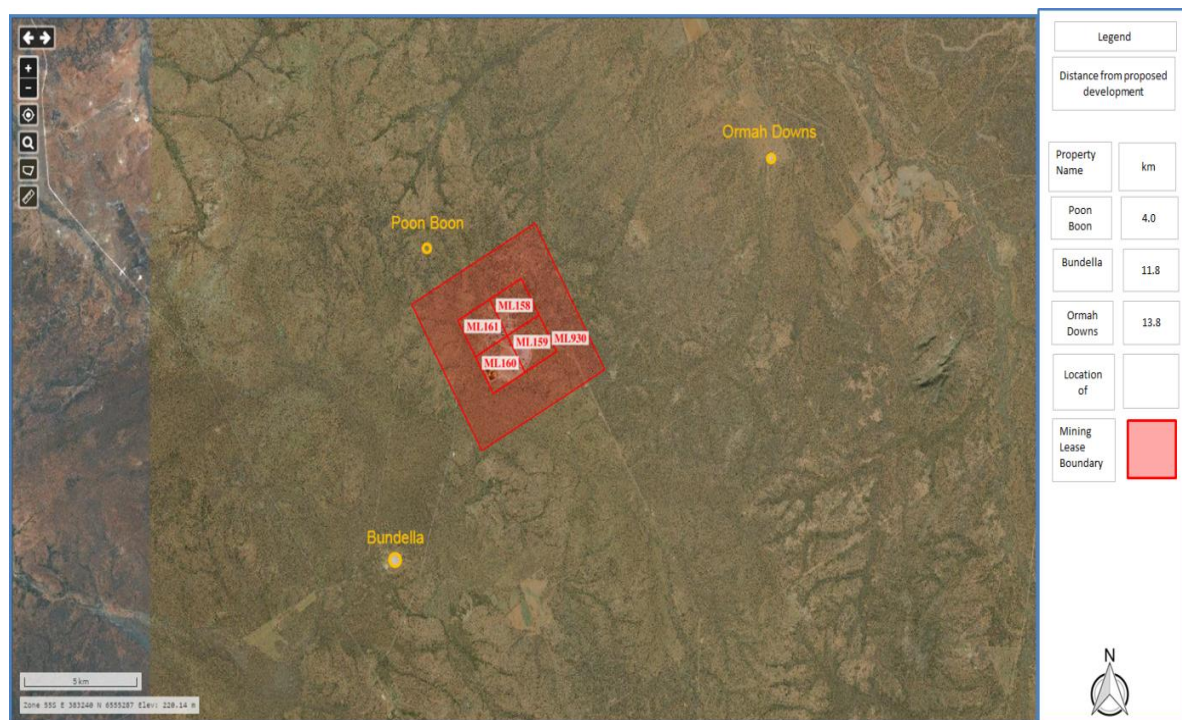
Figure 7.1: Closest Neighbours to Endeavor Mine

Potential Monitoring locations will include neighbouring properties. Figure 7.1 shows the location of the neighbouring properties.
