# ENDEAVOR MINE

## OCTOBER 2018 MONTHLY ENVIRONMENTAL REPORT

## Monthly Environmental Report

For Month Ending 31 October 2018

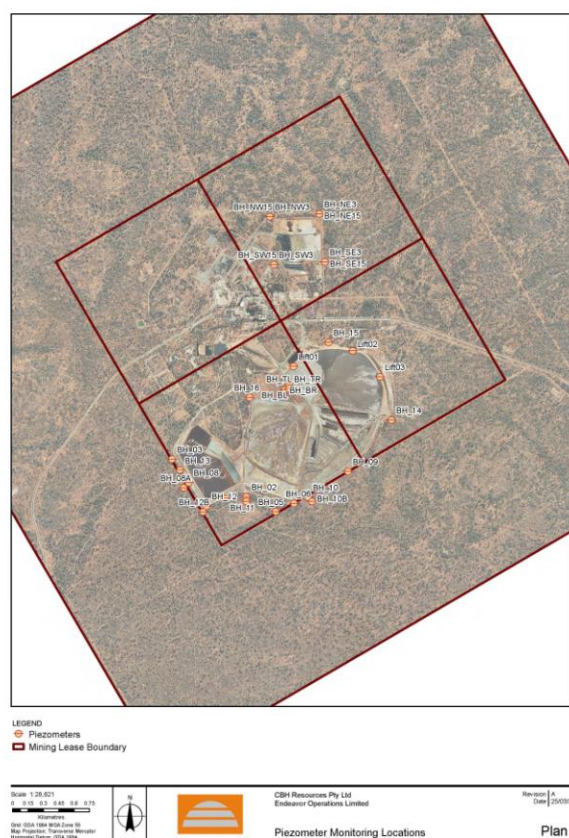
**Figure 4.1: : Location of the Piezometer Monitoring Locations**

Endeavor Mine's groundwater monitoring locations are concentrated around the perimeter of the Central Tailings Discharge (CTD) and the Sector 5 Tailings Storage Facility (CTF), while surface water monitoring locations are focused on water storages that could potentially discharge to environment during a major rain or storm event. Table 4.1 describes the monitoring stations where Figure 2 shows the locations of the piezometers. Depending on availability of water or flow, unfortunately on some occasions, piezometers cannot be monitored as a result of being dry.

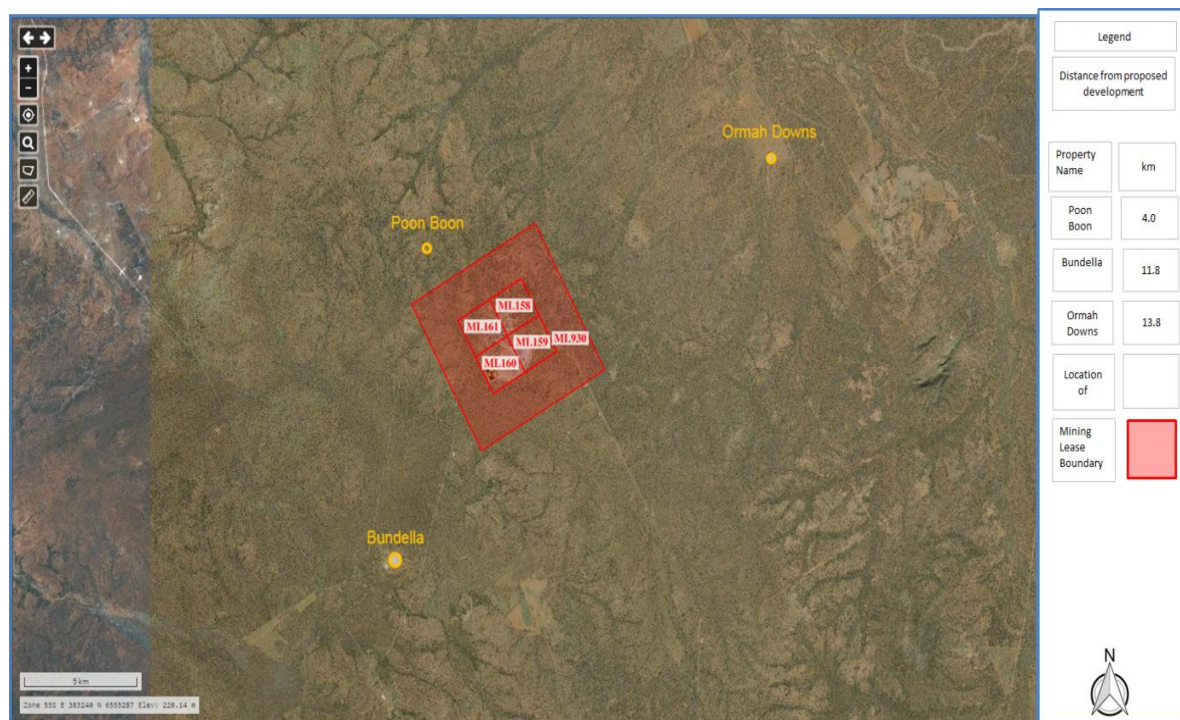
Figure 7.1: Closest Neighbours to Endeavor Mine

Endeavor Operations has never received a noise complaint from its neighbours. The closest sensitive receptor (neighbouring property) is Poon Boon Station, which is located 4.5 kms away from operations and has never reported a complaint for noise, dust, vibration or visual amenity. The predominant wind direction is from the east to north-east, therefore; the greatest potential noise risk is for 'Bundella', 11.8 km from the mine. Again, no complaints have been registered.
