ENDEAVOR MINE

March 2019 MONTHLY ENVIRONMENTAL REPORT

For Month Ending 31 March 2019

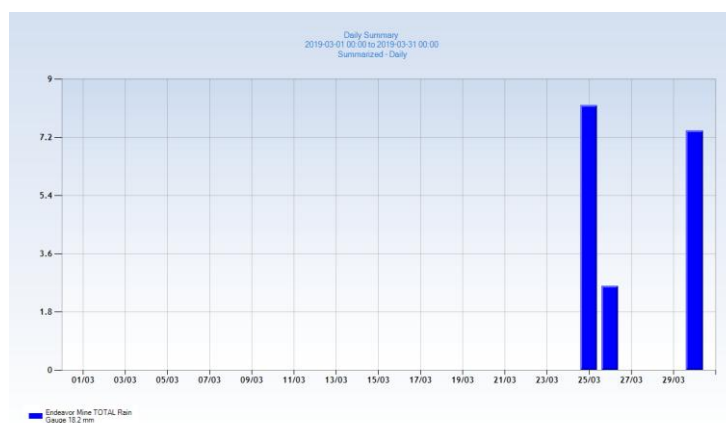
Figure 1.6: Rain Gauge Total for March 2019

Table 1.2 and Figure 1.6 show the daily and total rainfall for March 2019 and YTD total. YTD for 2019 as of March 31, 2019 was 71.4 mm compared to 2018 of 6.4mm. No rainfall was recorded during March 2018.

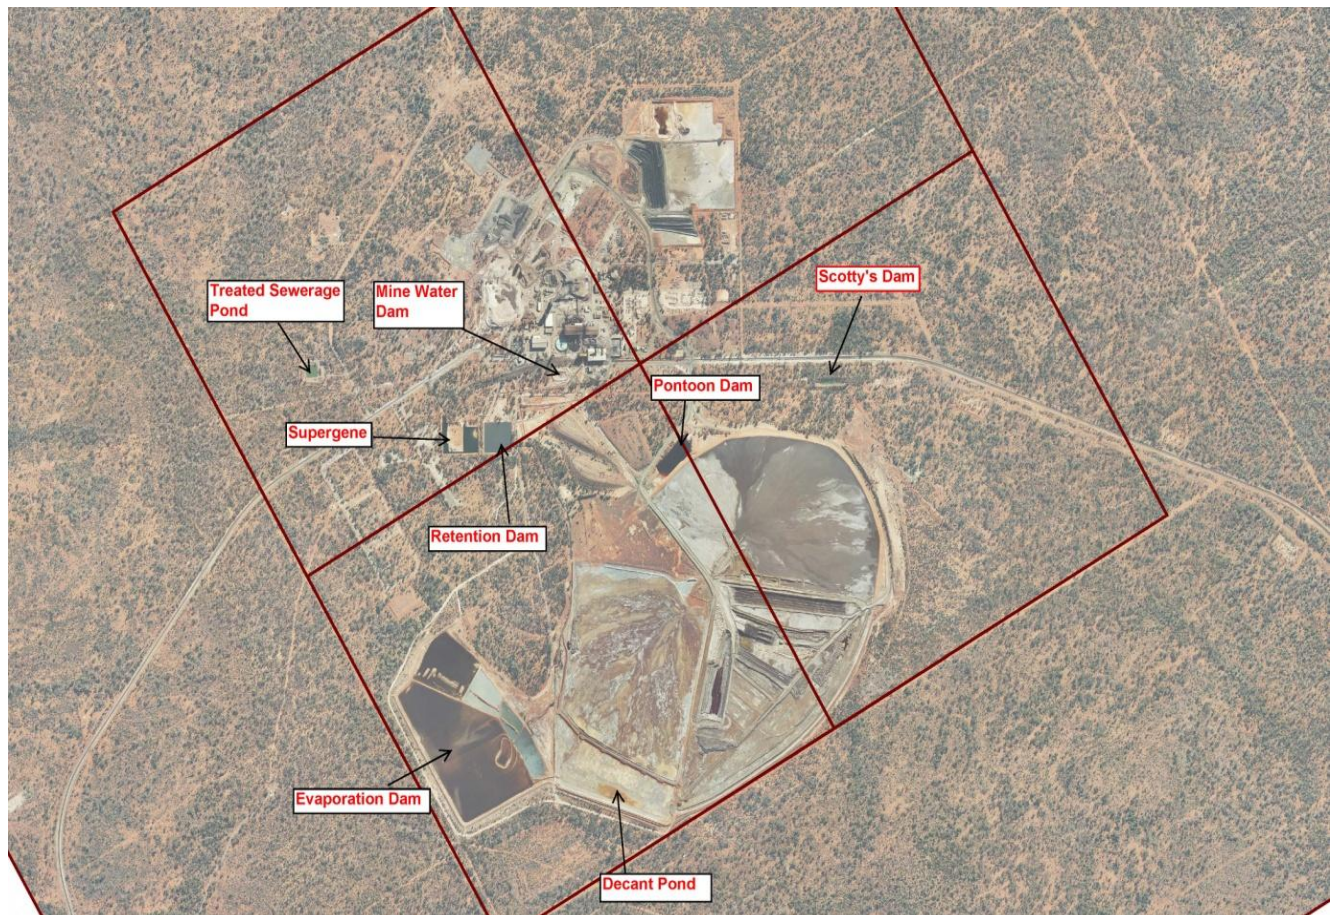
Figure 5.1: The Endeavor Mine: Main Water Storages

Figure 5.1 shows the location of the surface water dams on site that are monitored for water quality bi-annually.

Due to the drought and low rainfall, it is difficult to access water in most of the dams with the exception of the Retention Dam. Access to the water's edge is hazardous. If rain occurs during April and it is safe, samples will be collected.

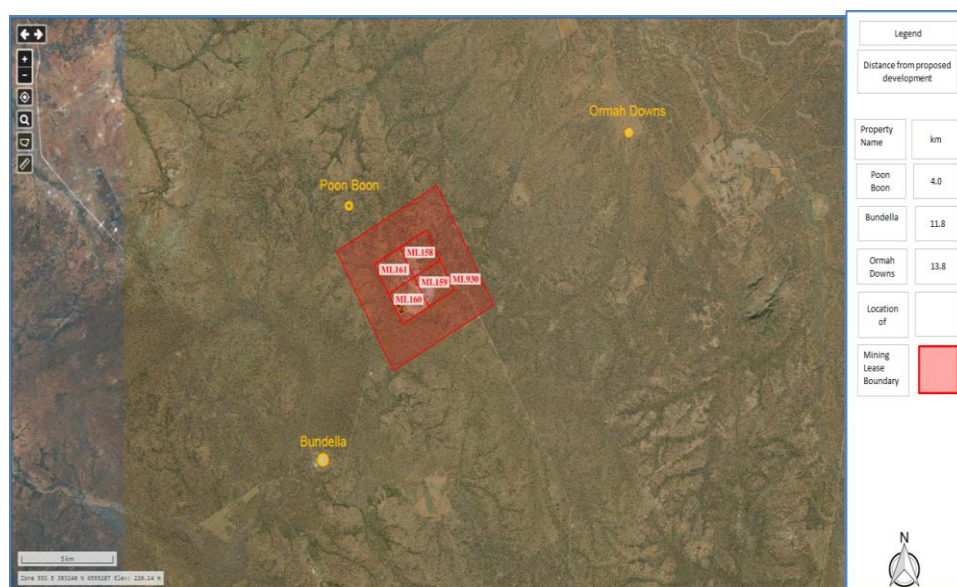
Figure 7.1: Closest Neighbours to Endeavor Mine

Potential Monitoring locations will include neighbouring properties. Figure 7.1 shows the location of the neighbouring properties.
