ENDEAVOR MINE

May 2019 MONTHLY ENVIRONMENTAL REPORT

Monthly Environmental Report

For Month Ending 31 May 2019

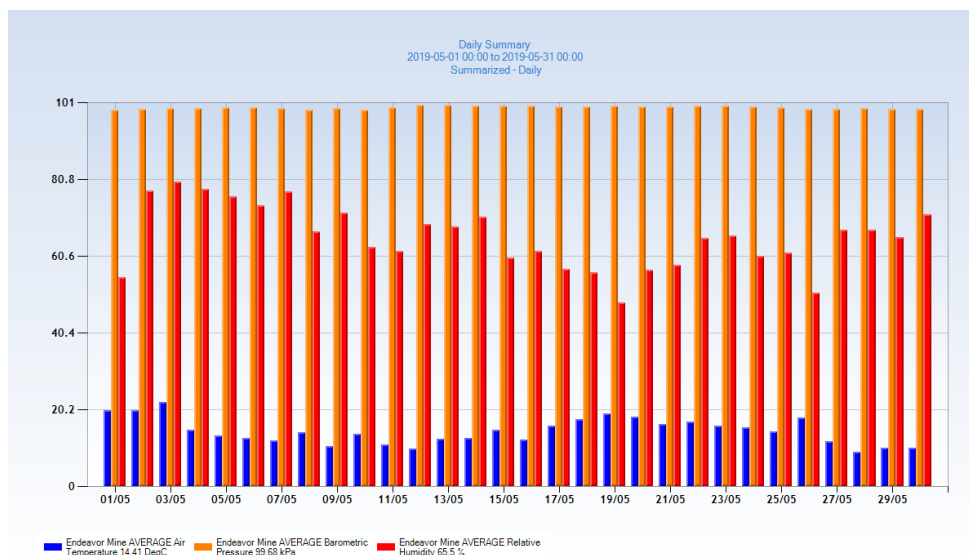
Figure 1.1: Monthly Temperature, Humidity and Barometric Pressure for May 2019

The average air temperature for the Endeavor Mine for May 2019 was 14.41°C with a maximum temperature of 27.2 °C. Figure 1.1 shows the data in a daily graphical representation of averages for Air Temperature, Relative Humidity and Barometric Pressure. Figure 1.2 shows the Daily Maximum Air Temperature for May 2019.

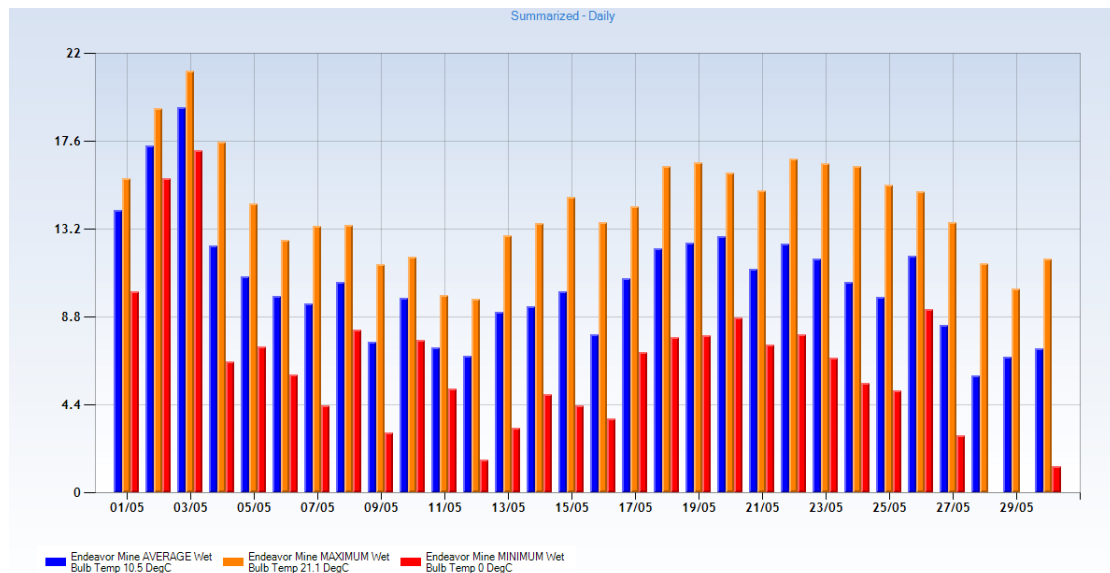
Figure 1.3: Daily Max, Min and Ave Wet Bulb Temperature Levels for May 2019

Figure 1.3 shows the Maximum, Minimum and Average Wet Bulb temperature. All maximum measurements remained well under the 27⁰ threshold and show surface Wet Bulb work conditions to be safe during May.

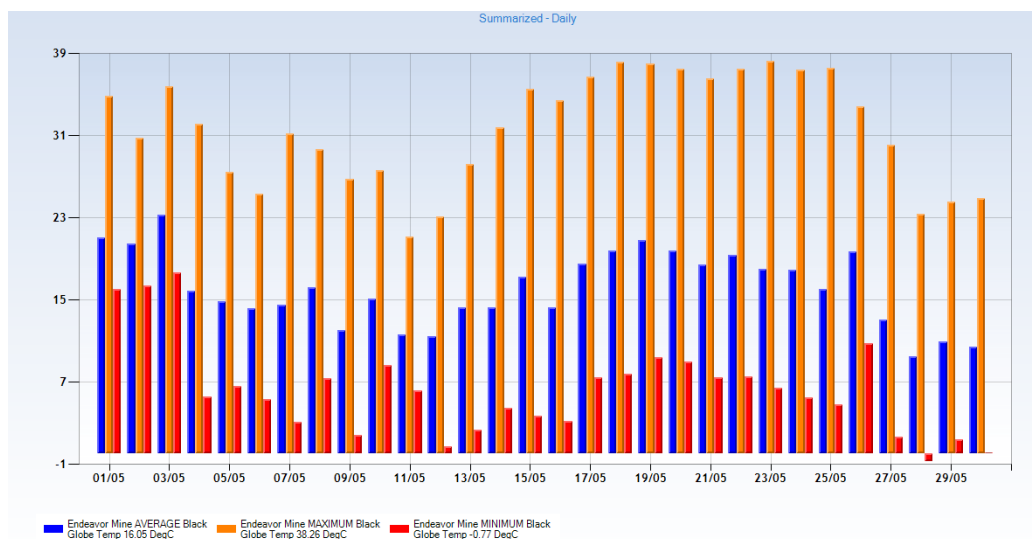
Figure 1.4: Min, Max and Ave Black Globe Temperature for May 2019

As shown in Figure 1.4, the measurement of Black Globe Temperatures was within normal range.

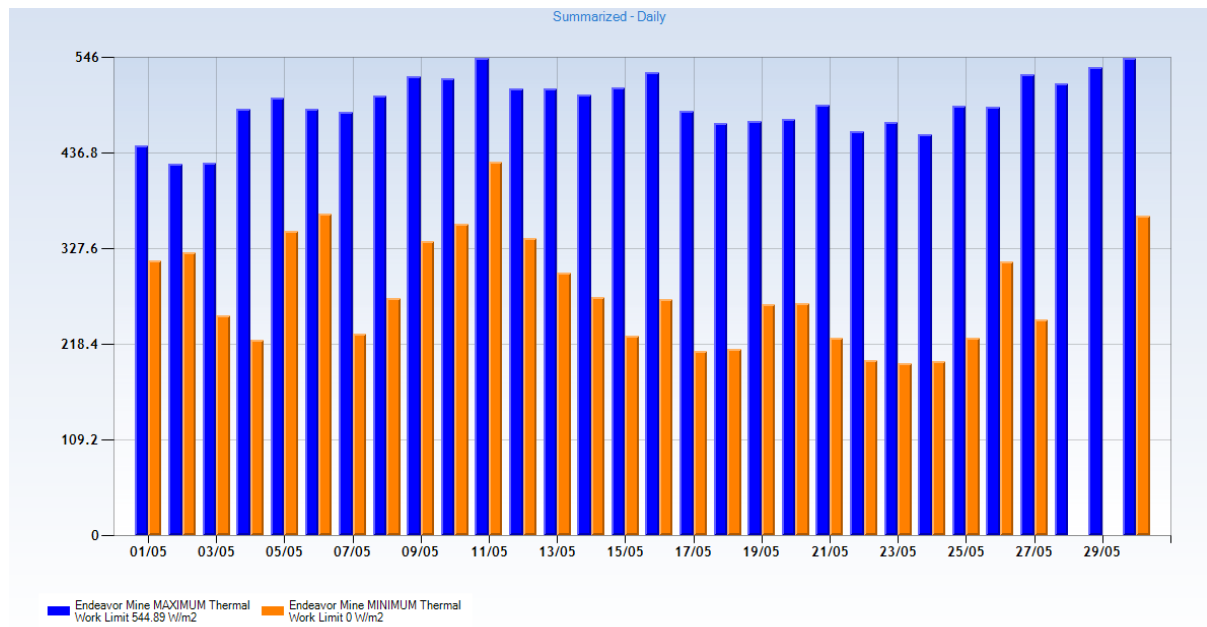
Figure 1.5: Thermal Work Limits: Maximum and Minimum Levels for May 2019

The lower the reading the more risk to human health. As shown in Figure 1.4, that during May 2019, the lowest score was 151.04 W/m² which is a moderate risk requiring safety controls to be initiated.

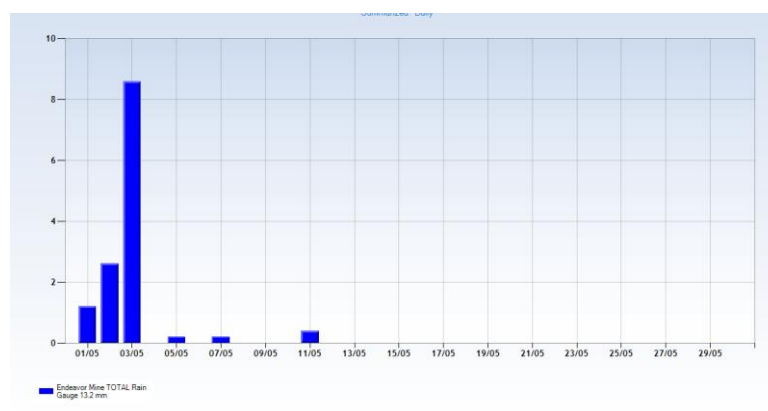
Figure 1.6: Rain Gauge Total for May 2019

Table 1.2 and Figure 1.6 show the daily and total rainfall for May 2019 (13.2mm) and YTD total. YTD for 2019 as of May 31, 2019 was 159.8 mm compared to 2018 of 8.4mm. 1.4 rainfall was recorded during May 2018.

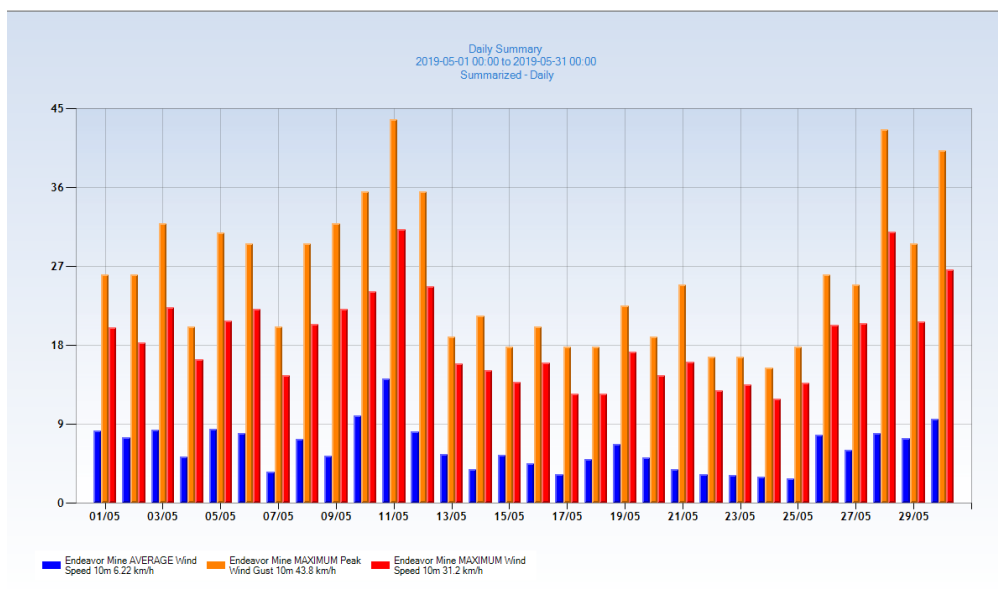
Figure 1.7: Average Wind Speed, Maximum Wind Speed and Maximum Wind Gusts for May 2019

As shown in Figure 1.7, the average wind speed for May 2019 was 6.22km/h with a maximum speed of 31.2 km/h and a maximum wind gust of 43.8 km/h and max wind speed of 36.5km/h.

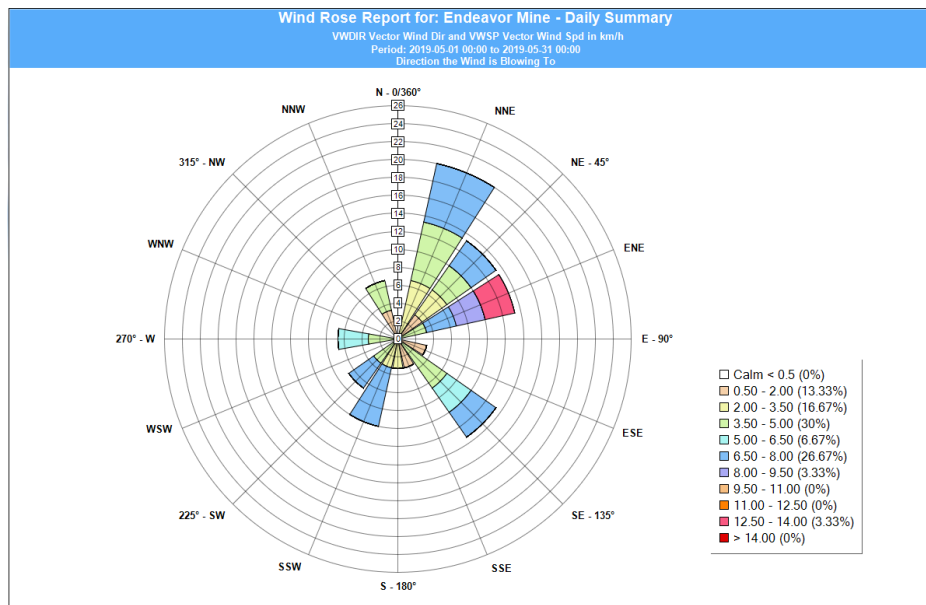
Figure 1.8: Wind Rose for the Endeavor Mine for May 2019

With decreasing air temperatures, wind patterns became more orientated from the South/South West (S/SW). Figure 1.8 illustrates the Wind Rose for the Endeavor Mine for May 2019.

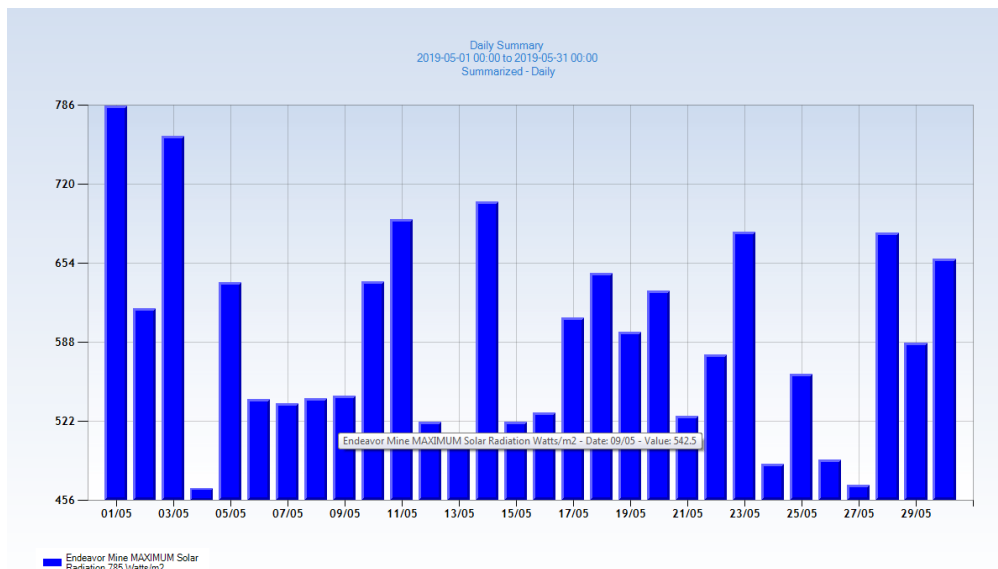
Figure 1.9: Daily Solar Radiation Levels (Ave and Max) May 2019

The Maximum Solar Radiation measurement was 785 Watts/m² (Figure 1.9), which was lower than February but still making a risk requiring PPE or avoidance to reducing direct exposure.

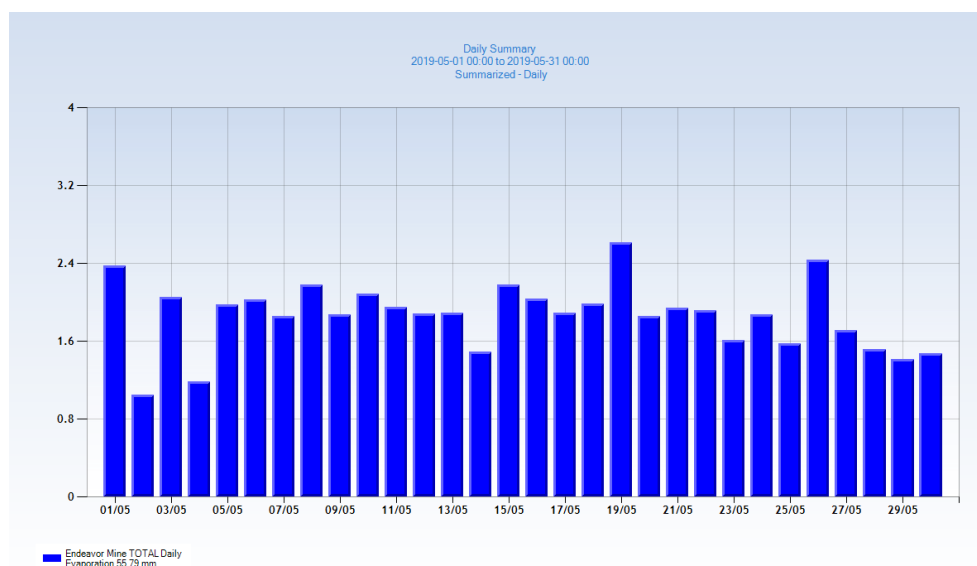
Figure 1.10: Daily Evaporation Rates for May 2019.

As shown in Table 1.3 and Figure 1.10, evaporation rates were considerably lower than February as a result of lower temperatures, lower humidity and solar radiation levels. The Highest evaporation was observed on the 13th of May with a rate of 2.43 mm. Total evaporation for May was 55.79mm. Historically, a reduction in evaporation coincides with a reduction in rainfall. Evaporation is a critical tool in the management of tailings supernatant.

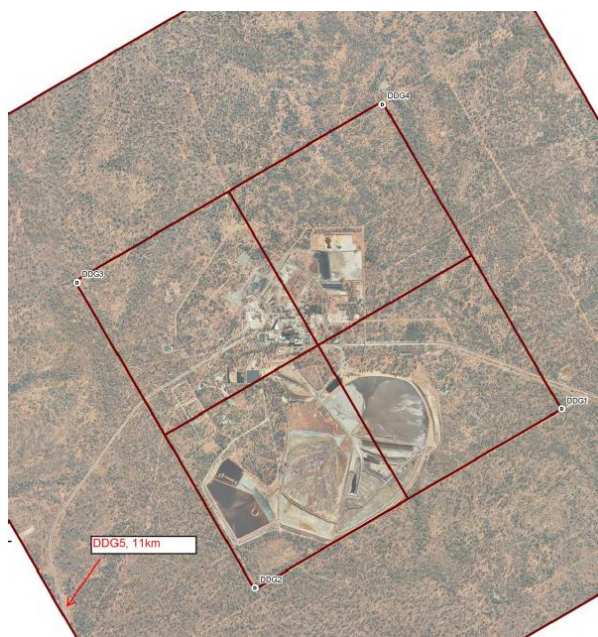
Figure 3.1: Endeavor Mine Dust Monitoring Locations

As shown in the satellite image (Figure 3.1), there are 5 dust monitoring locations on the boundary of the lease, with one located 11kms from the site at the turnoff to the Mine site near the Louth Road. This station was positioned to establish background levels.

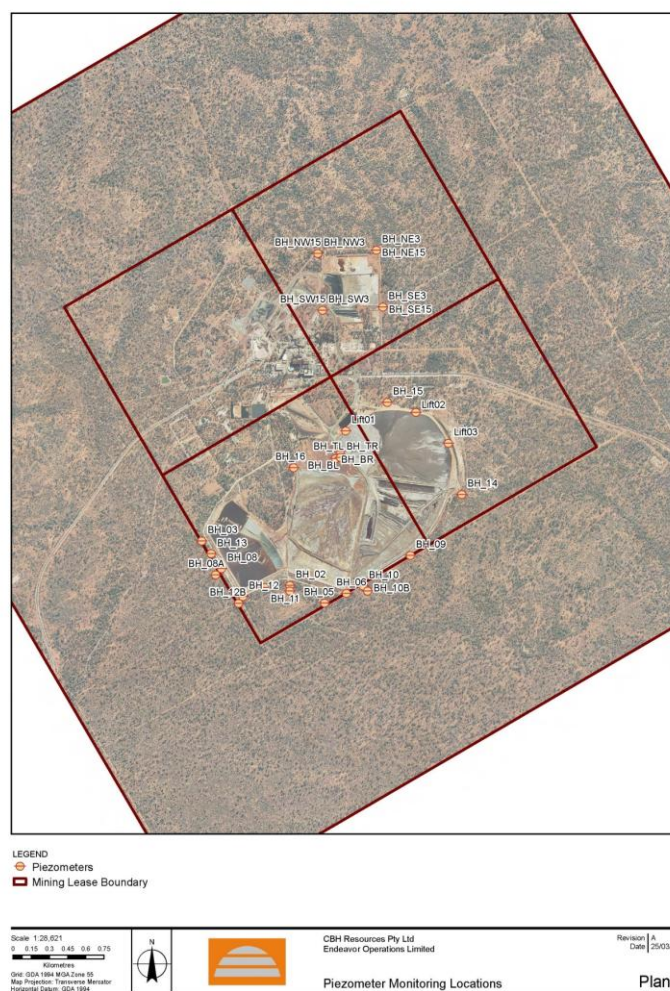
Figure 4.1: Location of the Piezometer Monitoring Locations

Endeavor Mine's groundwater monitoring locations are concentrated around the perimeter of the Central Tailings Discharge (CTD) and the Sector 5 Tailings Storage Facility (CTF), while surface water monitoring locations are focused on water storages that could potentially discharge to environment during a major rain or storm event. Table 4.1 describes the monitoring stations where Figure 4.1 shows the locations of the piezometers. Depending on availability of water or flow, unfortunately on some occasions, piezometers cannot be monitored as a result of being dry.

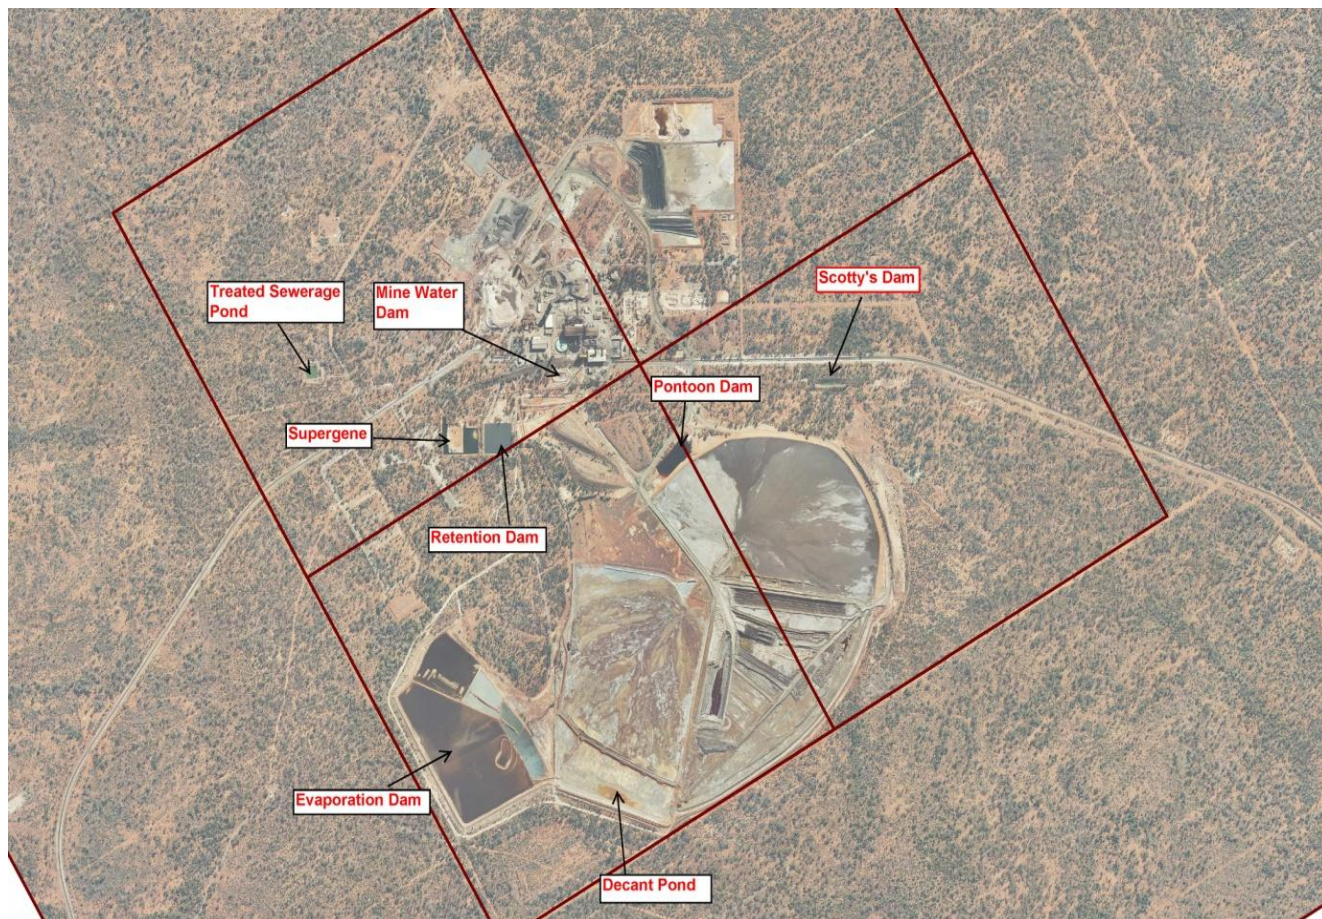
Figure 5.1: The Endeavor Mine: Main Water Storages

Figure 5.1 shows the location of the surface water dams on site that are monitored for water quality bi-annually.

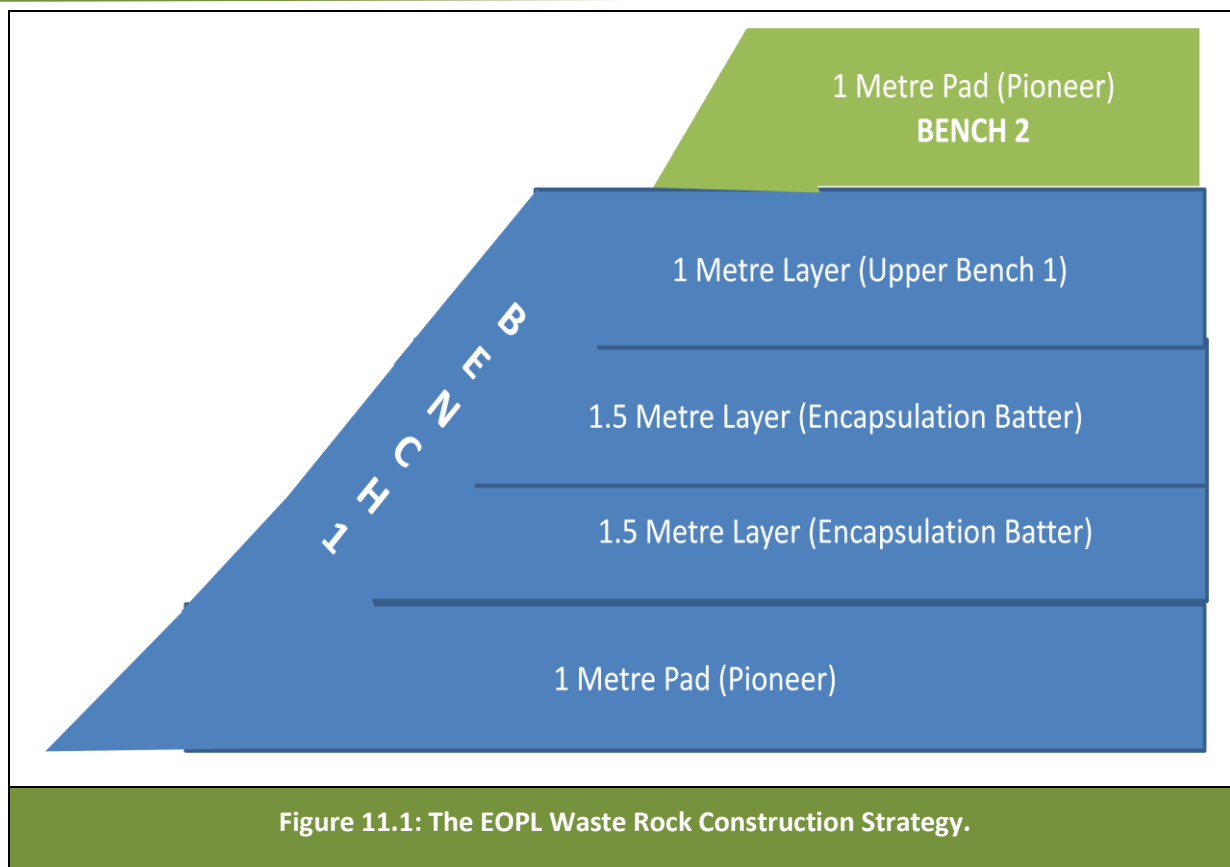
Figure 11.1: The EOPL Waste Rock Construction Strategy.

The storage of waste rock is within the catchment of the Sector 5 TSF. The material is placed on oversized tails and was assessed for geotechnical stability. The bottom up building approach is being applied in the construction which allows for the base batter of 5 metres and any change in volume will impact the top bench, which can be easily reshaped (Figure 11.1). Due to the nature of the tailings base, a layered approach was used as recommended by Golder Associates Pty. Ltd.

This involves the footprint being covered with a 1 Metre “pioneer” layer or pad. This provides an even coverage and place less point pressure on the in situ tails. Once in place, the next 1.5m encapsulation batter will be constructed to create the second level of the batter around the perimeter to encase any problematic material identified. This material will be encapsulated and capped using the 1.5metre 3rd level. The upper level will be compacted using heavy machinery prior to the laying of the pioneer pad for Bench 2.

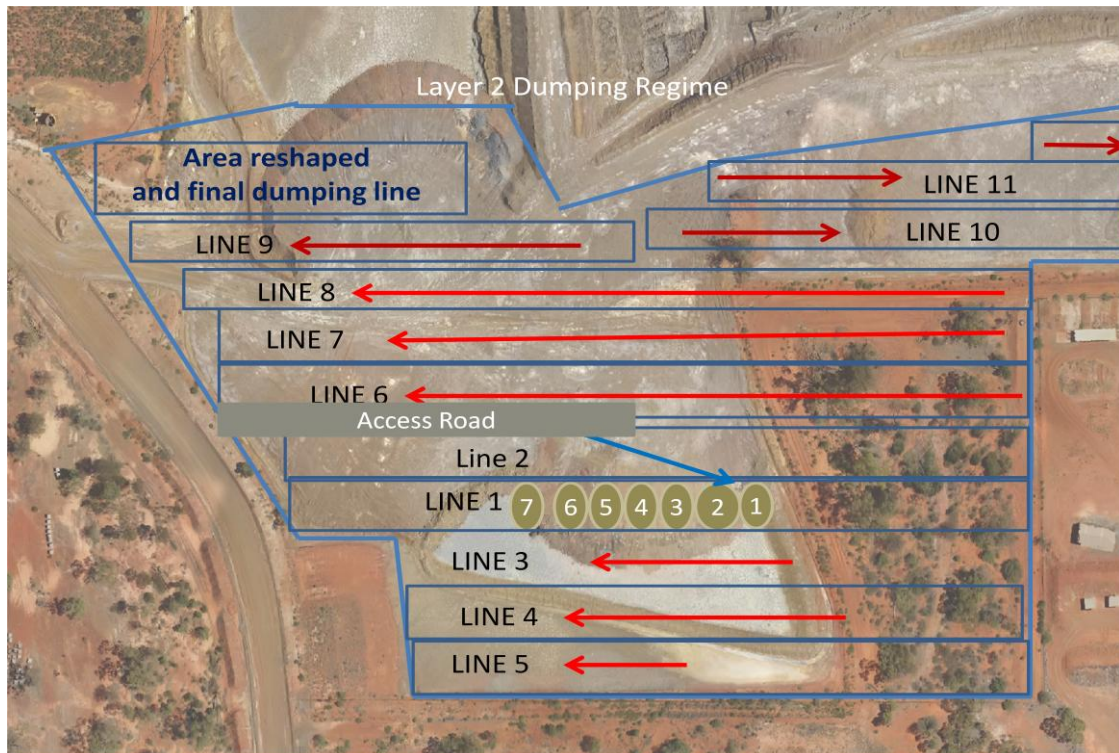
Figure 11.2: Waste rock placement plan

The initial placement of rock was done using a method of paddock dumping, spreading and compacting to create a 1 metre impervious barrier or “Pioneer” layer. This is Layer 1. The material will be pushed to the south and south east (Figure 11.2). The edge of the dump is designed to end 2 meters inside the fence line. Drainage and windrows will be constructed on the outer edge and will be designed to run water back into an exterior toe drain, reporting back to Pit 1 (Figure 11.3). Once the layer covers the designed footprint, the next layer (Layer 2) will follow the process. It is expected that the finalisation of the waste rock placement will be in the 3rd quarter 2019.
